Geo-Disaster Report

Large-scale flowslide in Sibalaya caused by the 2018 Sulawesi earthquake

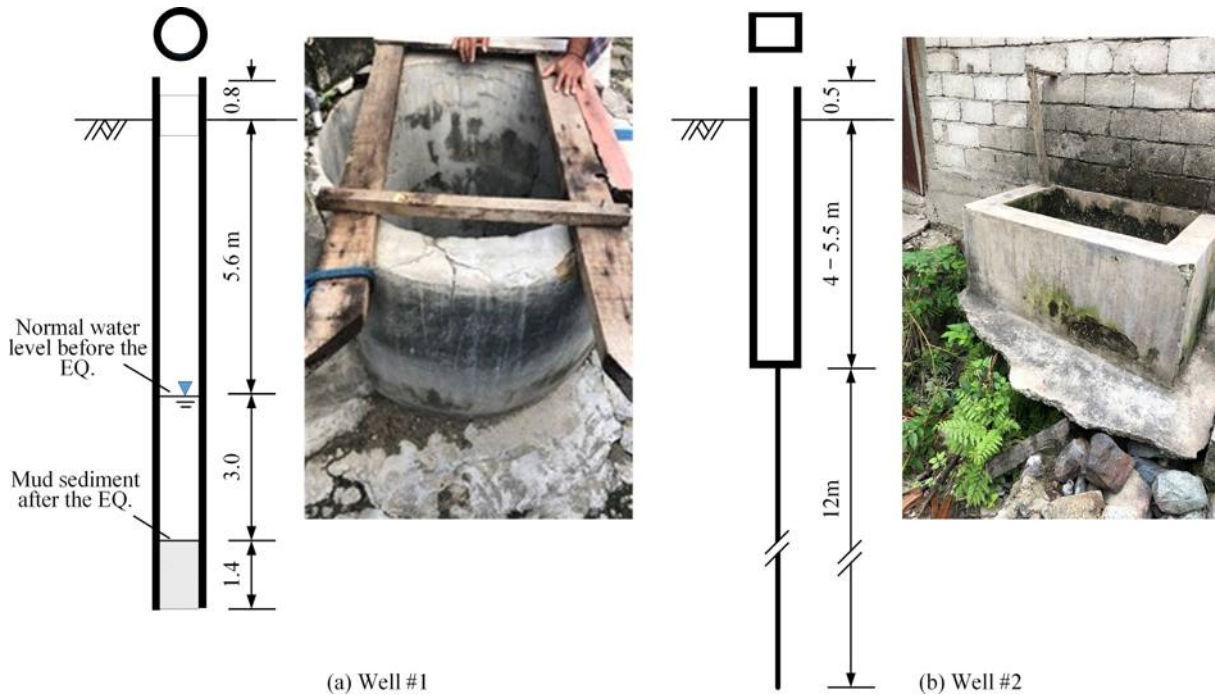
Fig. 2. Photos and cross sections of wells near flowslide area.

hood. Additionally, even several weeks after the earthquake, water could not be pumped up from all the wells except for well #3, whose pipe tip depth was 17.5 m below the ground surface, while for the rest, it ranged between 12 m and 17.5 m. Therefore, it is reasonable to assume that the ground water table was at 5.6 m and 17.5 m before and after the earthquake, respectively.

to rice paddies. It is most likely that water leakage from the unlined irrigation channel allowed water to seep down-slope, maintained the ground water level high, approximately at 5.6 m high before the earthquake, which resulted in an increased liquefaction potential.

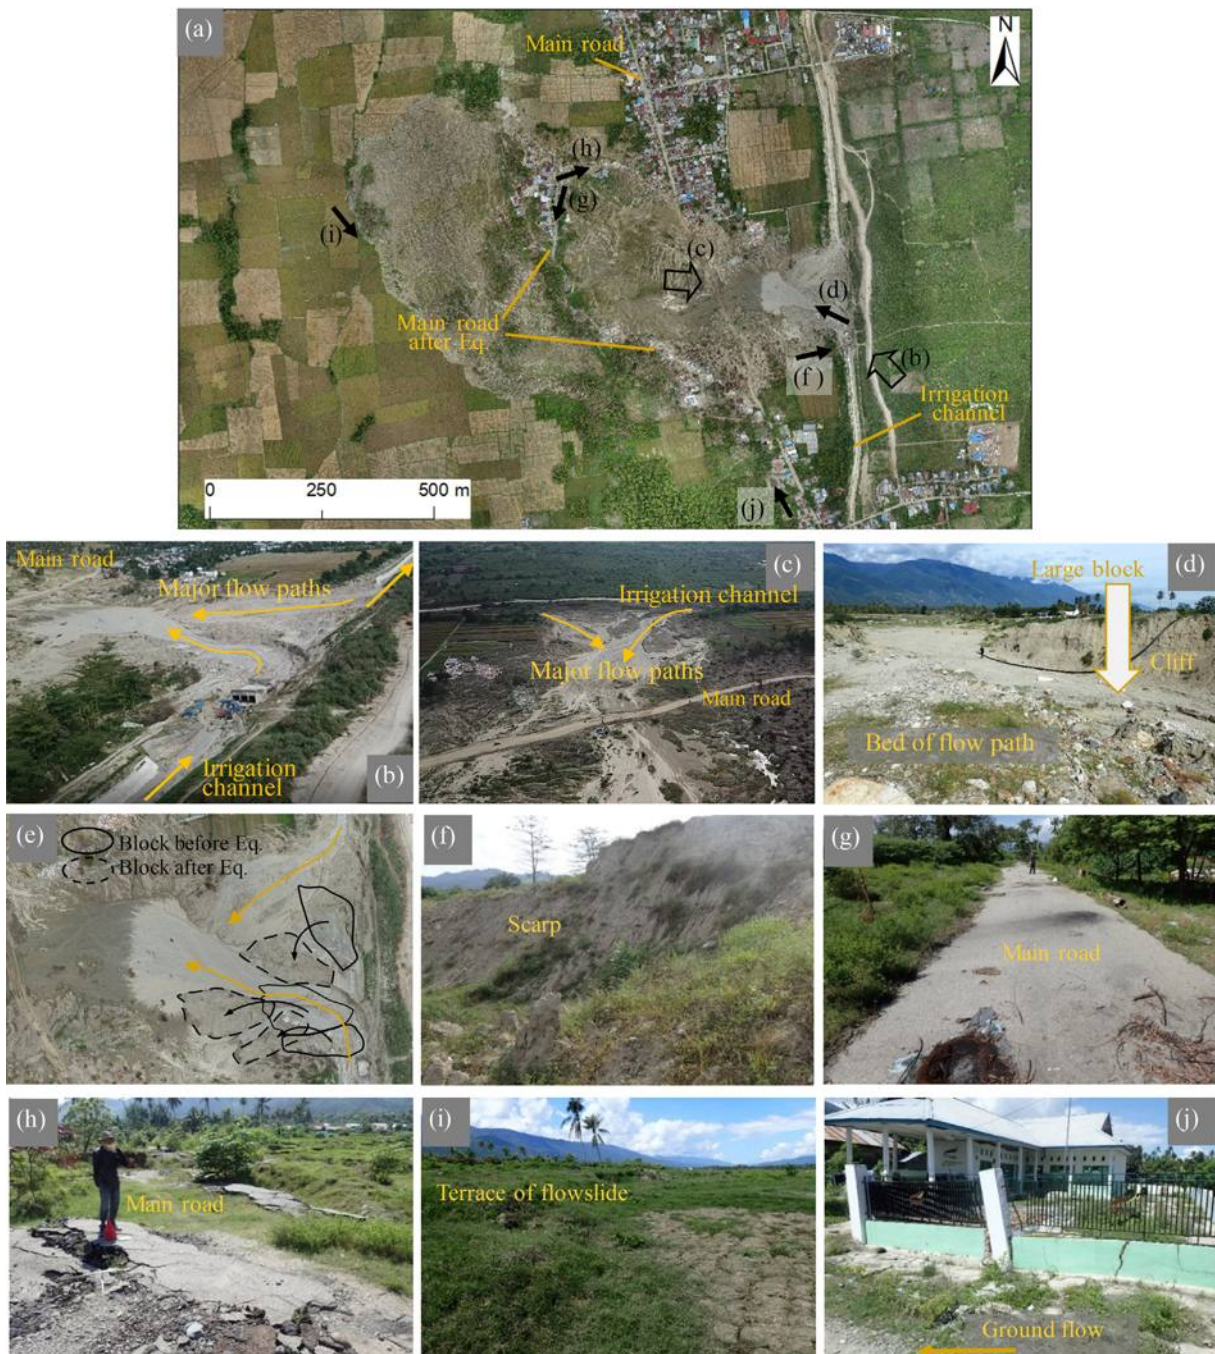
Fig. 3. (a) Orthophotomaps after the EQ (Courtesy by JICA, November 4, 2018). (b)–(j) Photos at locations in and around the flowslide area.

Fig. 3 shows the orthophotomap after the earthquake and photos of several locations. The easternmost margin of the affected area is bounded by the irrigation channel. Arrows in Fig. 3(a) indicate locations and orientations of photos shown in Fig. 3(b)–(j). Concrete panels were

placed on the eastern side surface of the channel, while soil was exposed unlined on the bottom and western sides (Fig. 3(b)). In one southern breached channel section, a box culvert and a sluice gate were heavily damaged, which was most probably the cause of the extremely loud sound heard by the residents. Fig. 3(c) demonstrates the overview of inundation area. There were two major flow paths from the channel that created a cliff as high as several meters (Fig. 3(d)). In this area, as shown in Fig. 3(e), three large blocks were identified, with dimensions of the largest block as 80-m-long and 42-m-wide, that moved about 50 m downwards, which most possibly triggered the irrigation channel failure. Meanwhile, head scarps were formed along the western side of the channel (Fig. 3(f)).

Structures including roads, houses, fences, channel, trees, and footpaths between rice fields were mapped on the two orthophotomaps before and after the earthquake to obtain pre- and post-earthquake locations. Corresponding points were connected to identify the direction and magnitude of ground displacement. The derived displacement vectors are presented in Fig. 4 together with topographic contours before the earthquake at 1-m intervals. Note that the number of mapped points added up to 280; all the points were used to evaluate the strain distribution in the area as described later in Fig. 5. However, in Fig. 4, only about half of them are presented to avoid unfavorable complication. The flowslide generally moved west-northwest, which was normal to the topographic contours. The largest flowslide displacement was in the northern half of the area, ranging between 320 m and 410 m (average 350 m), while smaller in the southern half. Fig. 3(g) illustrates the original main road pavement remained almost intact even after sliding down 360 m. The displacement decreased near the northern and southern margins of the flowslide area, which distorted the ground and ruined structures. Fig. 3(h) presents the main road pavement torn into pieces near the northern margin. The westernmost margin of the flowslide mass after the earthquake was clearly observed as a terrace 1–2 m higher than adjacent unaffected area (Fig. 3(i)).

In areas outside the flowslide, there also exist clear signs of liquefaction-induced lateral spreading. Fig. 3(j) shows concrete wall cracks with a 15 cm-opening, while the house behind tilted about two degrees, which are typical structural damage commonly presented in areas of liquefaction-induced lateral spreading in past earthquakes. Such evidential incidents were observed in many locations including all those surveyed wells shown in Fig. 2(a), indicating that foundation soil of wider area in Sibalaya indeed liquefied. Similar observations were reported for Petobo and Jono Oge (GEER, 2019; Kiyota et al., 2020; Hazarika et al., 2020). On the other hand, on the east of the irrigation channel, any noticeable indication of soil liquefaction was not found in the field survey and UAV photos, indicating that the irrigation channel affected the liquefaction occurrence. Meanwhile, based on the report by GEER (2019), the irrigation channel provided water for agricultural activities and was unlined until it reached the northern edge of the Petobo slide. The unlined channel allowed water to infiltrate downhill towards the river, which contributed to a higher groundwater table and deposit saturations, while increasing liquefaction potential during earthquake shaking.

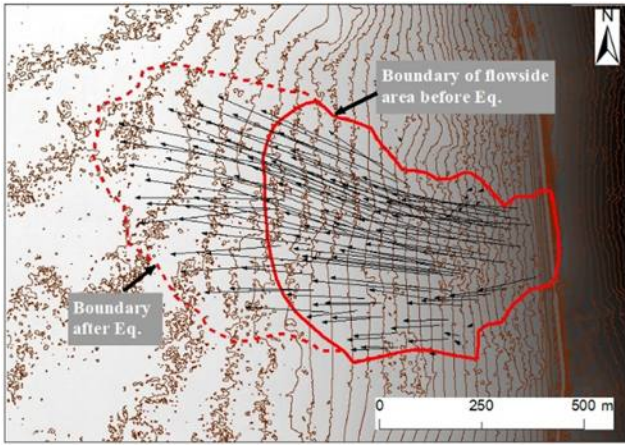
Fig. 4. Displacement vectors and contours before the earthquake.

The red solid line was drawn to inclusively cover all the vector origins in Fig. 4, representing a boundary before the earthquake between flowslide ground mass and ground that did not flow. The boundary moved west-northwest to the broken line. It is most likely that the ground between the two lines did not move significantly, and soil in the upstream side slid and covered the surface.

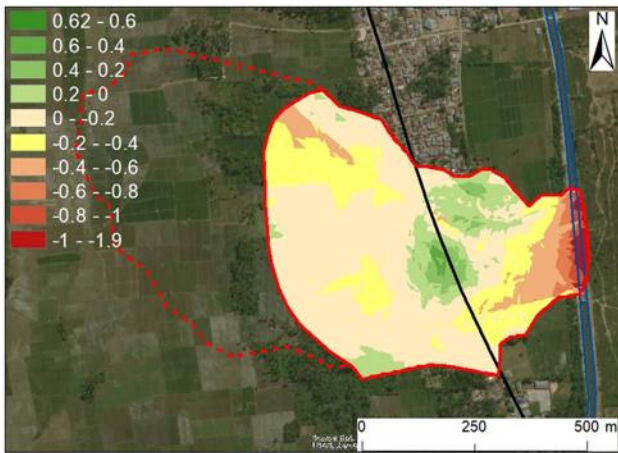
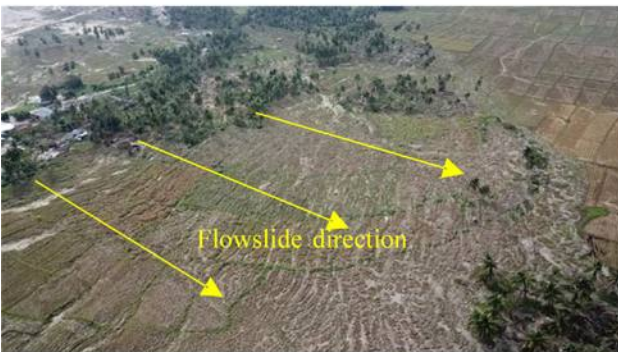
Fig. 5. Contours of strain in east-west direction and aerial photo of downslope area.

Fig. 5 presents a normal strain contours in the east–west direction that provides a clear view of the overall deformation characteristic. Strain is negative (tension) and extremely large in an originally narrow area between the irrigation channel and the large blocks translated downslope. Similarly, in the area of the upstream rice pads that immediately in the downslope side of the blocks (see Fig. 1(b)), large tensile strain ranging between 20% and 60% can be observed. In this area, all the structures, rice pads and trees that had been there were translated about

350 m and failed to survive the earthquake. By contrast, in the area between the upstream and downstream rice pads including the original road, the tensile strain is relatively smaller than surrounding areas or even positive (compression). Meanwhile, in the downstream rice pad area, large tensile strain is observed, which is also confirmed by surficial observation that many crack openings were filled with sand ejecta, with orientations mostly normal to the flowslide direction appeared (Fig. 5(b)). These observations suggest that tensile deformation in the flowslide direction generally prevailed in the flowslide area. However, the area of some 100 m width along with the original main road kept its integrity even after the deformation (Fig. 3(g)), while flowslide displacement of the area was somewhat smaller than the surrounding area. This might be because houses in this area pumped up ground water, which increased in thickness of the unsaturated stiff surface.

(b) Many significant cracks appeared in downslope area of the flowslide

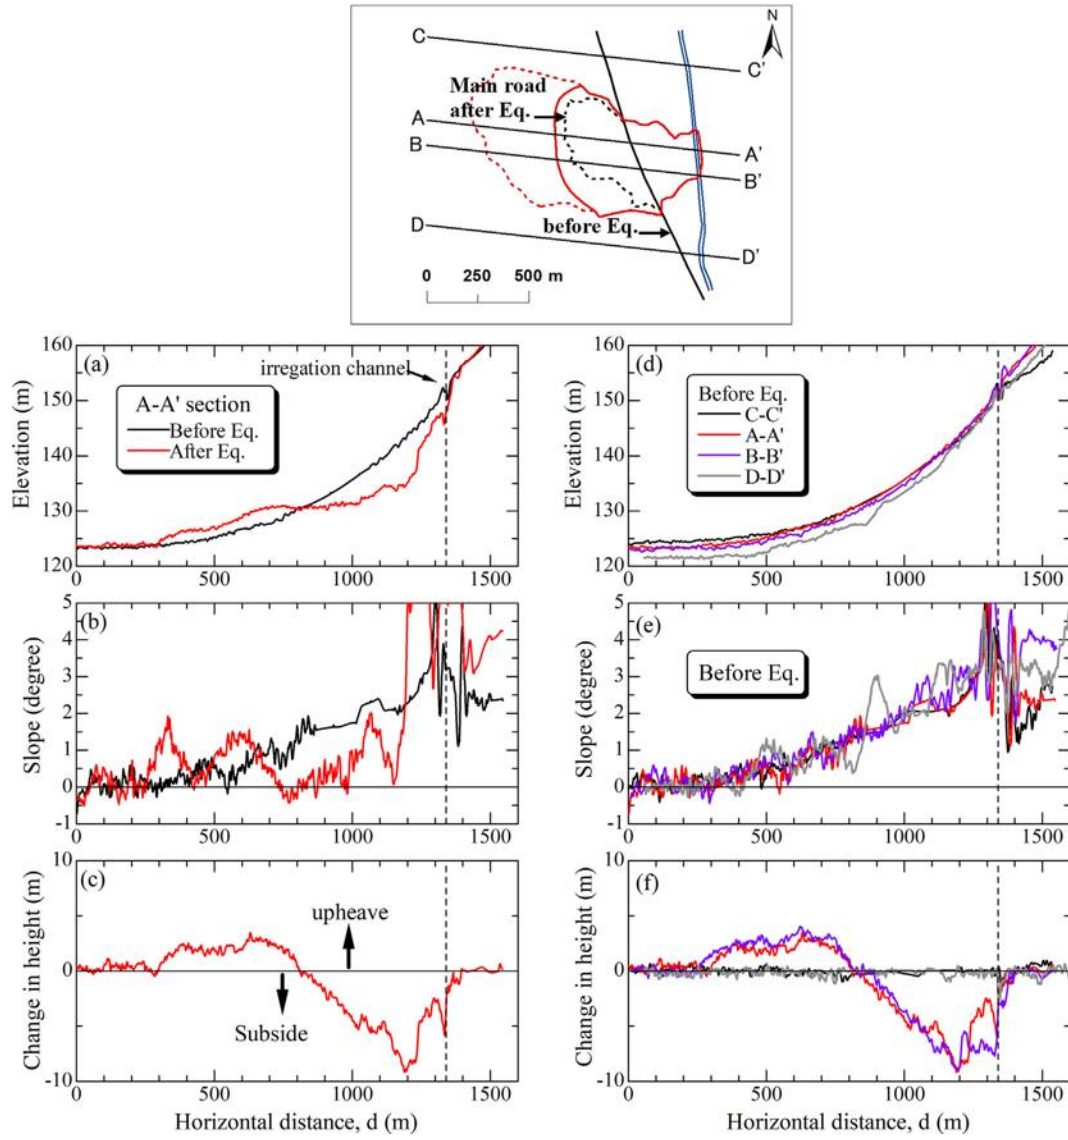
Fig. 6. Height of ground surface in sections parallel to the flowslide.

was three degrees at around the irrigation channel and gradually decreased as going down the slope to approximately zero near the westernmost margin, $d = 300$ m, where the flowslide finally reached. After the earthquake, the slope was particularly large at around $d = 1250$ m corresponding to the side cliff of the large block created by

flooded water erosion and the adjacent soil flowslide. Change in height (subsidence) was large at the upstream side, decreased to zero at $d = 800$ m, and turned into heaving until the flowslide margin ($d = 300$ m), as indicated in Fig. 6(c).

Fig. 6(d)–(f) compare vertical sections of the main-stream (A-A') and the sub stream (B-B'), as well as two sections outside the flowslide area (C-C' and D-D'), in which all the sections were chosen to be parallel to each other. The topography of all these sections before the earthquake were quite similar although deformations were significantly different. Differences in conditions other than topography including soil stratification, mechanical properties of soil and ground water table, should be the reasons for the different deformations between the sections.

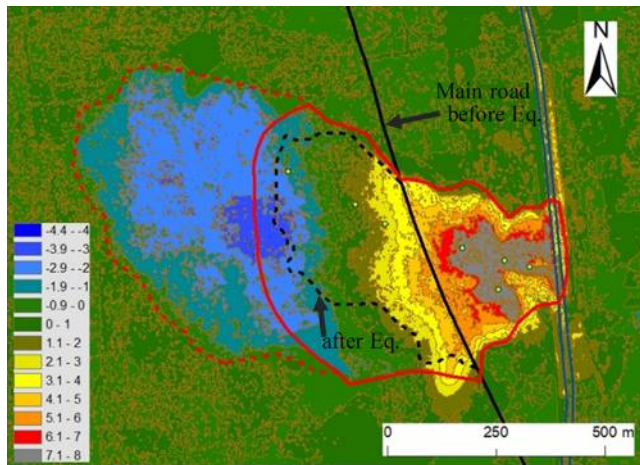
Fig. 7. Contours of change in elevation (in meter).

Fig. 7 represents change in height in the flowslide and surrounding areas. The area of the flowslide represented by the polygon in red in Fig. 4 is 534,700 m², consisting of 339,200 m² subsiding area and 195,500 m² heaving area. The total volume of subsidence and heaving are 609,900 m³ and 745,900 m³, respectively. Consequently, the average subsidence over the entire flowslide is 0.25 m, while that of the area outside the flowslide is also estimated to be 0.013 m, with the subsidence in the area in the east of irrigation channel being generally very small.

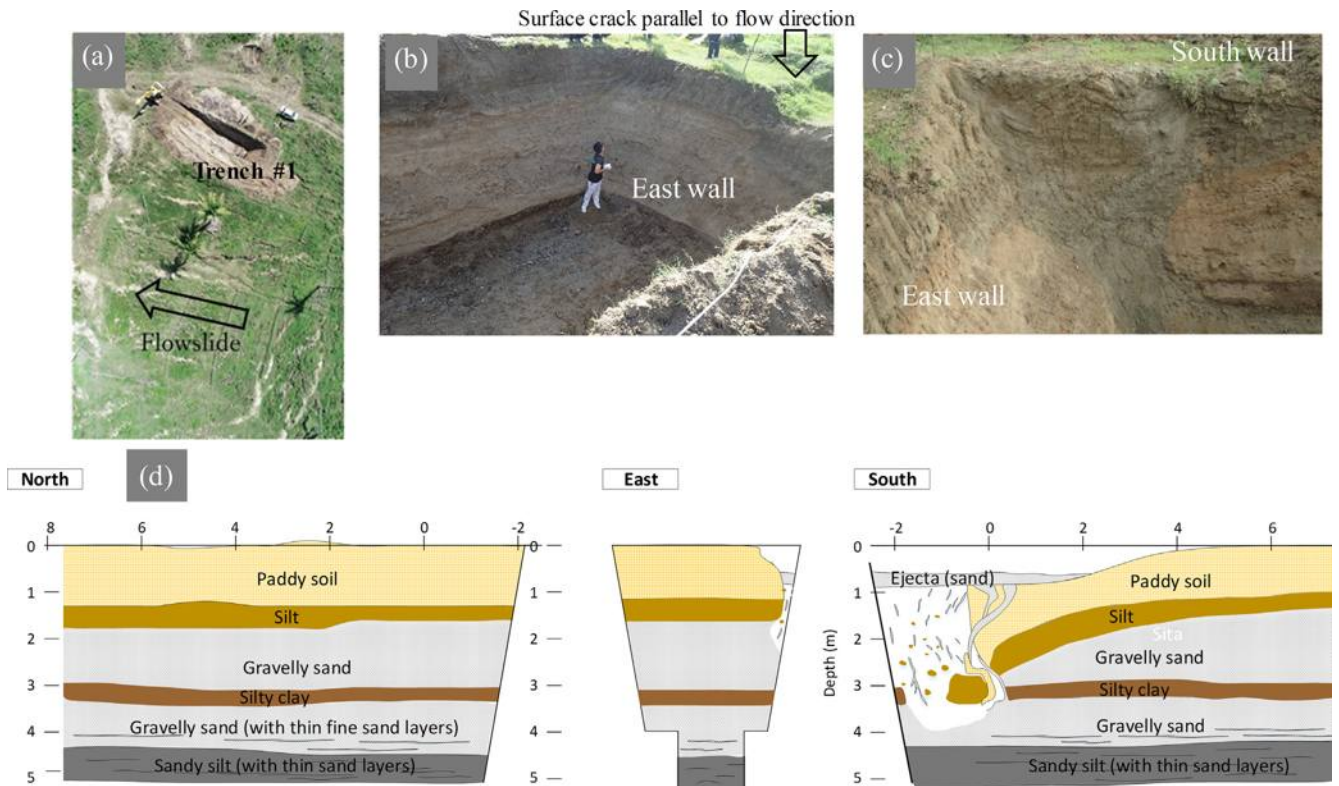
Fig. 9. Trench #1 and its walls. (a) Aerial photo (b) North and west walls in the trench (c) South-east corner in the trench (d) Sketches indicating stratification of soil layer exposed on the walls.

Fig. 9(a) shows an UAV photo of the trench #1, whose ground surface had been in the upstream rice pad, approximately 150 m downslope of the irrigation channel and 200 m upstream of the original main road. A 17-m-long and 5-m-wide area was excavated with the longitudinal axis parallel to the flowslide direction. White lines perpendicular to the flow direction are cracks filled with ejecta from liquefied layers formed by the tensile deformation (See Fig. 7). Meanwhile, smaller cracks parallel to the flow direction are also observed. Fig. 9(b) and (c) present the east and the south walls of the trench, respectively. Considering stability, all the walls of the trenches in this report were cut at a slope angle of 75-degree or less (approx-

imately 1H:3V slope). The east wall cut a crack while there exist ejecta at around the south-east corner. Fig. 9(d) illustrates sketches of the walls. The ground surface was covered with a paddy soil containing stalks and roots of rice overlaying a thin silt layer. These layers were mostly intact, but a difference was noted with respect to the south east corner of the trench. A gravelly sand layer underlying these surface layers was configured by several sand and sandy gravel layers of 10–30 cm thick, with a few thin silty sand layers with thicknesses of the order of ten cm sandwiched in between. The surface of this layer drooping towards the south-east corner suggests that this layer was liquefied and was squeezed near the corner. A thin stiff silty clay layer, which was separating two gravelly sand layers, was found to remain intact except for the corner. The lower gravelly sand layer was mostly uniform with only a few thin interlayers included near to its bottom. It has been observed in all the exposed walls that the typical configuration of non-liquefied gravelly sand layer was a stack of sand and sandy gravel layers every 10–30 cm thick, with thin silty sand layers having thicknesses of the order of ten centimeters sandwiched in between. This fact suggests that both the upper and lower gravelly sand layers liquefied, but due to the flowslide, only the lower gravelly sand layer highly sheared. Stratifications and thin interlayers in this layer were disappeared during long distance flow deformation. The sandy silt layer at the bottom of the trench contained thin interlayers of silt and fine sand (of

the order of one cm thick) with its surface being level and flat. Furthermore, the soil at the south-east corner is highly disturbed, a part of the silty clay layer was distorted and sand dikes extended from lower sandy gravel layer to the surface while many small fragments of fractured silt layer were contained.

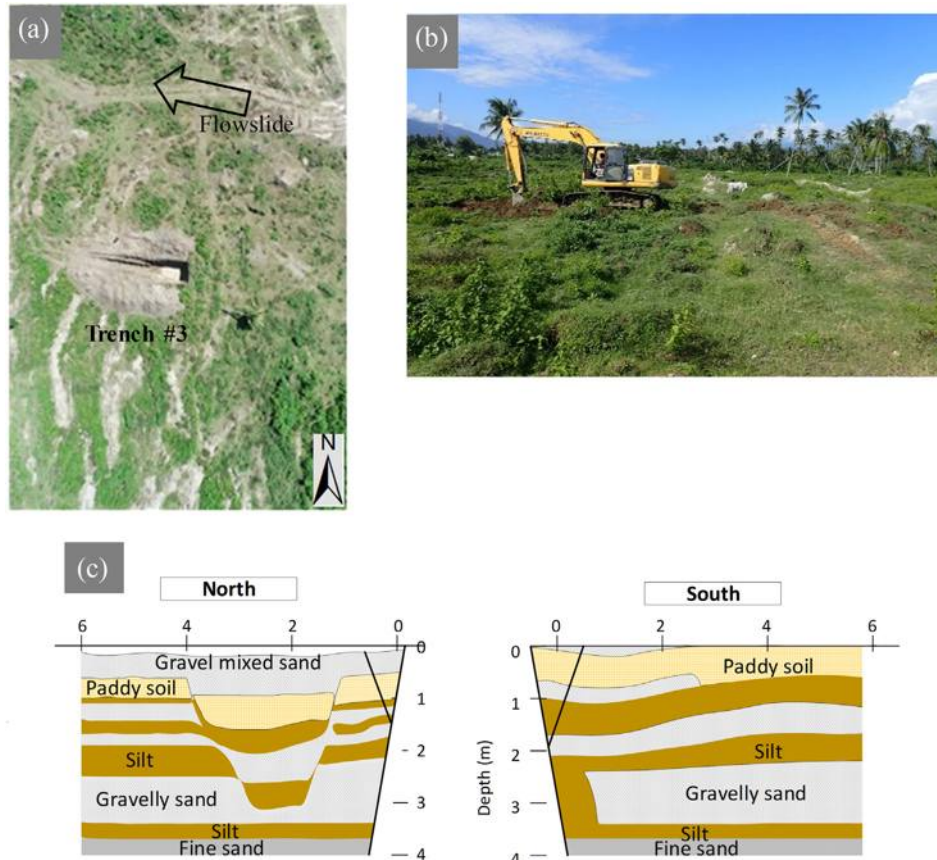
Fig. 10. Trench #3. (a) Aerial photo (b) Site of the trench just before the excavation initiated (c) Sketches indicating stratification of soil layer exposed on the walls.

Fig. 10(a) shows an UAV photo of the trench #3 located at 80 m upstream from the trench #1. The ground surface had been the upstream rice pad, located approximately 70 m downslope of the irrigation channel. This trench had dimensions of 15-m-long and 5-m-wide, with the longitudinal axis parallel to the flowslide direction. Fig. 10(c) presents sketches of the north and the south walls, indicating that the overall figure of the soil stratification is similar to that of trench #1. There were three gravelly sand layers below the surface paddy soil separated by thin silt layers. The gravelly sand layer at the greatest depth was largely uniform and did not have any laminar and interlayers, while the other two gravelly sand layers at shallower depths had. Moreover, the silt and fine sand layer at a depth from 3.5 m and 4 m from the surface seemed intact. Thus, it can

be claimed that the liquefied and largely deformed layer is the lower gravelly sand layer.

It should be noted in the north wall sketch that a part of the shallower layers fell into the underlying lower gravelly sand layer, which is a typical deformation pattern that can be observed in the trap-door-experiment (e.g. Stone and Wood, 1992). The soil mass clearly defined by the two conjugate slip surfaces behaved as a block, suggesting that the upper and middle gravelly sand layer did not liquefy. The block located immediately below the white band appeared on the ground surface (Fig. 10(a)), which is described as a tensile crack filled with ejecta.

- The water interlayer should be smooth and continuous over the flowslide area. However, as shown in Fig. 10, the soil blocks dropped into the liquefied layer were present, which made the water interlayer discontinuous and obstructed the soil sliding deformation above the layer as *shear keys*, as illustrated in Fig. 16. The existence of many similar tensile cracks suggested the existence of similar shear key blocks.

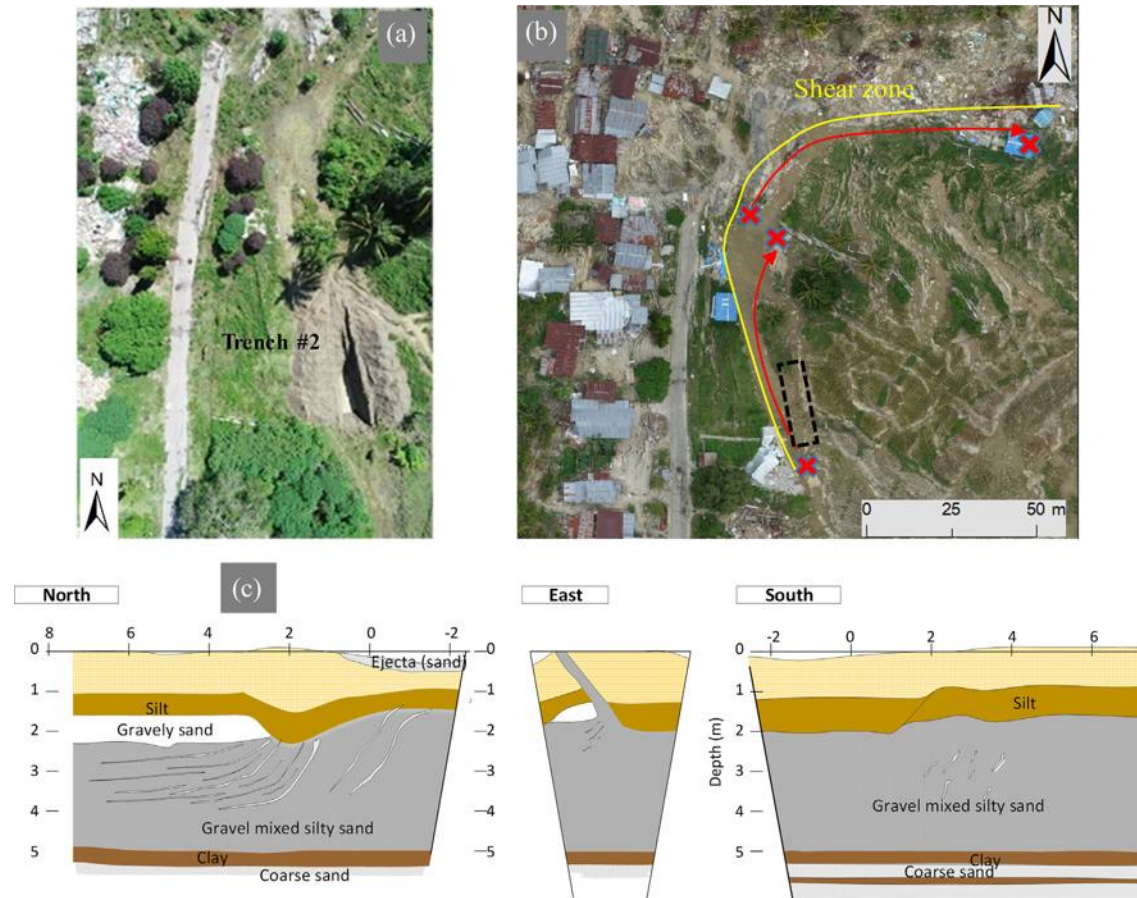
Fig. 11. Trench #2. (a) Aerial photo of the trench #2 (b) Orthophotomap of the wider area around the trench after the earthquake (c) Sketches indicating stratification of soil layer exposed on the walls.

Fig. 11(a) illustrates an UAV photo of the trench #2, which was located at 175 m downstream from the trench #1. The surface of the ground had been a soccer field, 20 m upslope from the original main road. This was the largest trench with dimensions of 20-m-long and 5-m-wide while the longitudinal axis approximately normal to the flowslide direction. It can be seen in Fig. 11(b) that a slip line (shear zone) passed through and divided this area into two blocks. Referring a house and a torn-off fence shown

by red crosses in the figure, the movement of the east side block relative to the west side block is estimated to be 55 m. The trench #2 was excavated on the shear zone between the two blocks. Fig. 11(c) demonstrates sketches of the north, east and south walls. A surface layer with silt layer underneath was similar to those in the trenches #1 and #3, while with a difference that a single thick sandy gravel layer was found below the surface layers, which was highly disturbed with apparently higher fines content in contrast to the trenches #1 and #3. Many clay fragments and dikes of clean fine sand with several centimeters width randomly existed, indicating that the layer was highly disturbed. It can be assumed that this layer was consisted of multiple sandy gravel layers, which were separated with thin silt layers but mixed altogether due to the extremely large shear deformation during the flow sliding. Thin interlayers of silt or fine sand remained only in a clay and a coarse sand layers at the bottom of the trench.

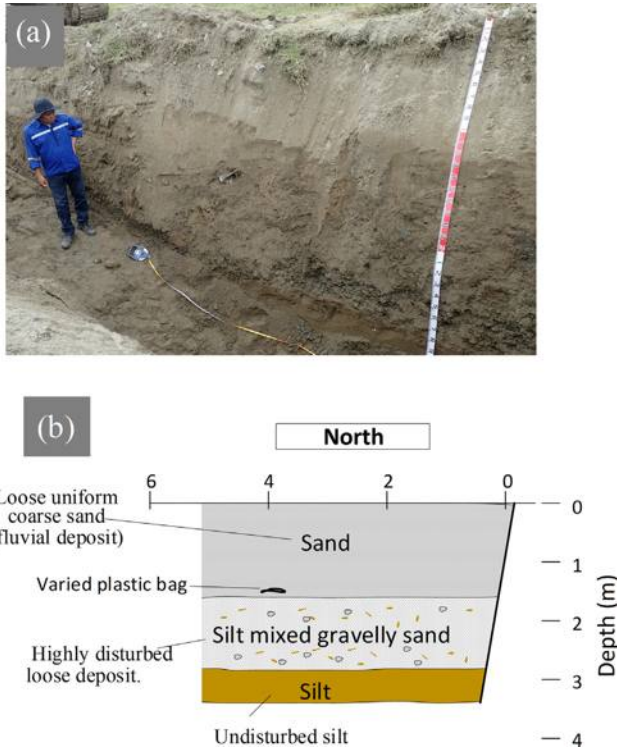
Fig. 12. Photo and sketch of trench #4.

compared to those in the downstream trenches. Fig. 12 shows a photo and a sketch of trench #4. At the ground surface, clean uniform coarse sand loosely deposited to the depth of 1.7 m. The color and grain size distribution of the sand were different from any layers in the downstream trenches #1, #2 and #3. In this layer, a relatively new plastic bag and garbage were found, indicating that it was a fluvial deposit brought by the flooding water from the irrigation channel. From 1.7 to 3 m below the ground surface, there was a highly disturbed layer without any thin interlayers included, whose soil was gravelly sand with many small clay and silt fragments being heterogeneously mixed, and was most likely liquefied and highly sheared as the overlaying surface layers slid downslope. A silt layer at 3 m deep observed as undisturbed, which contained thin interlayers of fine sand remained (several mm in thick).

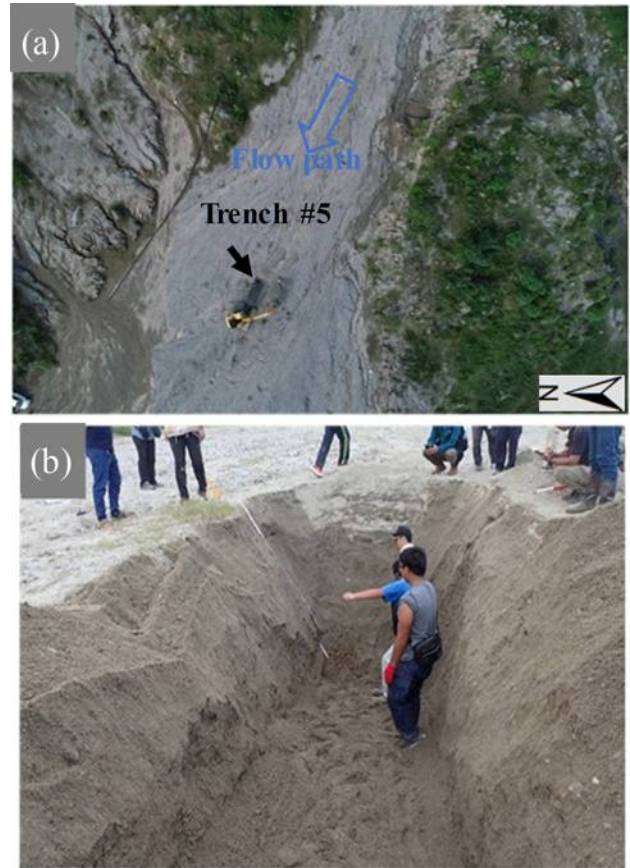
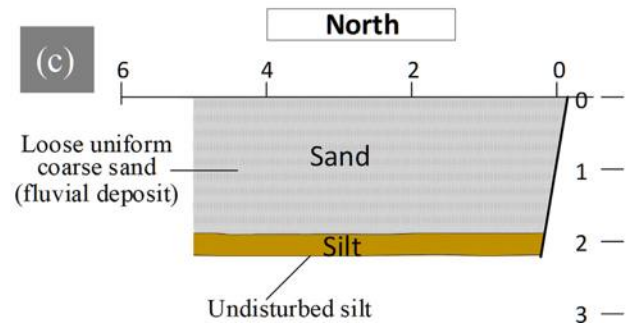
Fig. 13. Photos and sketch of trench #5.

Although trench #5 located only 30 m upstream from #4, the width of the inundation flow path at this location was approximately 2.5 times narrower than that at #4, suggesting that flow rate of the flooding water was considerably higher than #4. Fig. 13 indicates photos and a

sketch of the trench. The trench was excavated with the longitudinal direction parallel to the flow path. Clean uniform coarse sand, which is considered to be fluvial sand loosely deposited, and an undisturbed silt layer were appeared at a depth of 2 m. A possible scenario of deposit formations at trenches #4 and #5 is that the gravelly sand layers liquefied during the earthquake, while the overlying soils slid down to the slope and liquefied layer been exposed. During the flooding event triggered by the irrigation channel failure, the liquefied gravelly sand was fully flushed by the flooding water at #5, but only the surface of the liquefied sand was eroded at #4 because flooding water spread out and flow rate decreased at #4. Thereafter, the flow rate has slowed down and uniform coarse sand loosely deposited on the surface at both #4 and #5.

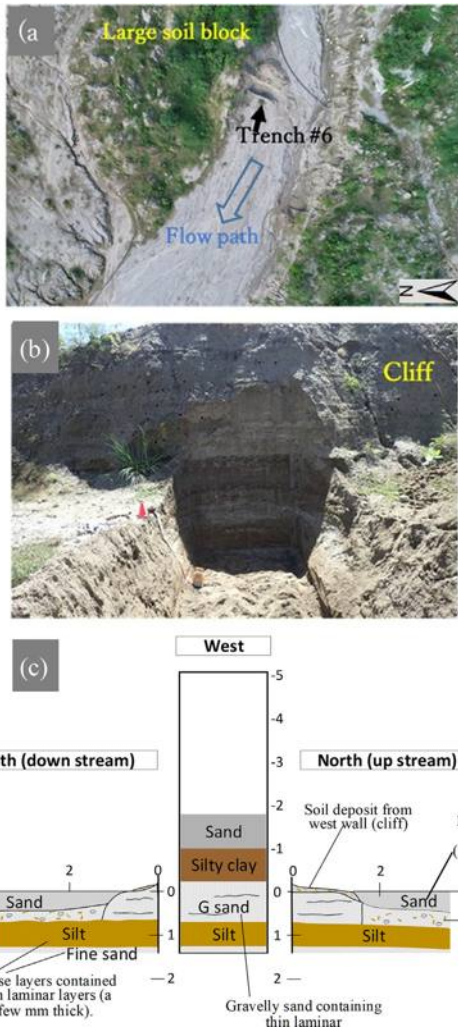
Fig. 14. Photos and sketch of trench #6.

Trench #6 was excavated at 105 m upstream from #5 and 120 m downstream from the irrigation channel on the side of a cliff of one of the large soil blocks and at the flow path edge. Fig. 14 depicts photos of the trench and sketches of the walls. The cliff of the block was 5 m high from the flow path bed and consisted of layers of gravelly sand, silt and silty clay, with all of their thicknesses in a range 10–80 cm. The west wall (Fig. 14(b)) is the cliff of the block. It is reasonable to consider that the gravelly sand layer below the silty clay layer liquefied and sheared, while the overlying soil block slid down approximately 30 m. Soil mass originally existed slid approximately 350 m down to

the slope, which highly disturbed the gravelly sand layer in the south and north wall. The fluvial coarse sand was deposited at the surface while its depth increasing with respect to increase in distance from the cliff.

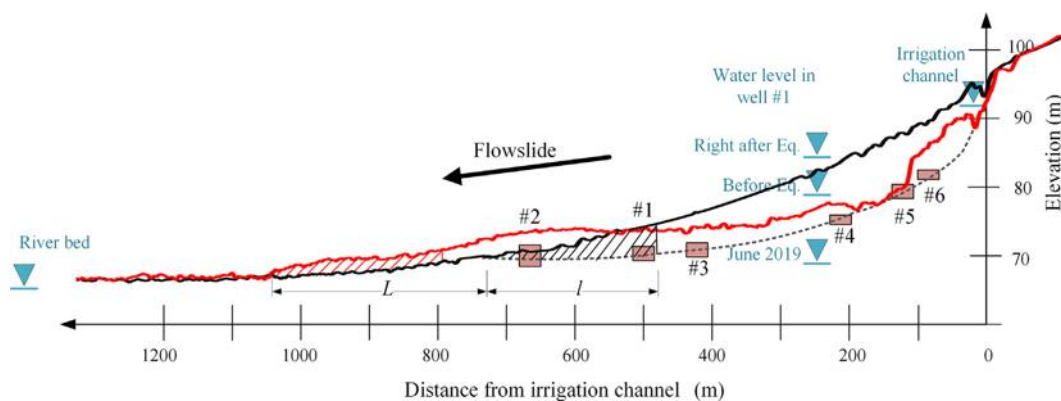
Fig. 15. Cross section of A-A section before and after the earthquake together with highly sheared depths detected in trenches.

Fig. 15 depicts the cross-section A-A' along with the main stream of the flowslide passing through most trenches excavated in this study, together with depths of identified liquefied layers in each trench. The broken line represents a possible slip surface or a shear zone, along which large

shear deformation is considered to have occurred, and soils above the line slid downslope while that underneath remained.

The flowslide is the consequence of the shear resistance of the zone degrading significantly or being completely lost against the sliding deformation. A soil mass in the flowslide

near the westernmost region, which was indicated by the shaded zone in the figure, was chosen as an example. The shear resistance mobilized along the base of the mass, τ_r , can be estimated simply based on the energy conservation as follows:
