Geo-Disaster Report

Large distance flow-slide at Jono-Oge due to the 2018 Sulawesi Earthquake, Indonesia

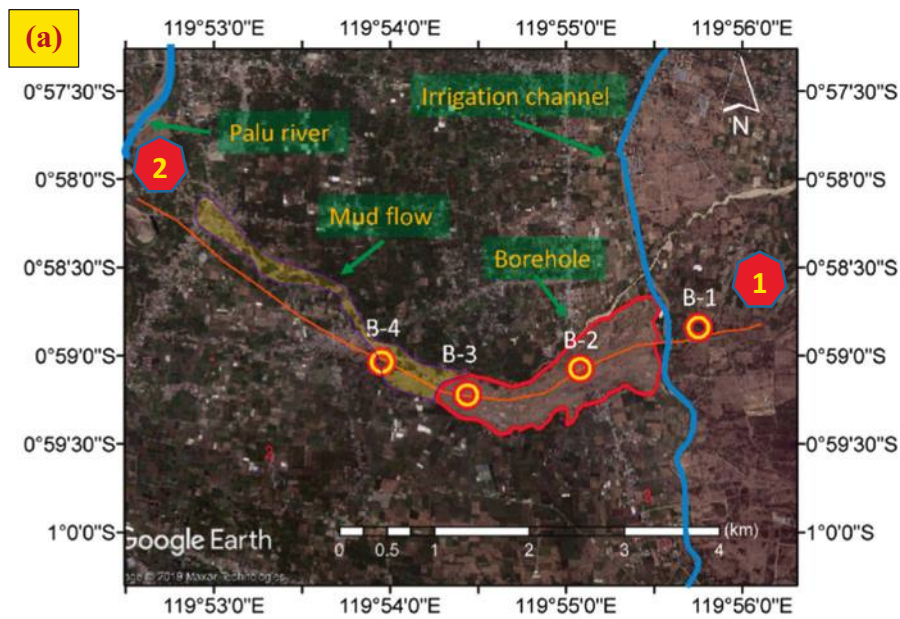
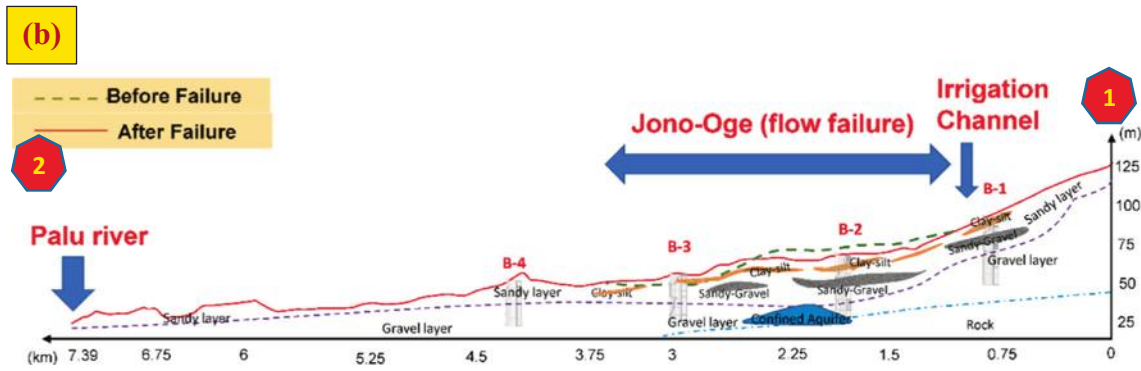
As shown in Fig. 9a and b, the flow-slide in Jono Oge started from the crown next to irrigation channel in eastern edge of Palu valley to the toe deposits on the western side of failure zone. The slide spread over 1.5 km² of area with

maximum displacement of 2 km. The slide swept away the residential buildings as well as the connecting roads between the north and south of Jono Oge with huge deposition of residuals on top of the sliding surface. It should be noted that the over 90% of the area where the flow-slide occurred was agriculture farms. A high ground water level and underground water in the surficial sandy layers due the presence of irrigation channel likely exacerbated the ground conditions, and contributed significantly to the large scale flow-slide, which extended over a number of kilometers.

Fig. 9. Satellite imagery and ground profile (a) Flow slide after earthquake (c) Cross section at profile 1–2 (Not to scale).

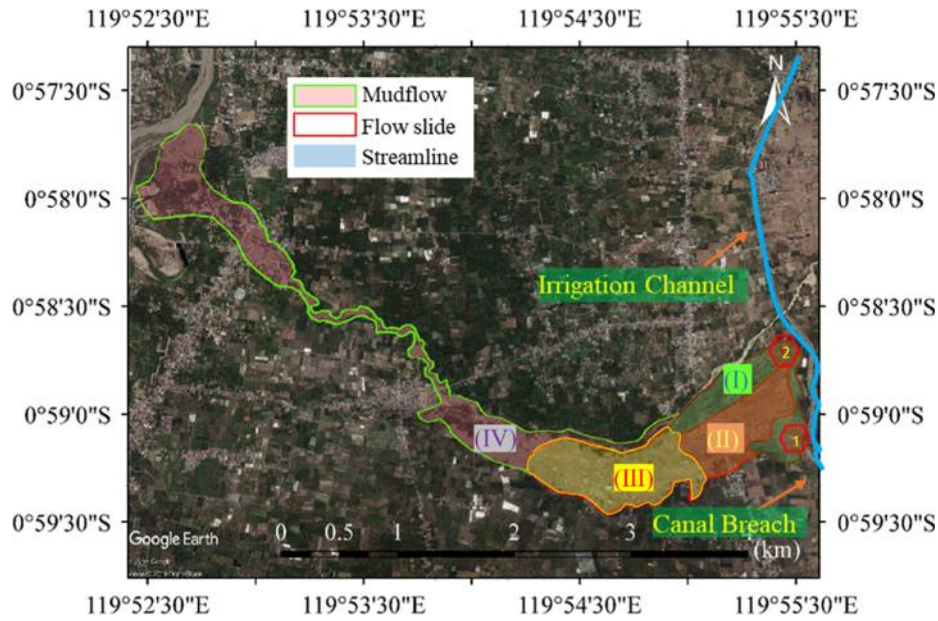
Zone (I): The lands enclosed by Zone (I) are mainly rice and tomato fields with a few numbers of residential buildings. Being the crown (head scrap) of the flow-slide region, Zone (I) extends from northeast side of the failure zone along the western boundary of the irrigation channel to the southeast side, where the failure zone intersects with the channel. The breach of the channel and the destruction of the water gate resulted in the discharge of a huge volume of water, resulting in the scouring of the neighboring fail-

ure bed, as shown in Fig. 11. The subsequent mudflow carried the soil residuals all the way down to the Palu river [Fig. 11]. The flow-slide in zone (II) resulted in the development of extensional cracks, and the rotation and transmission of individual blocks of surficial soils (Fig. 12a). The maximum displacement of soils in this zone varies between 2 and 50 m.

1- Zone (II): The flow-slide began in this zone, and then scouring, erosion and lateral displacement followed. After the onset of liquefaction in the sandy and sandy-silty layers below the ground surface, the top surficial layers started moving in the southwest direction of the failure zone. It carried the soil blocks and residuals along with the runout and deposited them in

2- Zone (III): The deposits of the flow-slide area were collected in this zone as well as the residuals of the rubble and trees which were transported from Zone (II). The transportation distance of soil deposits from zone (III) to zone (IV) due to the mudflow (yellow colored highlighted area in Fig. 10) is not clear. Some of the structures were carried by 1,200 m from the west of the flow-slide region. The mudflow resulted in the pile-up of runouts deposits a few meters in depth in this region (Fig. 12d).

3- Zone (IV): As explained above, the flow-slide in Zone (II) breached the walls of the irrigation channel, resulting in the flow of flood water through Zone (I) and Zone (II) until it joined the stream in the north and traveled the same path to Palu river.

Fig. 10. Divided zones based on ground displacement in flowslide area.

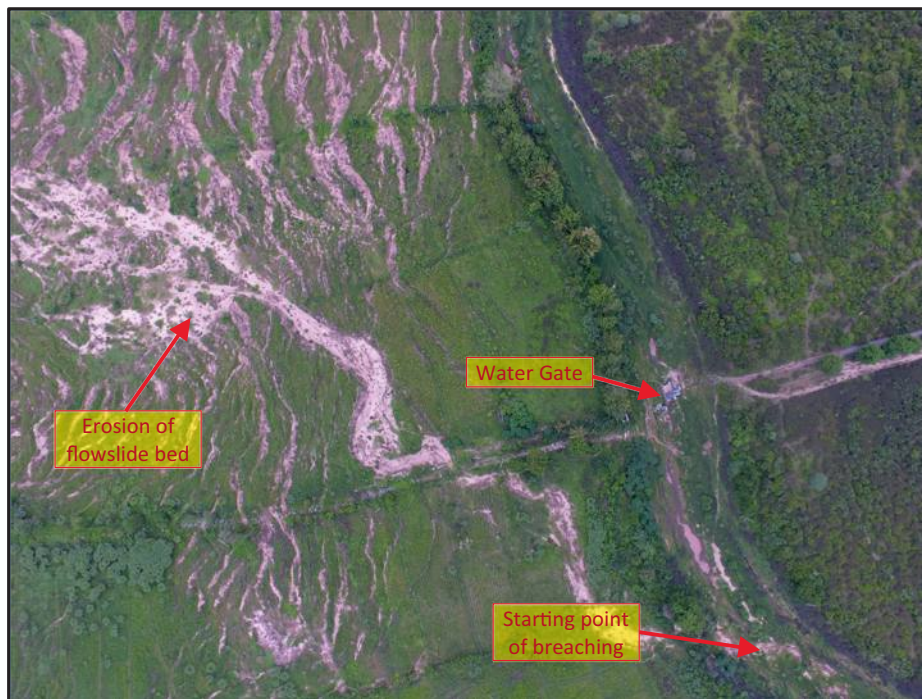
Fig. 11. UAV imagery of channel breaching and water gate destruction in Jono Oge (Location No. 1 of Fig. 10).

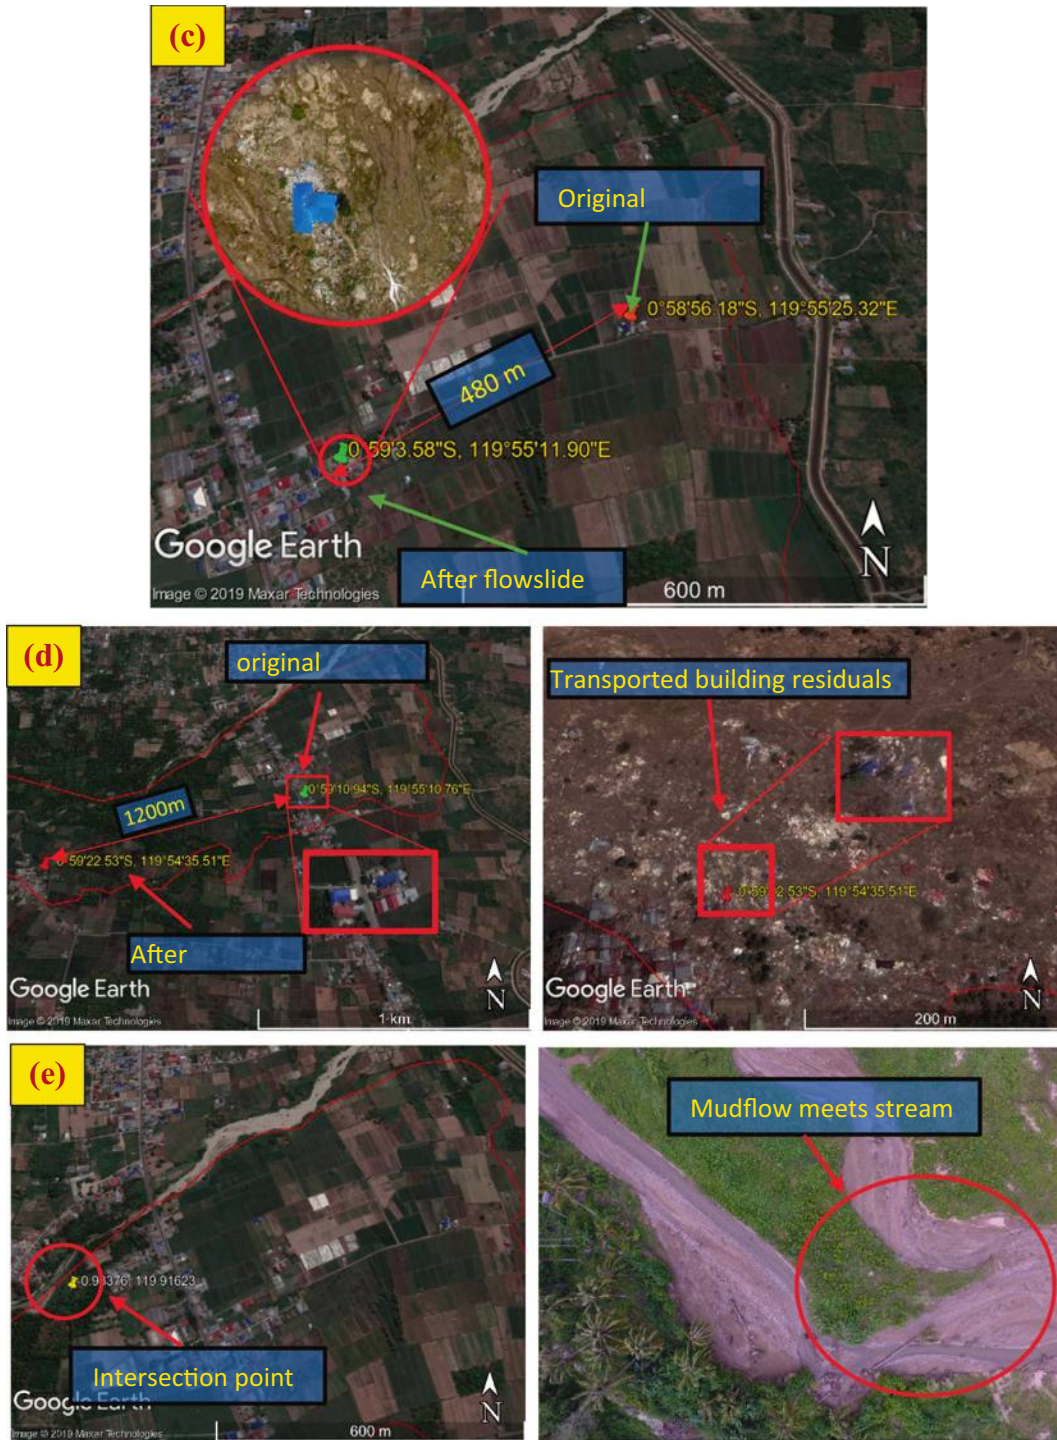
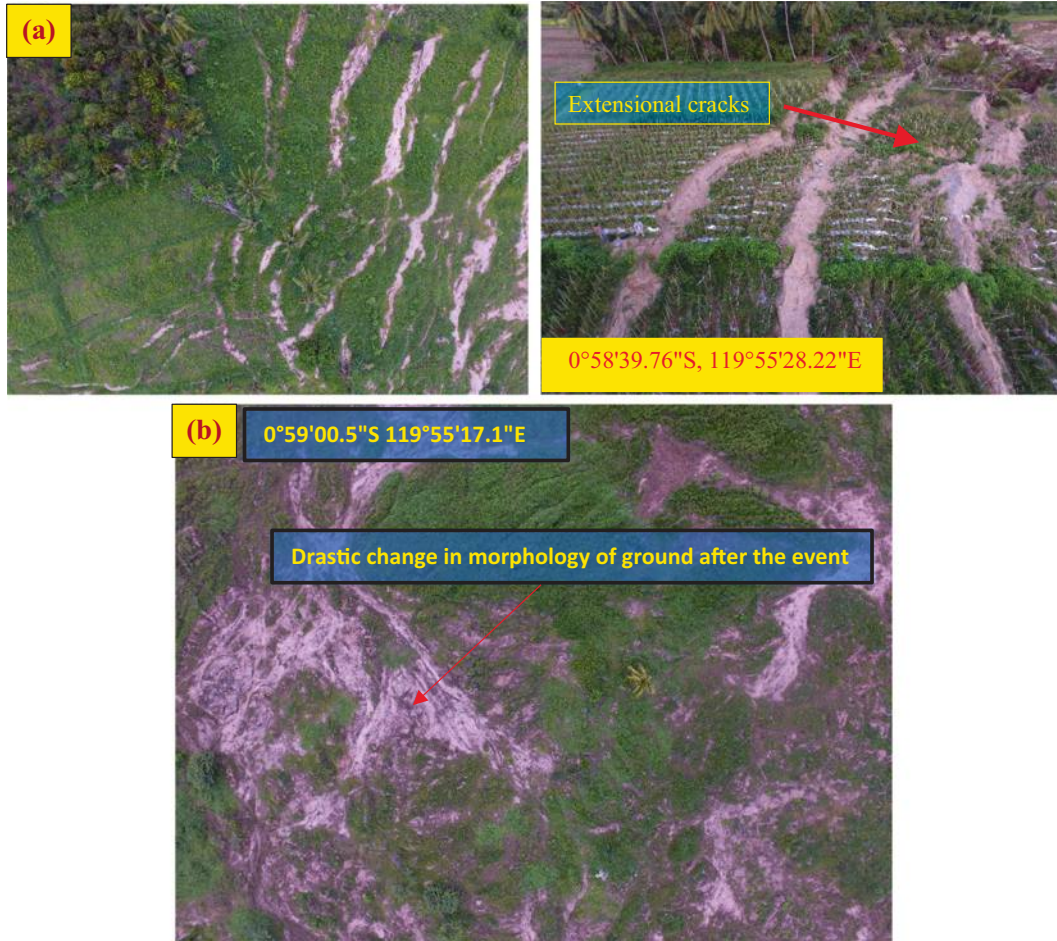
Fig. 12. Aerial imagery of damage within the failure Zones (a) extensional cracks in Zone (I) (b) flowslide and erosion of ground due to the mudflow Zone (II) (c) displacement of blue house in zone (II) (d) long distance transition of residential buildings after flowslide and mudflow (e) intersection of mudflow and stream.

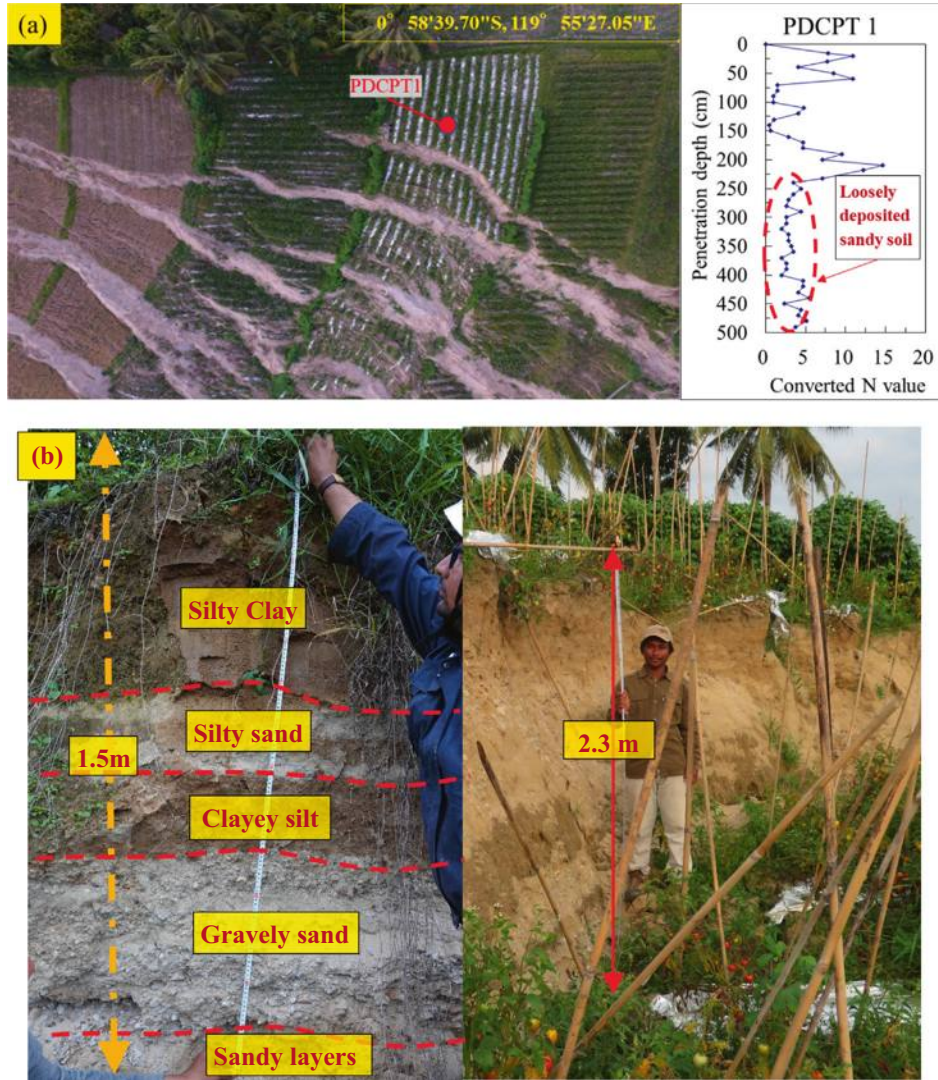
Fig. 14a shows the aerial view of the PDCPT1 location and the resulting N-values, which varied with depth. The test was conducted on an agriculture farm (with paddy fields and a tomato farm). The clear decrease in the N value in the soil layers below 3.5 m is an indication of loose liquefiable layers. The very high ground water level (which

was higher than the water level at the time of testing G. W. L = 2.3 m) also contributes to and increased risk of liquefaction in shallow underground layers.

In order to identify the soil profile of PDCPT1, an image of an extensional crack with depth of around 2.5 m in a nearby cliff is shown in Fig. 14b. The soil stratification is clearly visible and less disturbed due to the downhill flow-slide. The surface layer is composed of 10–20 cm of organic soil followed by 30–40 cm of clay and silty clay

layer. The underlying silty sand layer, which is between 10 and 20 cm in thickness, is sandwiched between the upper clayey layer and the lower clay silt layer, which is between 10 and 20 cm in thickness. Below the silty layer, there were

several layers of sandy and gravelly sand layers which appeared to be affected by liquefaction in the underlying layers. As described in Kokusho (1999), it is possible that the presence of these low permeable layers at the top allowed the formation of a water film between them and the underlying gravelly sand layers. Some soil samples were collected from the exposed parts of extensional cracks, and the basic physical properties of soils in the stratified layers were determined.

Fig. 14. PDCPT conducted within Zone (I) (a) Location and (b) test result at PDCPT1 (c) Profile of exposed soil layers at cliff created by extensional cracks.

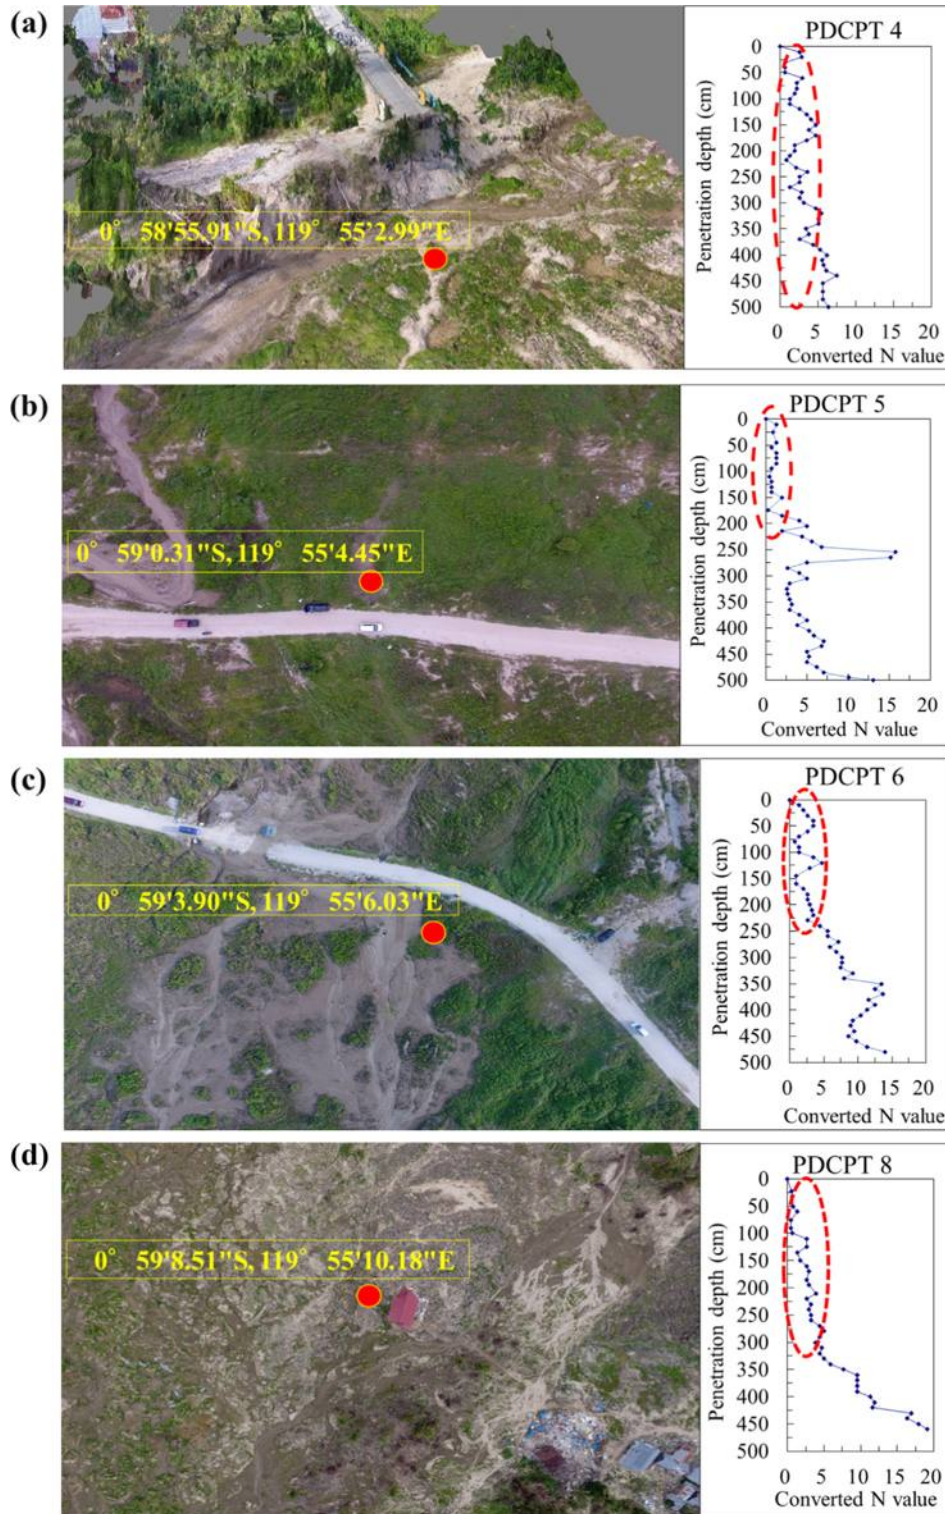
3.2.2.2. Results from the tests conducted within the flow-slide zone. As shown in Fig. 13, the PDCPT 4, 5, 6, 8 were conducted alongside the damaged road that connects the North and South of flow-slide region. The locations and results of PDCPT 4, 5, 6 and 8 are shown in Fig. 15a–d. PDCPT4 was conducted beside the collapsed bridge in the North of Jono-Oge (Fig. 15a). PDCPT5 was conducted within the flow-slide Zone (I) (the tension zone), where there were many soil blocks which had been dragged along and had rafted together in failure area (Zone (II)) (the compression zone) (Fig. 15b). PDCPT6 was conducted in zone (II), where the flow-slide apparently started (Fig. 15c).

PDCPT8 was conducted a few meters from the red building (Fig. 15d) which defied the ground movement and remained in its original position. Even though the building sustained considerable damage, rendering it uninhabitable, it did not experience displacement like the other structures in the flow-slide zone. This structure may have been able to resist the flow slide because of the massive raft foundation elaborated in Kiyota et al. (2020).

The N values obtained from all the PDCPTs for depths less than 5 m ranged between 5 and 10. These values indicate that the soils could be categorized as loose to very loose (USACE, 1994). These N values correspond to the critical N_{cr} values for soils categorized as potentially liquefiable at this range of depths (Koizumi, 1966). The soils appear to be loosely deposited sand and silty sand layers which were transported from the upstream of the flow-slide region. However, the resultant N-values from PDCPT 8 are greater than 10 beyond the depth of 3.5 m. That is,

the N-values for PDCPT 8, which was conducted close the red house, were higher than for the other tests. A trend similar to PDCPT 8 was observed in the tests conducted by Kiyota et al. (2020) in the same vicinity. The out of trend peak in the results for in PDCPT 5 was attributed to the presence of a gravelly layer at 2.5 m, which appears to have been liquefied. According to historical records, the liquefaction of gravelly soils is rare. However, some cases of liquefaction in gravelly soils were observed in past earthquakes, such as during the 1995 Hyogoken Nambu earthquake, Japan, as well as during the 1983 Borah Peak earthquake in the United States, where extensive liquefaction took place in fluvial sandy gravel layers (Kokusho et al., 2004). It should be noted, however, that the lateral displacement and flow-slide in these earthquakes was between only a few meters and tens of meters. In the 2018 Sulawesi earthquake, the displacement of soil blocks was between a few meters to hundreds of meters. This

Fig. 15. Aerial imagery of locations of PDCPT and N_{SPT} versus depth values (a) PDCPT4 (b) PDCPT5 (c) PDCPT6 (d) PDCPT8.

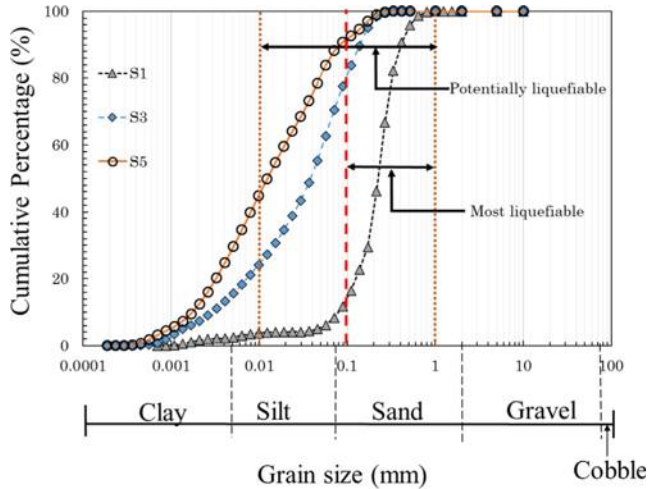
were tested to determine the grain size distribution. The grain size distribution of soil samples S1, S3 and S5 are shown in Fig. 16. The soil in sample S1 can be classified as a uniform sand with traces of silt, while the soils in samples S3 and S5 can be classified as non-plastic silt (Japanese Geotechnical Society Standard, 2016). As seen in Fig. 16, soil sample S1 is the most liquefiable among the samples,

Fig. 16. Gradation of soil samples S1, S3 and S5 collected from the site.

whereas the soils in samples S3 and S5 are potentially liquefiable soils, according to the soil classifications proposed by Tsuchida (1970). These soils were either transported by the flow slide, by the succeeding mudflow or deposited as residual soils. According to the handbook of Port and Harbor Research Institute of Japan (PHRI, 1997), the gradation of these soil samples indicates they are potentially liquefiable.

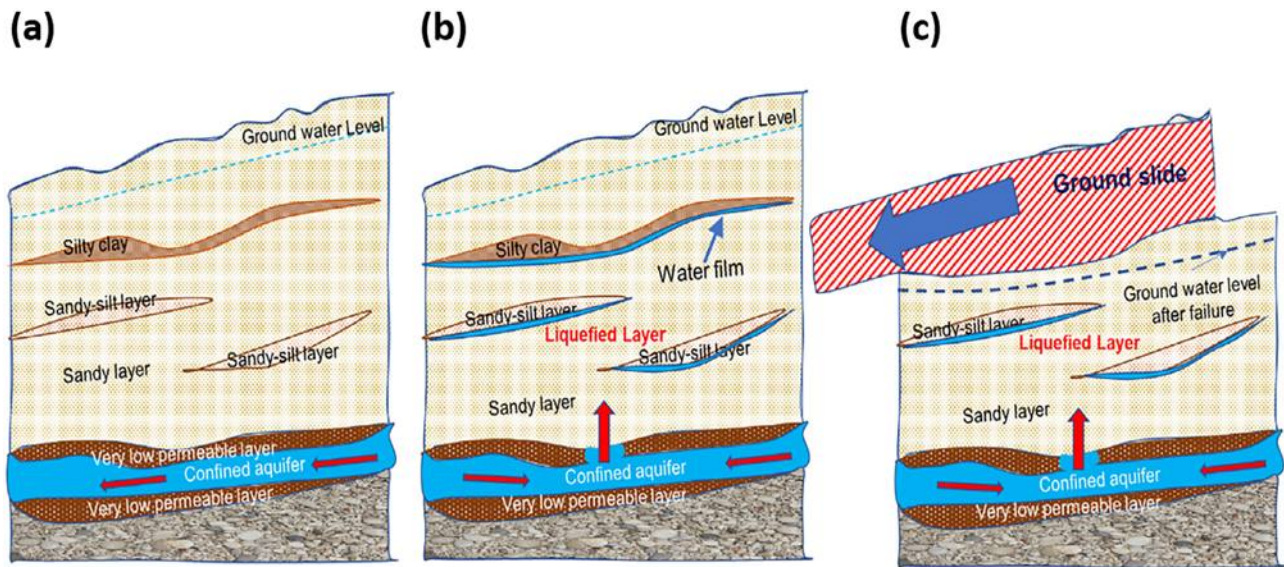
A series of model tests conducted by previous researchers (Kokusho, 1999, 2016; Kokusho and Kojima, 2002), have revealed that liquefaction at a site with sandwiched lithology results in the liquified soil being trapped below the low permeability cap layer. This creates a thin inter-layer of water, referred to as a “water film“. The resulting inhibition of excess pore water pressure dissipation and presence of the water-film reduces the residual shear strength of the sandy soil layer to below the initial static

Fig. 17. The mechanism of flow slide and development of water film under low permeable layers (a) before the earthquake (b) immediately after initiation of liquefaction (c) after the earthquake.

shear stress. Consequently, even on a very gentle slope, lateral flow takes place due to the action of gravitational force until equilibrium is achieved. Note that the results of common laboratory tests have shown that such capping layers may not be continuous and that they do not necessarily spread horizontally across the whole failure zone.

The authors believe that complex factors were involved in the triggering of the large-scale flow-slide at Jono-Oge on a very gentle sloping ground, which continued even after the seismic ground motion ceased. The combined effects of typical geology and the terrain, the formation of a water film due to liquefaction of the sandy layer overlain by capping layer, and the existence of underlying artesian aquifer may all have played a role in the long-distance flow-slide at Jono-Oge (Fig. 17a–c). The presence of a confined aquifer at a shallow depth and water springs in the Balaroa and Petobo flow-slide zone, which was confirmed by Kiyota et al. (2020), may also have contributed to the flow-slide.
