Influence of low permeability capping layers on liquefaction induced ground failure

Divyesh Rohit¹, S.M.K. Pasha¹, H. Hazarika¹, T. Kokusho², A. Arsyad³, and S. Nurdin⁴

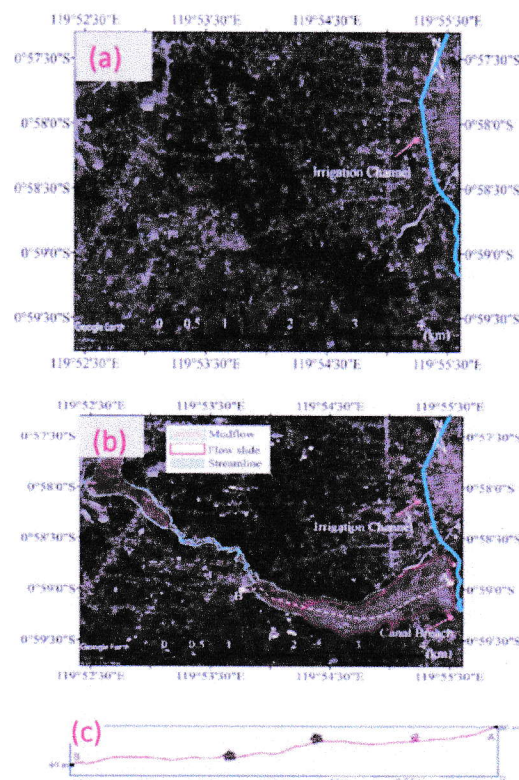
The study area was located in Sigi Regency in Juno Oge village. Fig. 2 shows the condition of the investigated site at Juno Oge before (Fig. 2(a)) and after the event (Fig. 2(b)). The site consisted of agricultural fields with a sparse population and an a very gentle sloping ground of less than 2% (Fig. 2(c)). Furthermore, an irrigation channel was located at the eastern side of failure zone as shown in Fig. 2(b). Due to the presence of irrigation channel, the ground water level was very high (<math>< 5\text{m}</math> from ground surface). This also contributed to the flow failure at the site. Earthquake induced liquefaction triggered massive flow slide which breached the water channel discharging a large volume of water into the already failed zone thereby causing massive mudflow as depicted in Fig. 2(b).

Figure 2: Lateral flow area in Juno Oge due to Donggala Earthquake. (a) before flow failure, (b) after flow failure with mud flow and water channel and (c) slope profile of the flow area (modified from Google Earth).

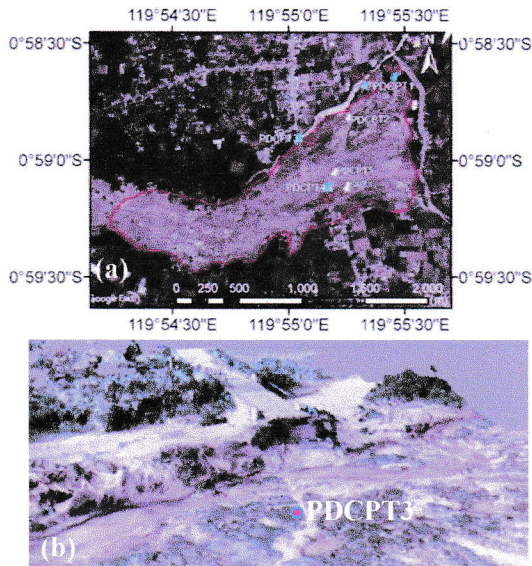
Fig. 3 shows the location of PDCPT tests (PDCPT1 to PDCPT5) and location of soil samples (S1 to S5) collected at depth of 0.5 to 2m. Except PDCPT 1 which was conducted in out of failure zone, the rest of them were conducted within the failure zone.

Fig3. (a) Location of PDCPT tests and soil samples (b) UAV3D map of PDCPT3

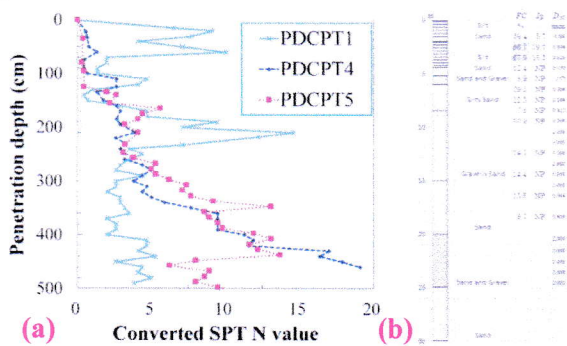
Ground water level was observed within a meter of ground surface in failed zone which indicates high risk of reliquefaction at susceptible areas in the future events. The results of PDCPT 1, 4 and 5 are plotted in Fig. 4(a). Ground water table was seen at depth of 2.3, 0.9 and 0.75

m from ground surface. Results of PDCPT1 (out of flow failure zone) indicates presence of a 2.5 m of layered loose to medium dense sandy soil deposit on top of relatively loose layers (SPT N value<5) of sandy-silt soils.

Comparison between results of field tests at PDCPT1 with that of PDCPT4 and 5 shows similarity between N values for very first 1-2 m of soil below the ground surface at PDCPT 4 and 5 with that of PDCPT1 at depth 2.5m below ground surface. This may explain the possible contribution of underlying loose layer of sandy-silt soil in flow failure of gentle ground. Grain size distribution of soil samples and Scanning Electron Microscopy (SEM) image of sample S2 as representative sample are shown in Fig. 5. All the samples were classified as silt with low liquid limit (ML) according to JGS 0051-2009. Furthermore, specific gravity of samples range between 2.62~2.65.

In order to better understand stratigraphy of soil deposits at the failure zone enclosed by red line, borehole data of a Standard Penetration Test (SPT) performed at location SPT1 (in Fig. 3a) is plotted in Fig.6. As seen from Fig. 4b layers of silt and silty sand are placed over and between the sandy layers which may increase the liquefaction susceptibility of deposit. Therefore, it is necessary to further investigate the effect of low permeable capping layers in liquefaction induced flow failure in Jono-Oge.

Fig4. (a) PDCPT test results (b) Soil condition at SPT1

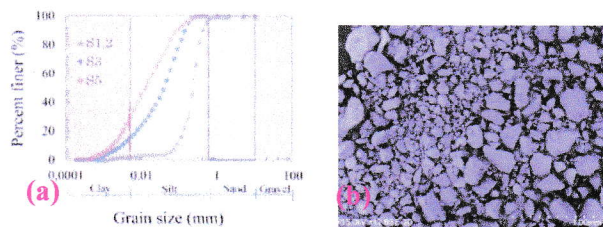
Fig5. (a) grain size distribution of soil samples (b) SEM image of sample S2

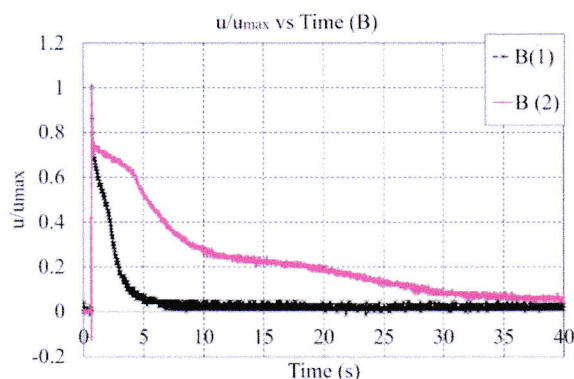
The results for 1D test after a single impact of hammer have been plotted and shown as a ratio of excess pore water pressure to maximum excess pore water pressure (u/u_{max}). The u/u_{max} value has been plotted against the duration to show the effect of clay seam on development and dissipation of excess pore water pressure in saturated sand under impact loading. Here in Fig. 8, the excess pore water pressure B (1) is for no seam condition while B (2) is for condition with a sandwiched clay seam. The location of pore pressure transducer is just below the clay seam. From the figure it can be

observed that ratio u/u_{max} for B (2) takes longer duration to dissipate after reaching peak and still has a higher value while that for B (1) is dissipated. This implies the capping effect of clay seam which inhibits the dissipation of excess pore water pressure in the sand layer below. Further in Fig. 9 the plots for u/u_{max} versus duration for pore pressure transducers A and C are shown, where A is located above the clay seam and C is located at a distance of 15 cm from the bottom of the sand layer with D_r 70%. Here for both the transducers the duration for dissipation of excess pore water pressure for sand with clay seam is higher than the condition without clay seam. This shows that the presence of a low permeability layer can not only hinder the dissipation of pore water pressure in adjacent areas but also in regions at a higher distance from the layer vertically.

Figure 8: Dissipation of excess pore water pressure versus duration for pore pressure transducer B just below clay layer with/without clay layer.

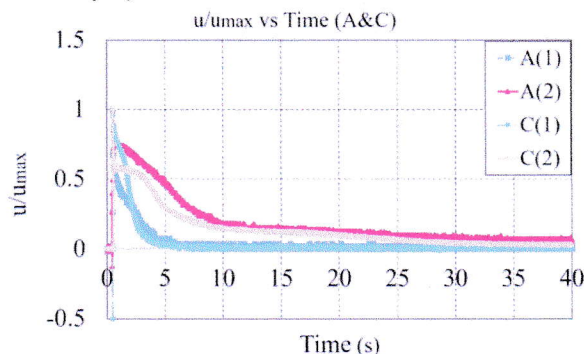
Figure 9: Dissipation of excess pore water pressure versus duration for pore pressure transducers A and C above and far below the clay layer, with and without clay layer.

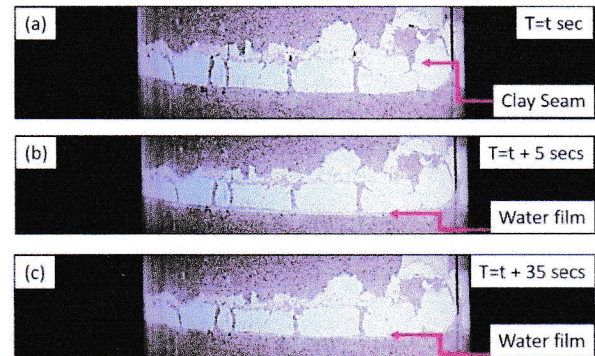
Further Fig. 10 depicts the development of water layer below the clay seam. Fig. 10(a) is recorded at $T - t$ seconds when the hammer impact was made. Fig. 10 (b) depicts the maximum thickness of the water film at $t + 5$ secs while Fig. 10 (c) shows the decreased water film thickness at $t + 35$ secs. This shows how the water film dissipates slowly in turn influencing the dissipation of excess pore water pressure from the below sand layers by forming an impermeable capping layer.

Figure 10: Formation of water layer under the clay seam at different time durations: (a) Time (T) = t secs, (b) $T = t + 5$ secs and (c) $T = t + 35$ secs.
