23rd Annual National Conference on Geotechnical Engineering

Liquefaction Disaster Mitigation and Geohydrology Conditions, Lessons from The Palu Earthquake Magnitude 7.4 M_w 28 September 2018

ABSTRACT: The Palu earthquake with a magnitude of 7.5 M_w occurred on September 28th, 2018 at 18:02 WITA time. Palu-Koro Fault experienced a strike with a mechanism of "strike slip". Earthquake epicentre is located 72 km north of the city of Palu with an earthquake depth of 10 km. This earthquake triggered a tsunami, a shift in the fault (rupture) along The Palu-Koro Fault and its secondary fault, and the occurrence of extensive and massive landslides in the Petobo, Jono Oge, Sibalaya, Balaroa and Lolu villages. One important element in responding to disasters is conducting comprehensive studies related to the phenomena caused by disasters as study material to understand the phenomena that occur, post-disaster handling and disaster mitigation in the future. This report presents the results of a survey of several locations affected by the earthquake in the city of Palu on September 28th, 2018 (6:03 pm local time), such as in the Balaroa and Petobo areas. Studies in the form of groundwater geoh

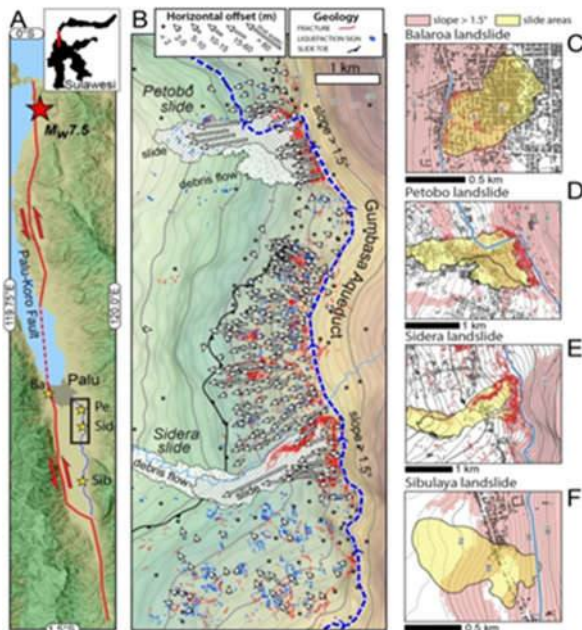
Fig. 5. Map of A Landslide Triggered by An Earthquake in The Palu Valley, Central Sulawesi, Indonesia. (a). Map of The Palu-Koro Fault. (Source: Kyle Bradley et al., 2019)

life due to landslides in Palu can be attributed to four landslides that occurred, three of which came from lateral distribution under the Gumbasa Canal (Petobo, Jonoyoge, and Sibalaya), and the fourth in Palu (Balaroa) where waterways were smaller dividing dry land at higher altitudes than failed fertile city land (Fig. 5A, C).

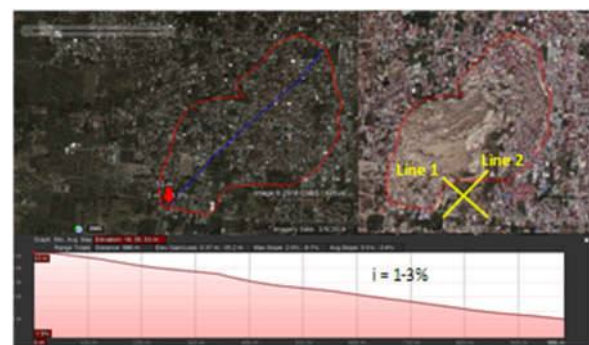
Fig. 6. Balaroa Satellite Imagery (a) Before The Earthquake (b) After The Earthquake and Track 2-D Electrical Resistivity Tomography and Topography Testing

Specifically for conditions in the Balaroa area, it can be seen in Fig. 6a (Citra Ikonos satellite acquisition on 3 September 2018), where the area experiencing liquefaction is a slope with a slope of 1-3.8% with an elevation range of 56 m to 18 m and a track length of 988 m (blue track line). This is what supports the mass movement of material. Satellite image of the acquisition on October 2nd, 2018 after liquefaction can be seen in Fig. 6b.

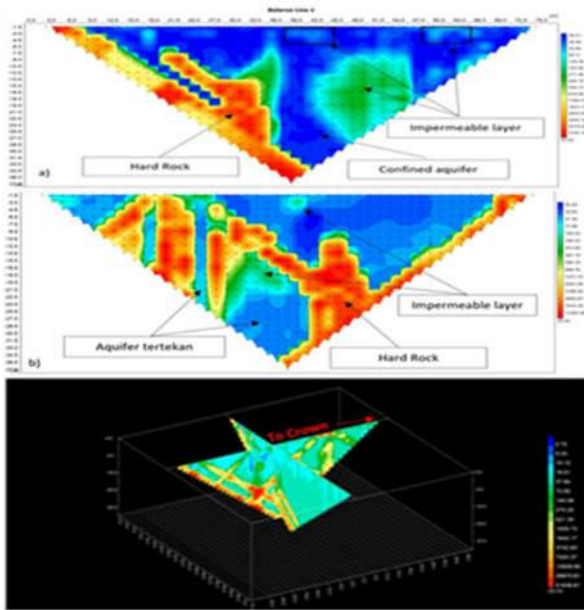
Fig. 7. 2 Line of 2-D Electrical Resistivity Tomography Test at Balaroa

Fig. 7 below shows the resistivity cross-section obtained from iteration 12 with an RMS error value of 1.5%. This resistivity cross-section reaches a depth of 37 m with a value of resistivity range 23.12- 7,922.7 Ω m. Resistivity values of 23.12 - 34.11 Ω m in shallow aquifer layers with depth distribution ranging from 1.5-12 m. In addition, it can also be predicted slip fields marked by resistivity contrast seen at the bottom (between red and yellow). At this location, it was also found the phenomenon of a ruptured aquifer that caused increased water content in the soil layers above. This phenomenon is an indicator of increasing liquefaction potential in this area.

- a. The results of the resistivity test at lane 1 (Balara) show the occurrence of the phenomenon of a distressed aquifer that breaks, causing an increase in water content in the soil layers above. This phenomenon is one indicator causing the occurrence of liquefaction in this area. While the resistivity test results in Petobo do not show any broken aquifer, so it can be concluded that the influence of shallow surface water can be derived from infiltration from the Gumbasa irrigation channel or can also come from aged river channels that have been closed due to sedimentation and landfill for settlement land settlement the citizens.
- b. Further research needs to be done on groundwater modelling in the Balara and Petobo liquefaction areas so that sources and influences of groundwater can be known to contribute to the process; liquefaction in the two regions.

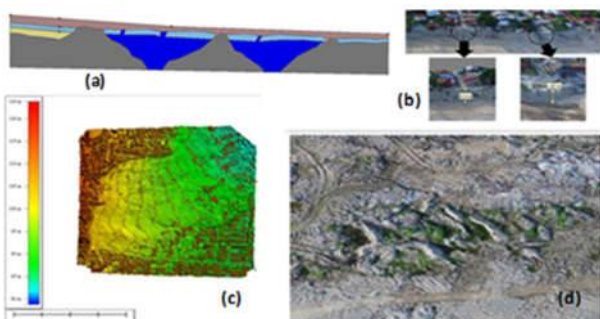
Fig. 8. (a) Model of The Mechanism of The Collapse of Balaroa Liquidation Collapse, (b) Land Slide on The Crown, (c) Digital Elevation Model of Balouroa Contour, (d) Image of Liquefaction Aerial Flow After 15 Days of The Palu Earthquake

The mechanism of land collapse in the village of Balaroa which is located about 1 km west of the Palu-Koro Fault can be illustrated as shown in Fig. 8a. Where the beginning of the ground movement (crown) is located on Jalan Gunung Gawalise, while the end is located on Jalan Balaroa. The area affected is housing with an area of impact around 34.5 Ha with a circumference of 2.5 km. An aerial view of the damage in Balaroa is presented in Fig. 8d. Direct observations on Jalan Gunung Gawalise where the peak of the landslide began showed that an avalanche took place in the form of a landslide with a slope height after a landslide of around +10 m (Fig. 8b). While the liquid flow (Nalodo) triggered by the earthquake began to appear at a distance of about 60 m from the crown of Fig. 8d, where this liquid flow causes the house in the location to sink and move as far as 300-600 m from the original location.

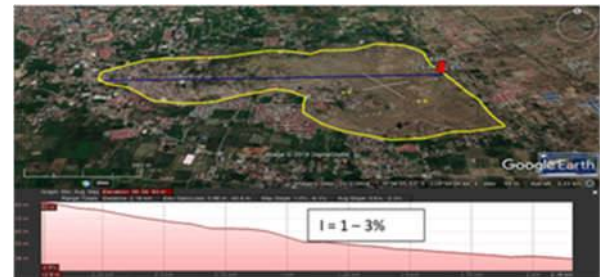
Fig. 9. Petobo Satellite Image After The Earthquake and 2-D Electrical Resistivity Tomography and Topography Test Track

During the 2018 Palu earthquake, two interesting major events were observed, namely the liquefaction event which was followed by massive lateral spreading. This incident caused the affected villages to be buried and moved (Fig. 9). According to the Center for Groundwater Resources and Environmental Geology, most of the Palu Region has very high liquefaction potential with a liquefaction potential index (LPI) > 15 with shallow groundwater level < 12 m. However, many aspects of geotechnical engineering after an earthquake are interesting to investigate to find the actual causes and mechanisms that occur. Deeper Investigations and Research are important to support the government in the relocation and reconstruction stages.

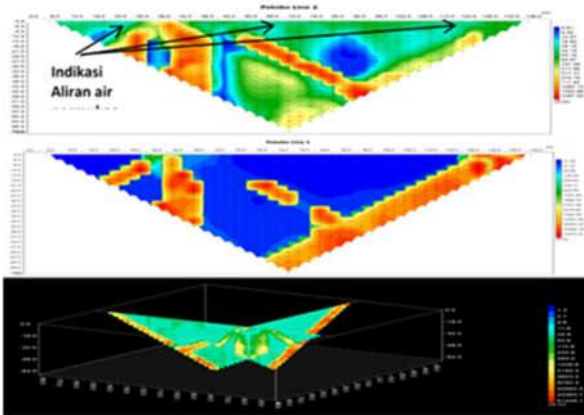
Fig. 10. Result of 2 Line of 2-D Electrical Resistivity Tomography Test

Fig. 10 below shows the resistivity cross-section obtained from iteration 12 with an RMS error value of 1.5%. This resistivity cross-section reaches a depth of 70.4 m with a resistivity range value of 5.61 – 2,387.5 Ω m. Resistivity values of 5.61 - 42.196 Ω m in shallow aquifer layers with depth distribution ranging from 3-12 m. In addition, it can also be predicted slip fields marked by resistivity contrast seen at the bottom (between red and yellow). At this location, it was also found the phenomenon of shallow aquifers that were widespread that caused an increase in the level of soil saturation in the area. The source that causes shallow aquifers can be caused by infiltration from the Gumbasa irrigation channel above, or it could also be the influence of aged river seepage, the Niga River whose dukes once flowed in the Petobo subdistrict, but

were closed due to sediment siltation and eventually disappeared due to settlement development. This high level of saturation is an indicator of increasing liquefaction potential in this area.

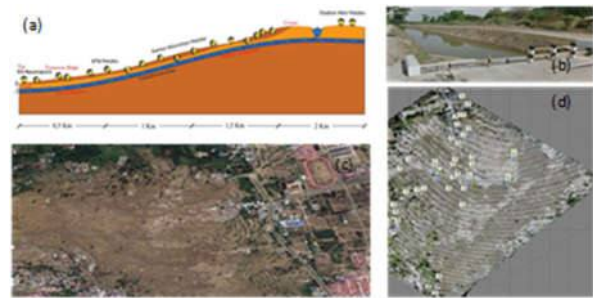
Fig. 11. (a) Model of The Collapse Mechanism of the Petobo Liquefaction Collapse, (b) Gumbasa Irrigation Canal Before The Earthquake, (c) Image of Liquefaction Aerial Flow 16 Days After The Earthquake, (d) Aerial Contour Image

The mechanism of land collapse in the Petobo subdistrict can be described as shown in Fig. 11a. Where the initial ground motion (crown) is located in the western area close to the Gumbasa irrigation primary canal Fig. 10b. while the tip (toe) is located near Dewi Sartika Street. The affected area is housing with a total area of about 180 ha with a total number of affected around 744 houses. An aerial view of the damage at Petobo is presented in Fig. 11c. From direct observation on the crown of the Petobo liquefaction area, where in the crown area there is a lateral movement of land followed by an avalanche with a slope height after a landslide of about +6 m. While the liquefaction flow (Nalodo) triggered by the earthquake began to appear at a distance of about 110 m from the crown of Fig. 11d in a massive sand boiling storm. where debris from the liquefaction flow is expected to go hand in hand when massive sand boils occur. Debris flow is continued by free aquifers that have come out to the surface of the ground.
