## *23<sup>rd</sup> Annual National Conference on Geotechnical Engineering*

# Liquefaction Disaster Mitigation and Geohydrology Conditions, Lessons from The Palu Earthquake Magnitude 7.4 $M_w$ 28 September 2018

**ABSTRACT:** The Palu earthquake with a magnitude of 7.5  $M_w$  occurred on September 28<sup>th</sup>, 2018 at 18:02 WITA time. Palu-Koro Fault experienced a strike with a mechanism of "strike slip". Earthquake epicentre is located 72 km north of the city of Palu with an earthquake depth of 10 km. This earthquake triggered a tsunami, a shift in the fault (rupture) along The Palu-Koro Fault and its secondary fault, and the occurrence of extensive and massive landslides in the Petobo, Jono Oge, Sibalaya, Balaroa and Lolu villages. One important element in responding to disasters is conducting comprehensive studies related to the phenomena caused by disasters as study material to understand the phenomena that occur, post-disaster handling and disaster mitigation in the future. This report presents the results of a survey of several locations affected by the earthquake in the city of Palu on September 28<sup>th</sup>, 2018 (6:03 pm local time), such as in the Balaroa and Pet

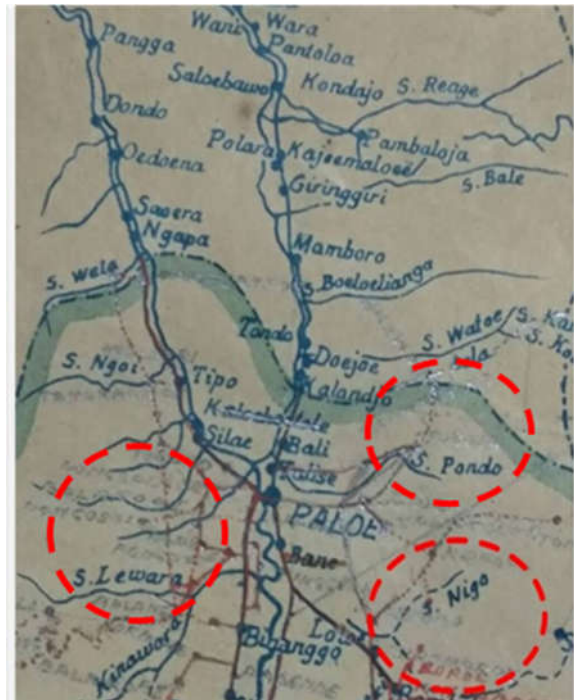
The presence of confined aquifer that broke resistivity test results, that in the Petobo and Balaroa areas, as well as the Talise area which also experienced local liquefaction it is estimated that recharging groundwater which results in very shallow groundwater is filled by subsurface i.e. from the aged river has experienced siltation due to sedimentation of downstream sand and gravel material, due to the absence of river normalization efforts and material retrieval, causing several rivers in the Palu Valley that led to Palu cities to become shallow. Finally, because of the large housing needs in the Palu town of the watershed, it was made a settlement. Because the type of material available is in the form of sand and gravel which has high porosity, it is estimated that the river water still continue to flow below the surface and participate in recharging groundwater in areas traversed such as in the Petobo liquefaction area on the river Niga, Balaroa area in the aged river flow (see Fig. 4).

Fig. 4. Map of Palu Valley Aged River

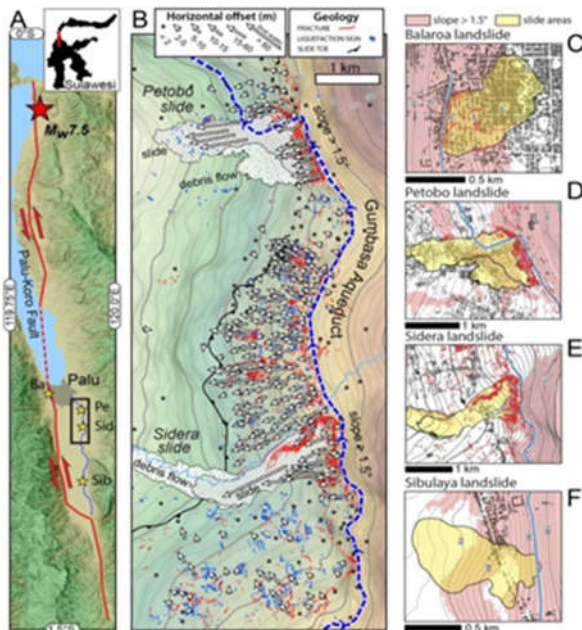
life due to landslides in Palu can be attributed to four landslides that occurred, three of which came from lateral distribution under the Gumbasa Canal (Petobo, Jonoyoge, and Sibalaya), and the fourth in Palu (Balaroa) where waterways were smaller dividing dry land at higher altitudes than failed fertile city land (Fig. 5A, C).

Fig. 5. Map of A Landslide Triggered by An Earthquake in The Palu Valley, Central Sulawesi, Indonesia. (a). Map of The Palu-Koro Fault. (Source: Kyle Bradley et al., 2019)

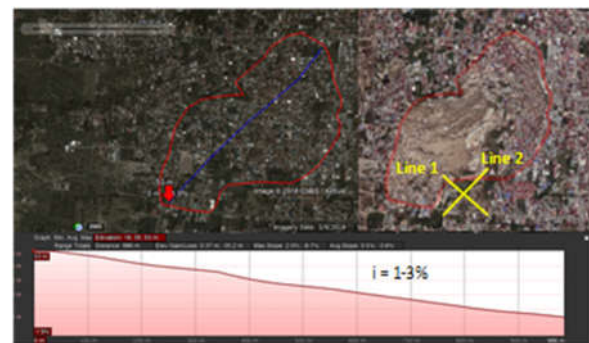
Specifically for conditions in the Balaroa area, it can be seen in Fig. 6a (Citra Ikonos satellite acquisition on 3 September 2018), where the area experiencing liquefaction is a slope with a slope of 1-3.8% with an elevation range of 56 m to 18 m and a track length of 988 m (blue track line). This is what supports the mass movement of material. Satellite image of the acquisition on October 2<sup>nd</sup>, 2018 after liquefaction can be seen in Fig. 6b.

Fig. 6. Balaroa Satellite Imagery (a) Before The Earthquake (b) After The Earthquake and Track 2-D Electrical Resistivity Tomography and Topography Testing

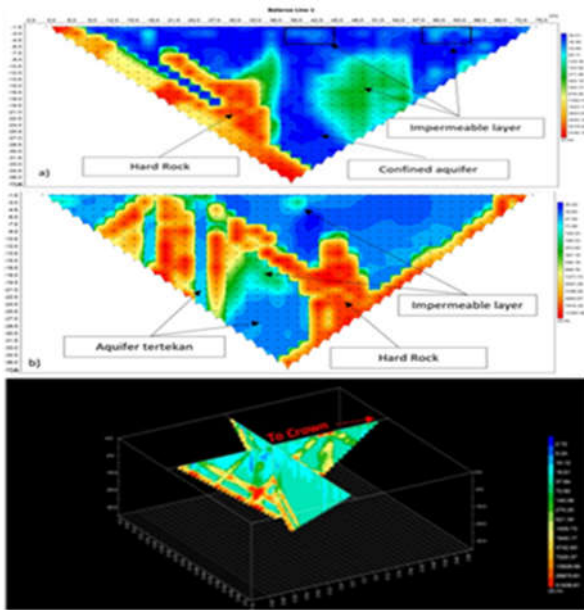
Fig. 7 below shows the resistivity cross-section obtained from iteration 12 with an RMS error value of 1.5%. This resistivity cross-section reaches a depth of 37 m with a value of resistivity range 23.12- 7,922.7  $\Omega$ m. Resistivity values of 23.12 - 34.11  $\Omega$ m in shallow aquifer layers with depth distribution ranging from 1.5-12 m. In addition, it can also be predicted slip fields marked by resistivity contrast seen at the bottom (between red and yellow). At this location, it was also found the phenomenon of a ruptured aquifer that caused increased water content in the soil layers above. This phenomenon is an indicator of increasing liquefaction potential in this area.

Fig. 7. 2 Line of 2-D Electrical Resistivity Tomography Test at Balaroa

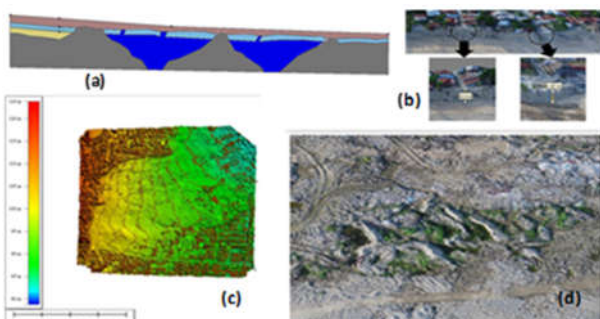
The mechanism of land collapse in the village of Balaroa which is located about 1 km west of the Palu-Koro Fault can be illustrated as shown in Fig. 8a. Where the beginning of the ground movement (crown) is located on Jalan Gunung Gawalise, while the end is located on Jalan Balaroa. The area affected is housing with an area of impact around 34.5 Ha with a circumference of 2.5 km. An aerial view of the damage in Balaroa is presented in Fig. 8d. Direct observations on Jalan Gunung Gawalise where the peak of the landslide began showed that an avalanche took place in the form of a landslide with a slope height after a landslide of around +10 m (Fig. 8b). While the liquid flow (Nalodo) triggered by the earthquake began to appear at a distance of about 60 m from the crown of Fig. 8d, where this liquid flow causes the house in the location to sink and move as far as 300-600 m from the original location.

Fig. 8. (a) Model of The Mechanism of The Collapse of Balaroa Liquidation Collapse, (b) Land Slide on The Crown, (c). Digital Elevation Model of Balouroa Contour, (d). Image of Liquefaction Aerial Flow After 15 Days of The Palu Earthquake

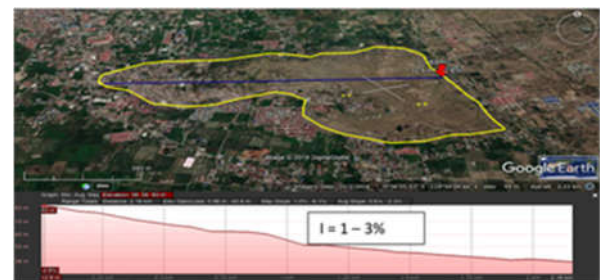
During the 2018 Palu earthquake, two interesting major events were observed, namely the liquefaction event which was followed by massive lateral spreading. This incident caused the affected villages to be buried and moved (Fig. 9). According to the Center for Groundwater Resources and Environmental Geology, most of the Palu Region has very high liquefaction potential with a liquefaction potential index (LPI)>15 with shallow groundwater level <12 m. However, many aspects of geotechnical engineering after an earthquake are interesting to investigate to find the actual causes and mechanisms that occur. Deeper Investigations and Research are important to support the government in the relocation and reconstruction stages.

Fig. 9. Petobo Satellite Image After The Earthquake and 2-D Electrical Resistivity Tomography and Topography Test Track

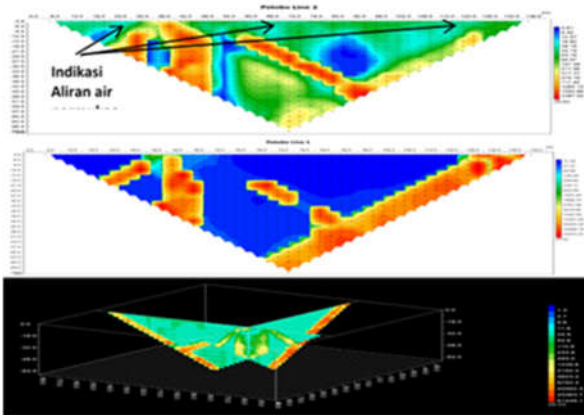
Fig. 10 below shows the resistivity cross-section obtained from iteration 12 with an RMS error value of 1.5%. This resistivity cross-section reaches a depth of 70.4 m with a resistivity range value of 5.61 – 2,387.5  $\Omega\text{m}$ . Resistivity values of 5.61 - 42.196  $\Omega\text{m}$  in shallow aquifer layers with depth distribution ranging from 3-12 m. In addition, it can also be predicted slip fields marked by resistivity contrast seen at the bottom (between red and yellow). At this location, it was also found the phenomenon of shallow aquifers that were widespread that caused an increase in the level of soil saturation in the area. The source that causes shallow aquifers can be caused by infiltration from the Gumbasa irrigation channel above, or it could also be the influence of aged river seepage, the Niga River whose dukes once flowed in the Petobo subdistrict, but

were closed due to sediment siltation and eventually disappeared due to settlement development. This high level of saturation is an indicator of increasing liquefaction potential in this area.

Fig. 10. Result of 2 Line of 2-D Electrical Resistivity Tomography Test

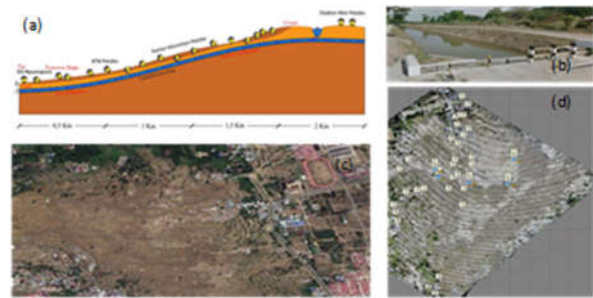
The mechanism of land collapse in the Petobo subdistrict can be described as shown in Fig. 11a. Where the initial ground motion (crown) is located in the western area close to the Gumbasa irrigation primary canal Fig. 10b. while the tip (toe) is located near Dewi Sartika Street. The affected area is housing with a total area of about 180 ha with a total number of affected around 744 houses. An aerial view of the damage at Petobo is presented in Fig. 11c. From direct observation on the crown of the Petobo liquefaction area, where in the crown area there is a lateral movement of land followed by an avalanche with a slope height after a landslide of about +6 m. While the liquefaction flow (Nalodo) triggered by the earthquake began to appear at a distance of about 110 m from the crown of Fig. 11d in a massive sand boiling storm. where debris from the liquefaction flow is expected to go hand in hand when massive sand boils occur. Debris flow is continued by free aquifers that have come out to the surface of the ground.

Fig. 11. (a) Model of The Collapse Mechanism of the Petobo Liquidation Collapse, (b) Gumbasa Irrigation Canal Before The Earthquake, (c) Image of Liquefaction Aerial Flow 16 Days After The Earthquake, (d) Aerial Contour Image
