# EVALUATION OF PONRE-PONRE DAM INSTRUMENTATION

Rita Tahir Lopa and farouk Maricar

**Keywords:** Dam security, instrument, Ponre-Ponre Dam.

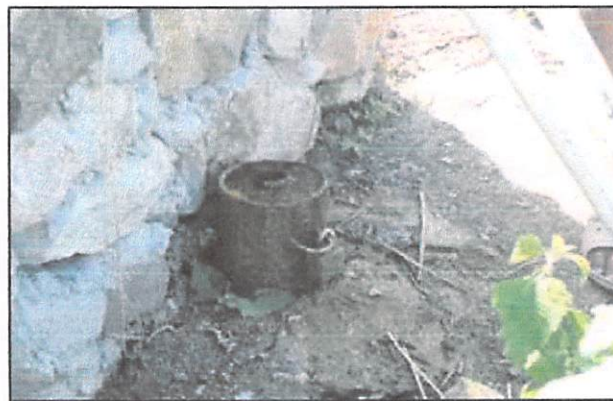
The condition of the water level on SP.4 (on the left side of the weir) is recorded that the ground water in the pipe has overflowed and can not be measured soil water level, can be seen in Figure 4.

**Figure 3.** Water overflows in SP.4

4. The results of evaluation of instrumentation demonstrate that piezometer equipment, seepage, and settlement survey are in un-maintained condition, requiring routine maintenance and maintenance as well as periodic cleaning.

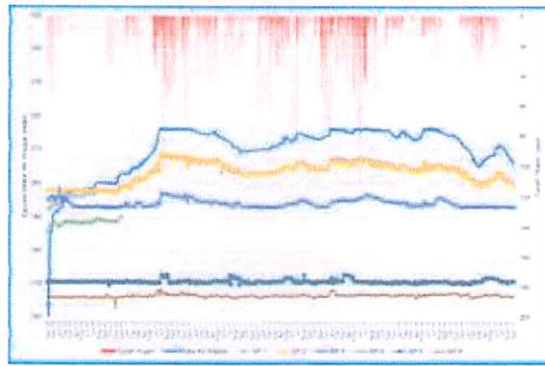
From the graph of MAW-CH-SP (2008-2015) relationship shown in Figure 5, the data shown in SP.4 (blue color) can only be observed to 24th Dec 2009.

Figure 4. Graph relation MAW-CH-SP (2008-2015)

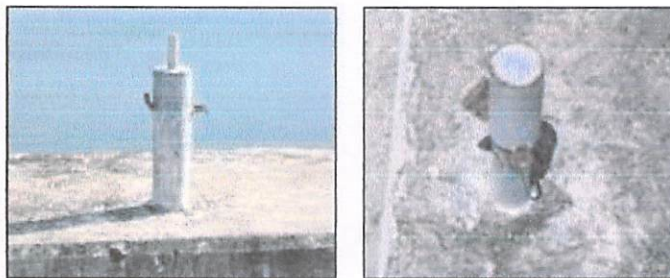
Conditions of Settlement Instrumentation to observe the point of observation of the shear and the reduction of the dam surface mounted at the top of the dam, many of which have no cover and a broken lock, as shown in Figure 6.

Figure 6. The crest Settlement staple cover is not installed and the padlock is broken

1. Many of the settlement settlements are damaged or missing. Where many padlocks is damage. Evaluation results indicate that the open stitch cover may cause the end of the monument to experience a change of position, as it is not protected from the irresponsible dam visitor behavior.

2. It is recommended that it need to improve the cover of the stakes and to need periodic measurements in accordance with the schedule for monitoring settlements.

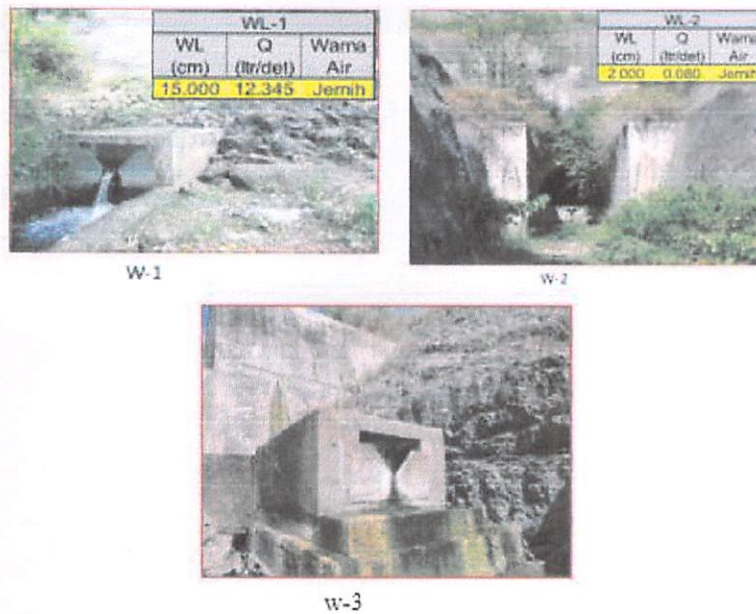
Condition of V-Notch Instrumentation mounted 3 V-Notch pieces, can be seen in Figure 7. Condition of Instrumentations are in good condition on the downstream and diversion works, while in the spillage, there are many moss, and it need maintenance (Figure 8).

**Figure 8.** Condition of seepage measurement *V-Notch* Ponre-Ponre Dam

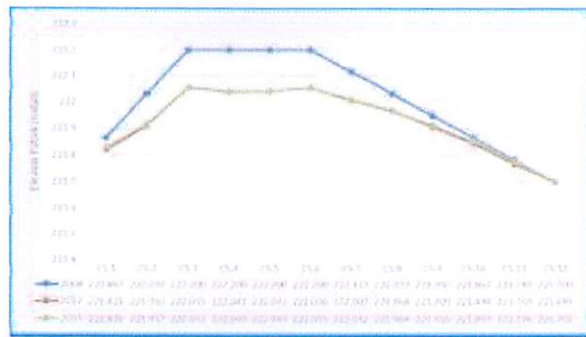
Condition of Crest Settlement Point Instrumentation, cover of many observation points at the top of many nonexistents, only CS-1 and CS-12 attached. Based on Design Riview Report Vol 6 annex Design, calculation section 4.2 crest camber is mentioned  $<0.25\%$  of Dam height = 14 cm. The graph of settlement measurement as showns in Figure 11.

Figure 11. Settlement at the top of the dam during the Big check

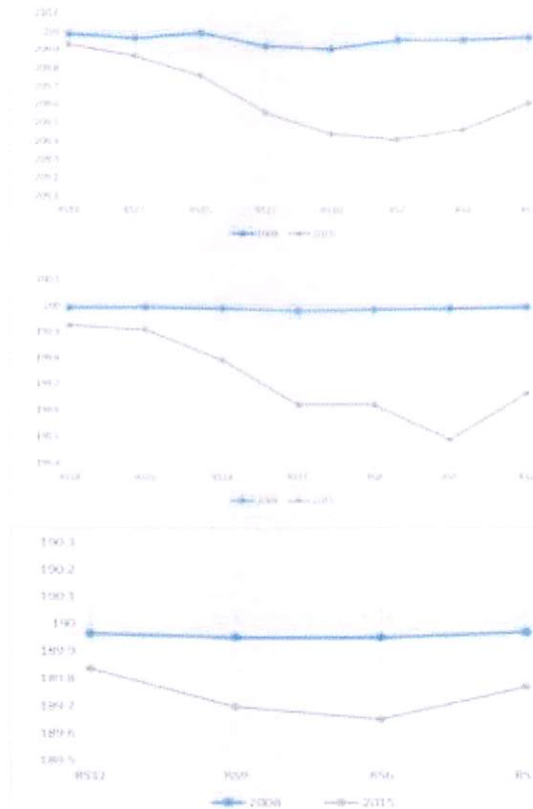
Condition of Rockfill Settlement Point instrumentation occurs weathering on the riprap arrangement on the first, second, and third rows. Benchmarks that are located downstream (RS) should be made permanent road eg trap for survey team / officer to safely perform for measuring. The graph of settlement measurement at the time of the inspection as shown in Figure 12.

Figure 12. Settlement at elevation of downstream dam +210 mdpl, + 200 mdpl, and +190 mdpl during inspection.

3. There is no safety access for surveyors at the observation point in the upstream slope. Evaluation results indicate that the absence of access roads may endanger OP officials in carrying out monitoring. It is recommended to make stairs / traps connecting observation points of settlement at downstream slopes.
