EVALUATION OF PONRE-PONRE DAM INSTRUMENTATION

Rita Tahir Lopa and farouk Maricar

ABSTRACT

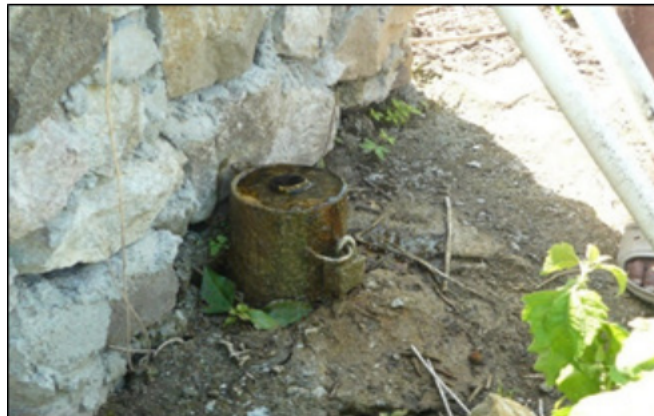
The condition of the water level on SP.4 (on the left side of the weir) is recorded that the ground water in the pipe has overflowed and can not be measured soil water level, can be seen in Figure 4.

Figure 3. Water overflows in SP.4

4. The results of evaluation of instrumentation demonstrate that piezometer equipment, seepage, and settlement survey are in un-maintained condition, requiring routine maintenance and maintenance as well as periodic cleaning.

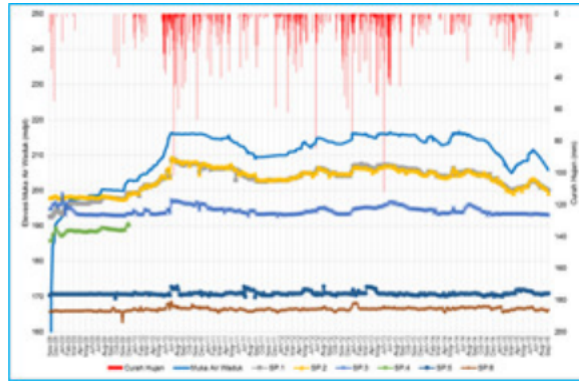
Figure 4. Graph relation MAW-CH-SP (2008-2015)

From the graph of MAW-CH-SP (2008-2015) relationship shown in Figure 5, the data shown in SP.4 (blue color) can only be observed to 24th Dec 2009.

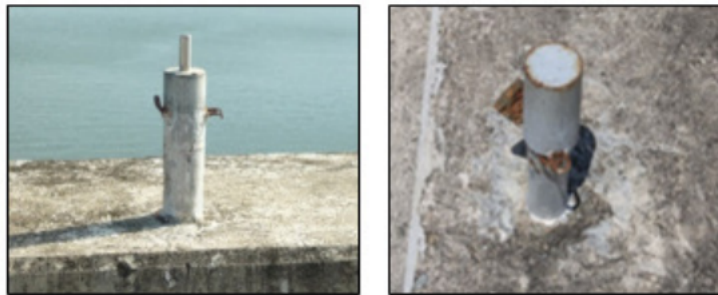
Conditions of Settlement Instrumentation to observe the point of observation of the shear and the reduction of the dam surface mounted at the top of the dam, many of which have no cover and a broken lock, as shown in Figure 6.

Figure 6. The crest Settlement staple cover is not installed and the padlock is broken

1. Many of the settlement settlements are damaged or missing. Where many padlocks is damage. Evaluation results indicate that the open stitch cover may cause the end of the monument to experience a change of position, as it is not protected from the irresponsible dam visitor behavior.

2. It is recommended that it need to improve the cover of the stakes and to need periodic measurements in accordance with the schedule for monitoring settlements.

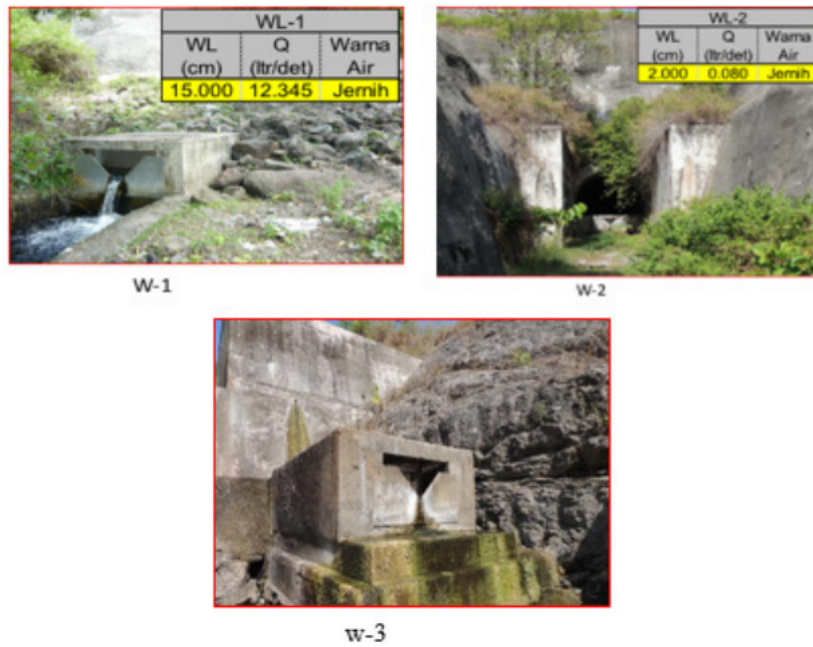
Figure 8. Condition of seepage measurement *V-Notch* Ponre-Ponre Dam

Condition of V-Notch Instrumentation mounted 3 V-Notch pieces, can be seen in Figure 7. Condition of Instrumentations are in good condition on the downstream and diversion works, while in the spillage, there are many moss, and it need maintenance (Figure 8).

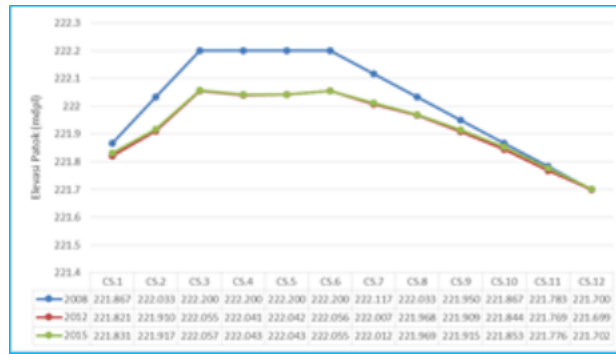
Figure 11. Settlement at the top of the dam during the Big check

Condition of Crest Settlement Point Instrumentation, cover of many observation points at the top of many nonexistents, only CS-1 and CS-12 attached. Based on Design Riview Report Vol 6 annex Design, calculation section 4.2 crest camber is mentioned $<0.25\%$ of Dam height = 14 cm. The graph of settlement measurement as shows in Figure 11.

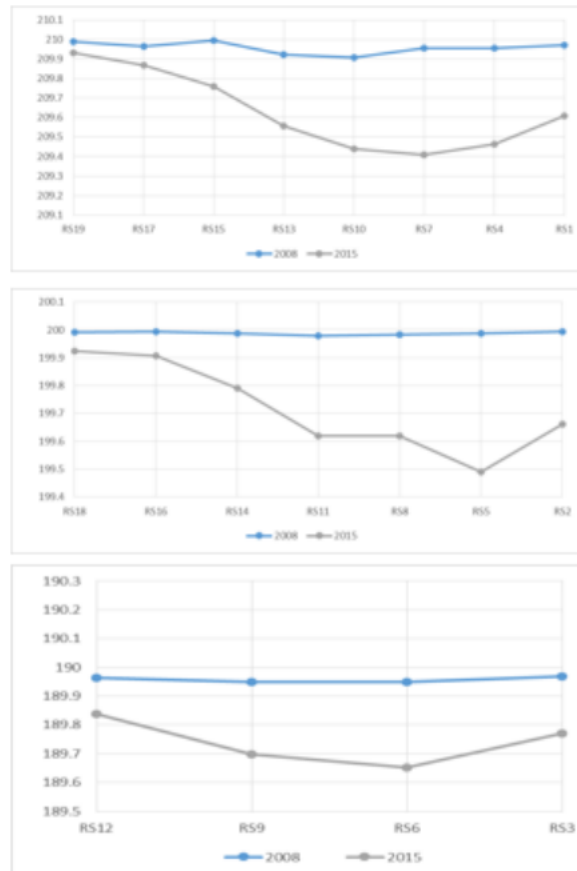
Condition of Rockfill Settlement Point instrumentation occurs weathering on the riprap arrangement on the first, second, and third rows. Benchmarks that are located downstream (RS) should be made permanent road eg trap for survey team / officer to safely perform for measuring. The graph of settlement measurement at the time of the inspection as shown in Figure 12.

Figure 12. Settlement at elevation of downstream dam +210 mdpl, + 200 mdpl, and +190 mdpl during inspection.

3. There is no safety access for surveyors at the observation point in the upstream slope. Evaluation results indicate that the absence of access roads may endanger OP officials in carrying out monitoring. It is recommended to make stairs / traps connecting observation points of settlement at downstream slopes.
