Geo-Disaster Report

Large-scale flowslide in Sibalaya caused by the 2018 Sulawesi earthquake

Mitsu Okamura^{a,*}, Kohei Ono^a, Ardy Arsyad^b, Utari S. Minaka^a, Sukiman Nurdin^c

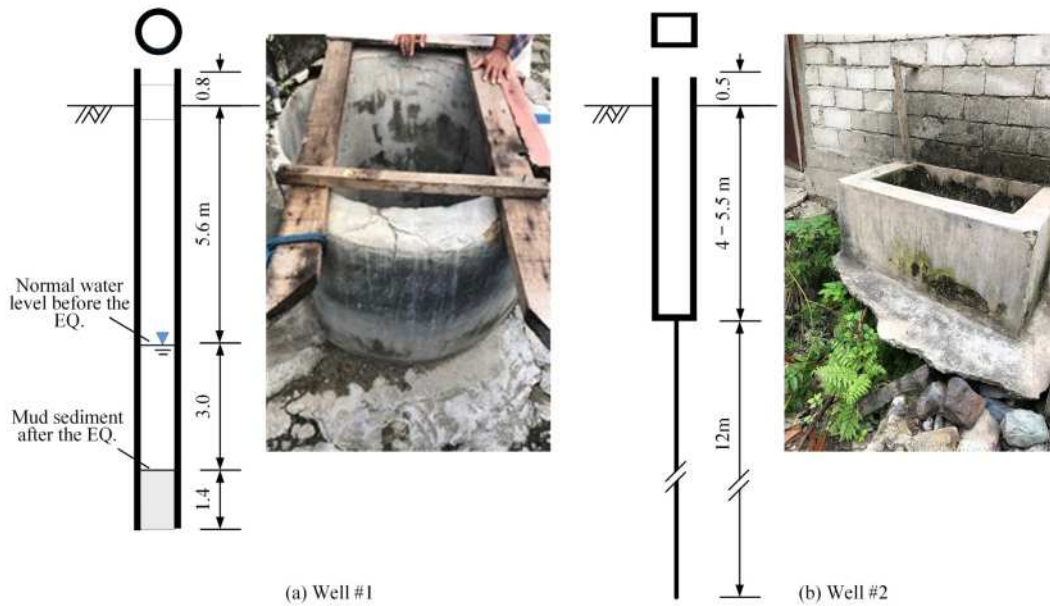
Information of the ground water level is a key when investigating the liquefaction potential. We found eleven wells at the locations shown in Fig. 1(b) and interviewed their owners. Fig. 2(a) shows a photograph and a schematic illustration of well #1, whose internal diameter and depth were 1 m and 10 m, respectively. Its water level before the earthquake was 5.6 m below the ground surface with small seasonal variations (in the order of a few tens centimeters), which was confirmed through the trace left on the inside wall of the well. Soon after the earthquake, the owner noticed that water overflowed from the well; this overflowing lasted two days. Thereafter, the water level gradually lowered and the well completely dried up in the next two weeks. Although outside the flowslide area, some features typical to areas of liquefaction-induced lateral spreading were detected near the well, including cracks on house walls and fences, house subsidence, as well as sand ejecta on the ground surface. All the other wells, wells #2 - #11, had a similar structure, as shown in Fig. 2(b); a 12-m-long pipe was installed at the bottom of a 4–5 m-deep excavated well, through which water was pumped up. They did not observe any water at the bottom of the excavated well before the earthquake, indicating that the ground water level was lower than 5 m in the neighbor-

Fig. 2. Photos and cross sections of wells near flowslide area.

hood. Additionally, even several weeks after the earthquake, water could not be pumped up from all the wells except for well #3, whose pipe tip depth was 17.5 m below the ground surface, while for the rest, it ranged between 12 m and 17.5 m. Therefore, it is reasonable to assume that the ground water table was at 5.6 m and 17.5 m before and after the earthquake, respectively.

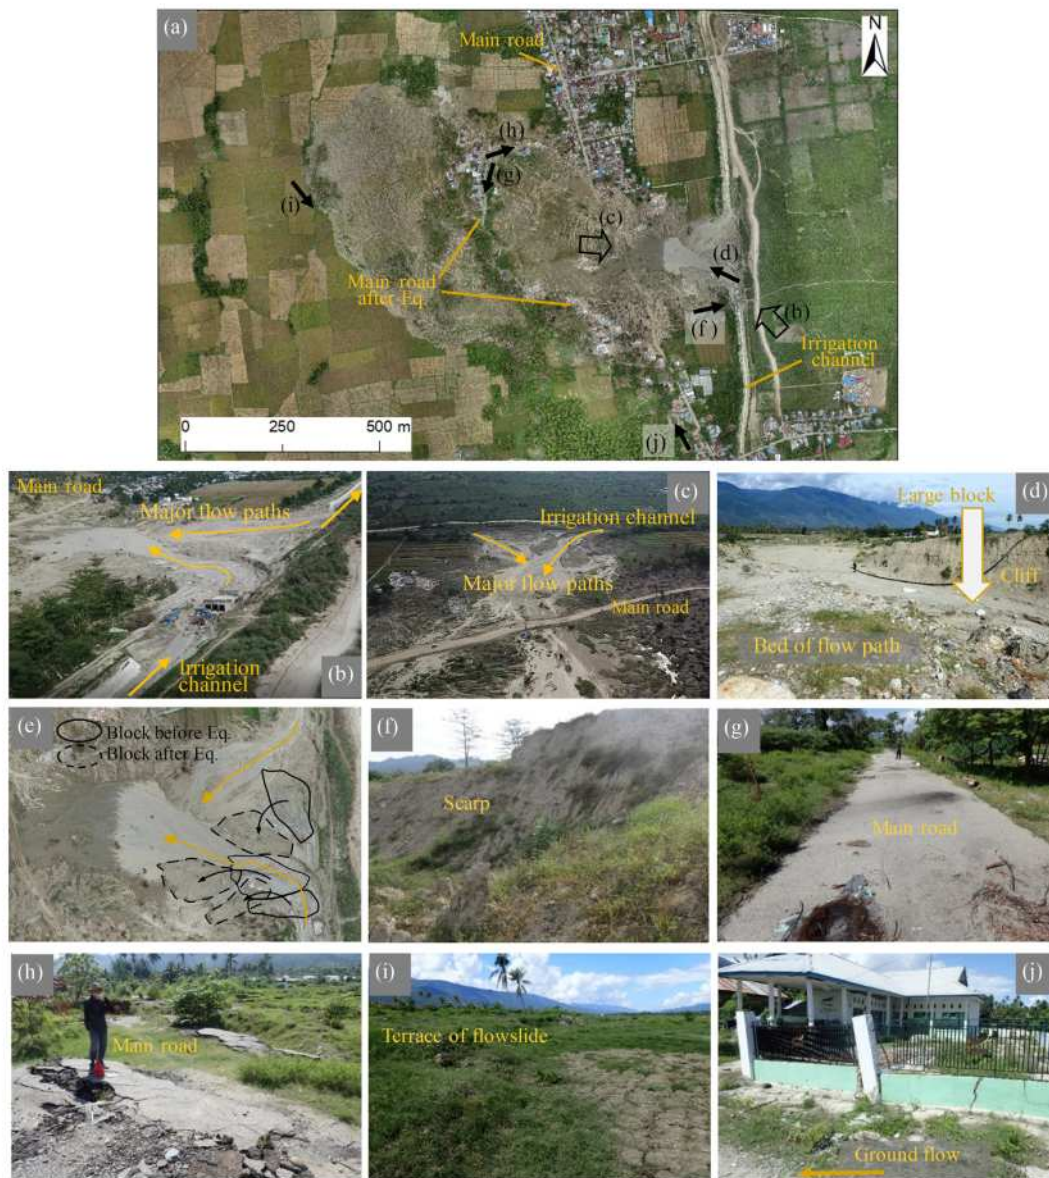
Fig. 3 shows the orthophotomap after the earthquake and photos of several locations. The easternmost margin of the affected area is bounded by the irrigation channel. Arrows in Fig. 3(a) indicate locations and orientations of photos shown in Fig. 3(b)–(j). Concrete panels were

Fig. 3. (a) Orthophotomaps after the EQ (Courtesy by JICA, November 4, 2018). (b)–(j) Photos at locations in and around the flowside area.

placed on the eastern side surface of the channel, while soil was exposed unlined on the bottom and western sides (Fig. 3(b)). In one southern breached channel section, a box culvert and a sluice gate were heavily damaged, which was most probably the cause of the extremely loud sound heard by the residents. Fig. 3(c) demonstrates the overview of inundation area. There were two major flow paths from the channel that created a cliff as high as several meters (Fig. 3(d)). In this area, as shown in Fig. 3(e), three large blocks were identified, with dimensions of the largest block as 80-m-long and 42-m-wide, that moved about 50 m downwards, which most possibly triggered the irrigation channel failure. Meanwhile, head scarps were formed along the western side of the channel (Fig. 3(f)).

Structures including roads, houses, fences, channel, trees, and footpaths between rice fields were mapped on the two orthophotomaps before and after the earthquake to obtain pre- and post-earthquake locations. Corresponding points were connected to identify the direction and magnitude of ground displacement. The derived displacement vectors are presented in Fig. 4 together with topographic contours before the earthquake at 1-m intervals. Note that the number of mapped points added up to 280; all the points were used to evaluate the strain distribution in the area as described later in Fig. 5. However, in Fig. 4, only about half of them are presented to avoid unfavorable complication. The flowslide generally moved west-northwest, which was normal to the topographic contours. The largest flowslide displacement was in the northern half of the area, ranging between 320 m and 410 m (average 350 m), while smaller in the southern half. Fig. 3(g) illustrates the original main road pavement remained almost intact even after sliding down 360 m. The displacement decreased near the northern and southern margins of the flowslide area, which distorted the ground and ruined structures. Fig. 3(h) presents the main road pavement torn into pieces near the northern margin. The westernmost margin of the flowslide mass after the earthquake was clearly observed as a terrace 1–2 m higher than adjacent unaffected area (Fig. 3(i)).

In areas outside the flowslide, there also exist clear signs of liquefaction-induced lateral spreading. Fig. 3(j) shows concrete wall cracks with a 15 cm-opening, while the house behind tilted about two degrees, which are typical structural damage commonly presented in areas of liquefaction-induced lateral spreading in past earthquakes. Such evidential incidents were observed in many locations including all those surveyed wells shown in Fig. 2(a), indicating that foundation soil of wider area in Sibalaya indeed liquefied. Similar observations were reported for Petobo and Jono Oge (GEER, 2019; Kiyota et al., 2020; Hazarika et al., 2020). On the other hand, on the east of the irrigation channel, any noticeable indication of soil liquefaction was not found in the field survey and UAV photos, indicating that the irrigation channel affected the liquefaction occurrence. Meanwhile, based on the report by GEER (2019), the irrigation channel provided water for agricultural activities and was unlined until it reached the northern edge of the Petobo slide. The unlined channel allowed water to infiltrate downhill towards the river, which contributed to a higher groundwater table and deposit saturations, while increasing liquefaction potential during earthquake shaking.

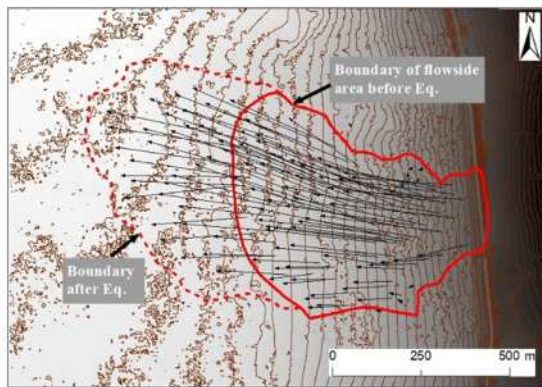
The red solid line was drawn to inclusively cover all the vector origins in Fig. 4, representing a boundary before the earthquake between flowslide ground mass and ground that did not flow. The boundary moved west-northwest to the broken line. It is most likely that the ground between the two lines did not move significantly, and soil in the upstream side slid and covered the surface.

Fig. 4. Displacement vectors and contours before the earthquake.

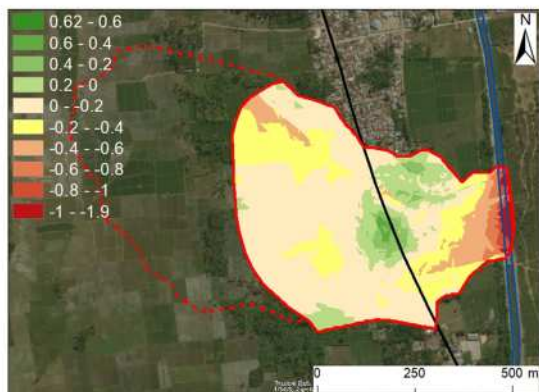
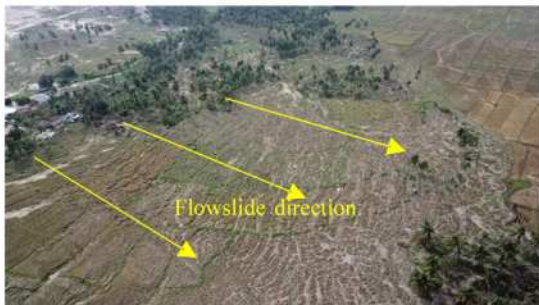
Fig. 5 presents a normal strain contours in the east–west direction that provides a clear view of the overall deformation characteristic. Strain is negative (tension) and extremely large in an originally narrow area between the irrigation channel and the large blocks translated downslope. Similarly, in the area of the upstream rice pads that immediately in the downslope side of the blocks (see Fig. 1(b)), large tensile strain ranging between 20% and 60% can be observed. In this area, all the structures, rice pads and trees that had been there were translated about

350 m and failed to survive the earthquake. By contrast, in the area between the upstream and downstream rice pads including the original road, the tensile strain is relatively smaller than surrounding areas or even positive (compression). Meanwhile, in the downstream rice pad area, large tensile strain is observed, which is also confirmed by surficial observation that many crack openings were filled with sand ejecta, with orientations mostly normal to the flowslide direction appeared (Fig. 5(b)). These observations suggest that tensile deformation in the flowslide direction generally prevailed in the flowslide area. However, the area of some 100 m width along with the original main road kept its integrity even after the deformation (Fig. 3(g)), while flowslide displacement of the area was somewhat smaller than the surrounding area. This might be because houses in this area pumped up ground water, which increased in thickness of the unsaturated stiff surface.

(a) Normal strain in east-west direction, ϵ_x

(b) Many significant cracks appeared in downslope area of the flowslide

Fig. 5. Contours of strain in east-west direction and aerial photo of downslope area.

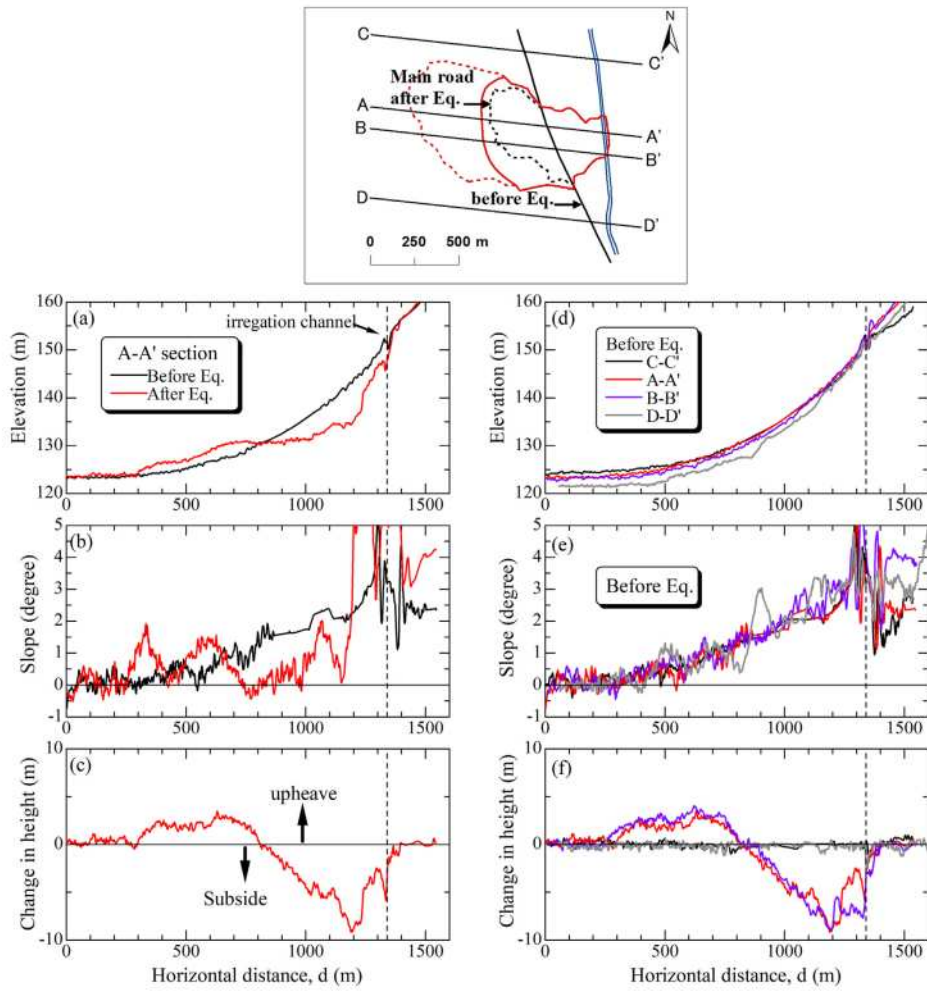
was three degrees at around the irrigation channel and gradually decreased as going down the slope to approximately zero near the westernmost margin, $d = 300$ m, where the flowslide finally reached. After the earthquake, the slope was particularly large at around $d = 1250$ m corresponding to the side cliff of the large block created by

flooded water erosion and the adjacent soil flowslide. Change in height (subsidence) was large at the upstream side, decreased to zero at $d = 800$ m, and turned into heaving until the flowslide margin ($d = 300$ m), as indicated in Fig. 6(c).

Fig. 6(d)–(f) compare vertical sections of the main-stream (A-A') and the sub stream (B-B'), as well as two sections outside the flowslide area (C-C' and D-D'), in which all the sections were chosen to be parallel to each other. The topography of all these sections before the earthquake were quite similar although deformations were significantly different. Differences in conditions other than topography including soil stratification, mechanical properties of soil and ground water table, should be the reasons for the different deformations between the sections.

Fig. 6. Height of ground surface in sections parallel to the flowslide.

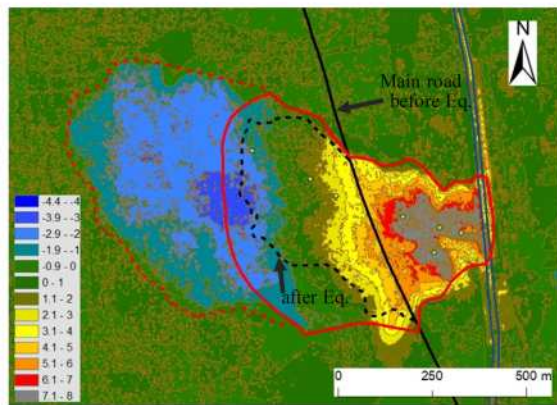
Fig. 7 represents change in height in the flowslide and surrounding areas. The area of the flowslide represented by the polygon in red in Fig. 4 is $534,700 \text{ m}^2$, consisting of $339,200 \text{ m}^2$ subsiding area and $195,500 \text{ m}^2$ heaving area. The total volume of subsidence and heaving are $609,900 \text{ m}^3$ and $745,900 \text{ m}^3$, respectively. Consequently, the average subsidence over the entire flowslide is 0.25 m , while that of the area outside the flowslide is also estimated to be 0.013 m , with the subsidence in the area in the east of irrigation channel being generally very small.

Fig. 7. Contours of change in elevation (in meter).

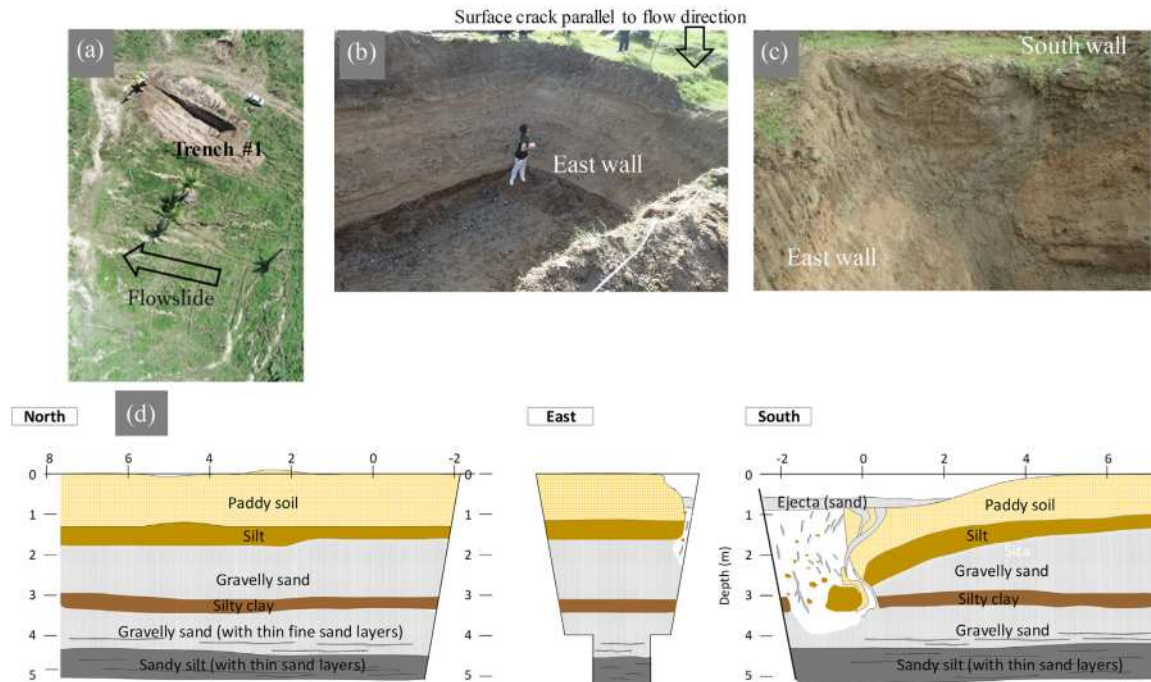
Fig. 9(a) shows an UAV photo of the trench #1, whose ground surface had been in the upstream rice pad, approximately 150 m downslope of the irrigation channel and 200 m upstream of the original main road. A 17-m-long and 5-m-wide area was excavated with the longitudinal axis parallel to the flowslide direction. White lines perpendicular to the flow direction are cracks filled with ejecta from liquefied layers formed by the tensile deformation (See Fig. 7). Meanwhile, smaller cracks parallel to the flow direction are also observed. Fig. 9(b) and (c) present the east and the south walls of the trench, respectively. Considering stability, all the walls of the trenches in this report were cut at a slope angle of 75-degree or less (approx-

mately 1H:3V slope). The east wall cut a crack while there exist ejecta at around the south-east corner. Fig. 9(d) illustrates sketches of the walls. The ground surface was covered with a paddy soil containing stalks and roots of rice overlaying a thin silt layer. These layers were mostly intact, but a difference was noted with respect to the south east corner of the trench. A gravelly sand layer underlying these surface layers was configured by several sand and sandy gravel layers of 10–30 cm thick, with a few thin silty sand layers with thicknesses of the order of ten cm sandwiched in between. The surface of this layer drooping towards the south-east corner suggests that this layer was liquefied and was squeezed near the corner. A thin stiff silty clay layer, which was separating two gravelly sand layers, was found to remain intact except for the corner. The lower gravelly sand layer was mostly uniform with only a few thin interlayers included near to its bottom. It has been observed in all the exposed walls that the typical configuration of non-liquefied gravelly sand layer was a stack of sand and sandy gravel layers every 10–30 cm thick, with thin silty sand layers having thicknesses of the order of ten centimeters sandwiched in between. This fact suggests that both the upper and lower gravelly sand layers liquefied, but due to the flowslide, only the lower gravelly sand layer highly sheared. Stratifications and thin interlayers in this layer were disappeared during long distance flow deformation. The sandy silt layer at the bottom of the trench contained thin interlayers of silt and fine sand (of

Fig. 9. Trench #1 and its walls. (a) Aerial photo (b) North and west walls in the trench (c) South-east corner in the trench (d) Sketches indicating stratification of soil layer exposed on the walls.

the order of one cm thick) with its surface being level and flat. Furthermore, the soil at the south-east corner is highly disturbed, a part of the silty clay layer was distorted and sand dikes extended from lower sandy gravel layer to the surface while many small fragments of fractured silt layer were contained.

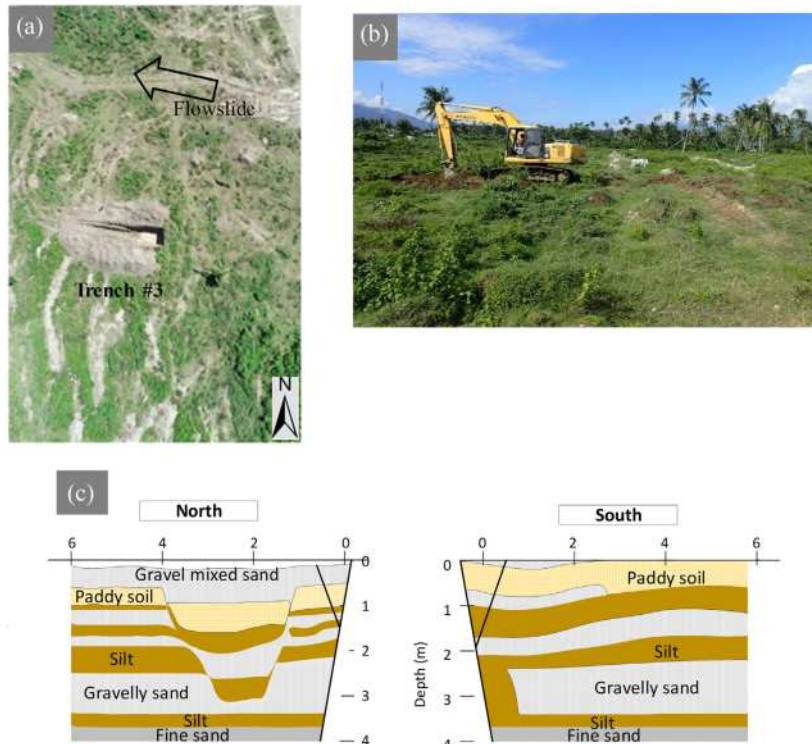
Fig. 10(a) shows an UAV photo of the trench #3 located at 80 m upstream from the trench #1. The ground surface had been the upstream rice pad, located approximately 70 m downslope of the irrigation channel. This trench had dimensions of 15-m-long and 5-m-wide, with the longitudinal axis parallel to the flowslide direction. Fig. 10(c) presents sketches of the north and the south walls, indicating that the overall figure of the soil stratification is similar to that of trench #1. There were three gravelly sand layers below the surface paddy soil separated by thin silt layers. The gravelly sand layer at the greatest depth was largely uniform and did not have any laminar and interlayers, while the other two gravelly sand layers at shallower depths had. Moreover, the silt and fine sand layer at a depth from 3.5 m and 4 m from the surface seemed intact. Thus, it can

be claimed that the liquefied and largely deformed layer is the lower gravelly sand layer.

It should be noted in the north wall sketch that a part of the shallower layers fell into the underlying lower gravelly sand layer, which is a typical deformation pattern that can be observed in the trap-door-experiment (e.g. Stone and Wood, 1992). The soil mass clearly defined by the two conjugate slip surfaces behaved as a block, suggesting that the upper and middle gravelly sand layer did not liquefy. The block located immediately below the white band appeared on the ground surface (Fig. 10(a)), which is described as a tensile crack filled with ejecta.

Fig. 10. Trench #3. (a) Aerial photo (b) Site of the trench just before the excavation initiated (c) Sketches indicating stratification of soil layer exposed on the walls.

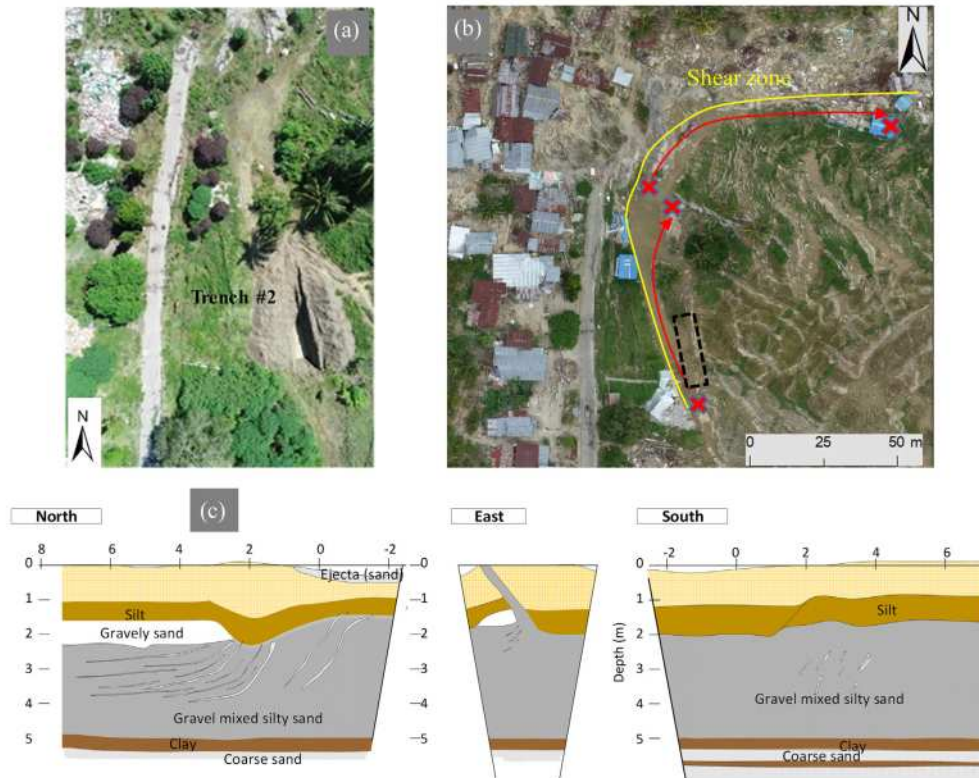
Fig. 11(a) illustrates an UAV photo of the trench #2, which was located at 175 m downstream from the trench #1. The surface of the ground had been a soccer field, 20 m upslope from the original main road. This was the largest trench with dimensions of 20-m-long and 5-m-wide while the longitudinal axis approximately normal to the flowslide direction. It can be seen in Fig. 11(b) that a slip line (shear zone) passed through and divided this area into two blocks. Referring a house and a torn-off fence shown

Fig. 11. Trench #2. (a) Aerial photo of the trench #2 (b) Orthophotomap of the wider area around the trench after the earthquake (c) Sketches indicating stratification of soil layer exposed on the walls.

by red crosses in the figure, the movement of the east side block relative to the west side block is estimated to be 55 m. The trench #2 was excavated on the shear zone between the two blocks. Fig. 11(c) demonstrates sketches of the north, east and south walls. A surface layer with silt layer underneath was similar to those in the trenches #1 and #3, while with a difference that a single thick sandy gravel layer was found below the surface layers, which was highly disturbed with apparently higher fines content in contrast to the trenches #1 and #3. Many clay fragments and dikes of clean fine sand with several centimeters width randomly existed, indicating that the layer was highly disturbed. It can be assumed that this layer was consisted of multiple sandy gravel layers, which were separated with thin silt layers but mixed altogether due to the extremely large shear deformation during the flow sliding. Thin interlayers of silt or fine sand remained only in a clay and a coarse sand layers at the bottom of the trench.

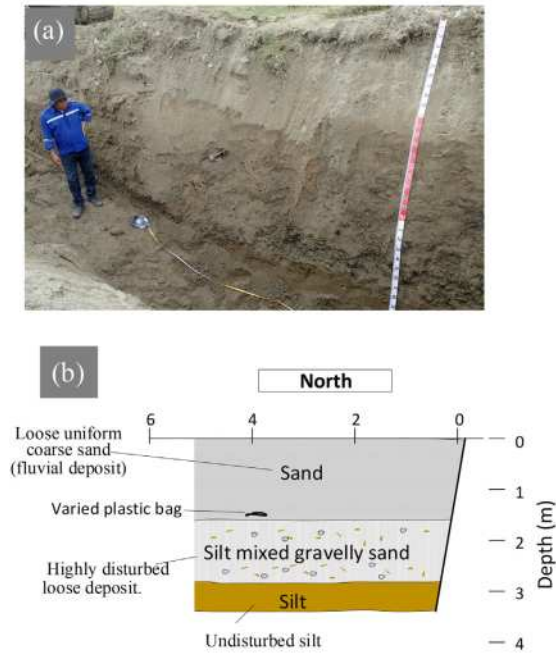
compared to those in the downstream trenches. Fig. 12 shows a photo and a sketch of trench #4. At the ground surface, clean uniform coarse sand loosely deposited to the depth of 1.7 m. The color and grain size distribution of the sand were different from any layers in the downstream trenches #1, #2 and #3. In this layer, a relatively new plastic bag and garbage were found, indicating that it was a fluvial deposit brought by the flooding water from the irrigation channel. From 1.7 to 3 m below the ground surface, there was a highly disturbed layer without any thin interlayers included, whose soil was gravely sand with many small clay and silt fragments being heterogeneously mixed, and was most likely liquefied and highly sheared as the overlaying surface layers slid downslope. A silt layer at 3 m deep observed as undisturbed, which contained thin interlayers of fine sand remained (several mm in thick).

Fig. 12. Photo and sketch of trench #4.

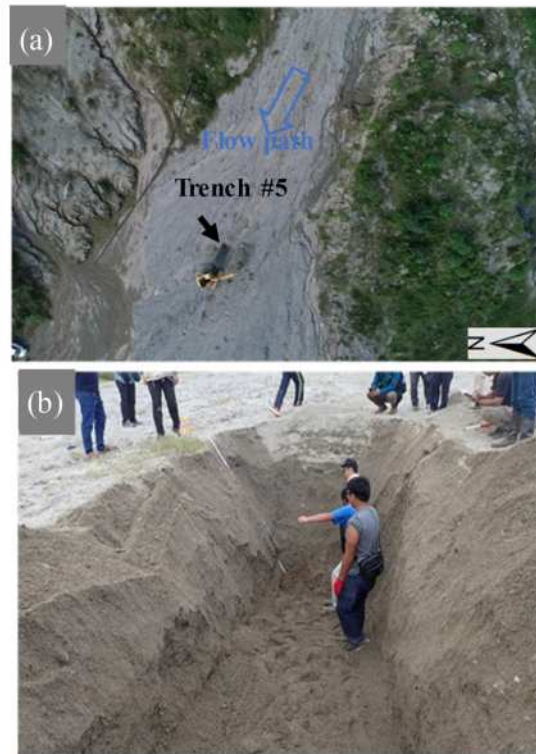
Although trench #5 located only 30 m upstream from #4, the width of the inundation flow path at this location was approximately 2.5 times narrower than that at #4, suggesting that flow rate of the flooding water was considerably higher than #4. Fig. 13 indicates photos and a

sketch of the trench. The trench was excavated with the longitudinal direction parallel to the flow path. Clean uniform coarse sand, which is considered to be fluvial sand loosely deposited, and an undisturbed silt layer were appeared at a depth of 2 m. A possible scenario of deposit formations at trenches #4 and #5 is that the gravelly sand layers liquefied during the earthquake, while the overlying soils slid down to the slope and liquefied layer been exposed. During the flooding event triggered by the irrigation channel failure, the liquefied gravelly sand was fully flushed by the flooding water at #5, but only the surface of the liquefied sand was eroded at #4 because flooding water spread out and flow rate decreased at #4. Thereafter, the flow rate has slowed down and uniform coarse sand loosely deposited on the surface at both #4 and #5.

Fig. 13. Photos and sketch of trench #5.

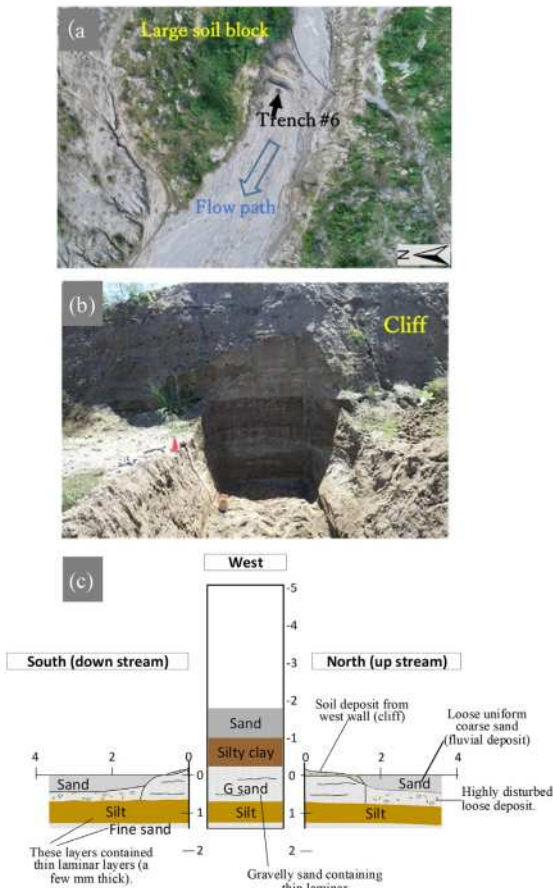
Trench #6 was excavated at 105 m upstream from #5 and 120 m downstream from the irrigation channel on the side of a cliff of one of the large soil blocks and at the flow path edge. Fig. 14 depicts photos of the trench and sketches of the walls. The cliff of the block was 5 m high from the flow path bed and consisted of layers of gravelly sand, silt and silty clay, with all of their thicknesses in a range 10–80 cm. The west wall (Fig. 14(b)) is the cliff of the block. It is reasonable to consider that the gravelly sand layer below the silty clay layer liquefied and sheared, while the overlying soil block slid down approximately 30 m. Soil mass originally existed slid approximately 350 m down to

the slope, which highly disturbed the gravelly sand layer in the south and north wall. The fluvial course sand was deposited at the surface while its depth increasing with respect to increase in distance from the cliff.

Fig. 14. Photos and sketch of trench #6.

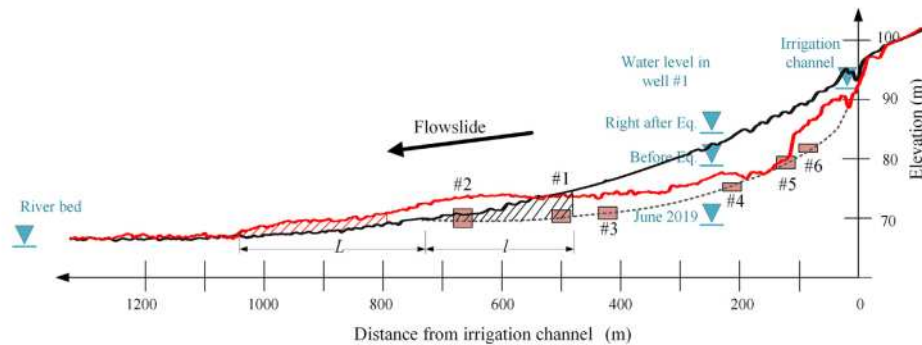
Fig. 15 depicts the cross-section A-A' along with the main stream of the flowslide passing through most trenches excavated in this study, together with depths of identified liquefied layers in each trench. The broken line represents a possible slip surface or a shear zone, along which large

shear deformation is considered to have occurred, and soils above the line slid downslope while that underneath remained.

near the westernmost region, which was indicated by the shaded zone in the figure, was chosen as an example. The shear resistance mobilized along the base of the mass, τ_r , can be estimated simply based on the energy conservation as follows:

Fig. 15. Cross section of A-A section before and after the earthquake together with highly sheared depths detected in trenches.

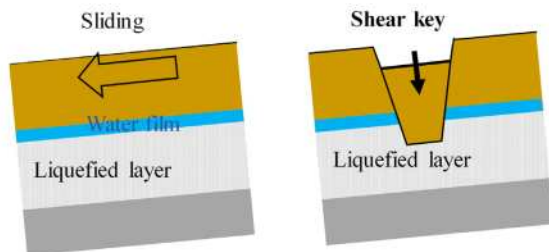
Fig. 16. Schematic illustrations of shear key effects of a part of sliding soil block submerged into an underlying liquefied layer.

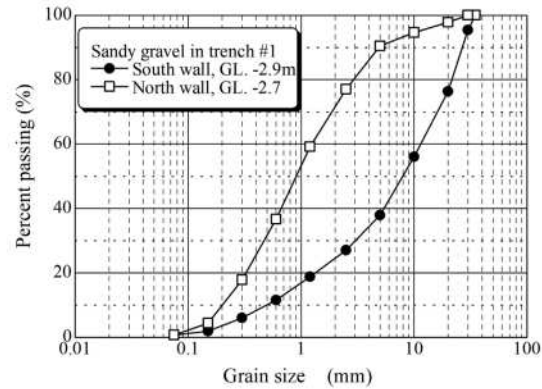
Fig. 17. Grain size distribution of soils obtained from highly sheared layer in trench #1.

small amount of silt as well as gravel. The fines in the soil was confirmed with laboratory testing to be non-plastic.
