Influence of low permeability capping layers on liquefaction induced ground failure

Divyesh Rohit¹, S.M.K. Pasha¹, H. Hazarika¹, T. Kokusho², A. Arsyad³, and S. Nurdin⁴

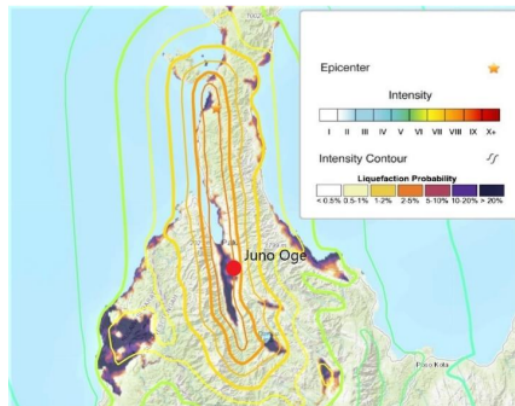
Fig.1. Intensity contour with liquefaction probability map of Palu city for September 28, Donggala Earthquake (USGS, 2018).

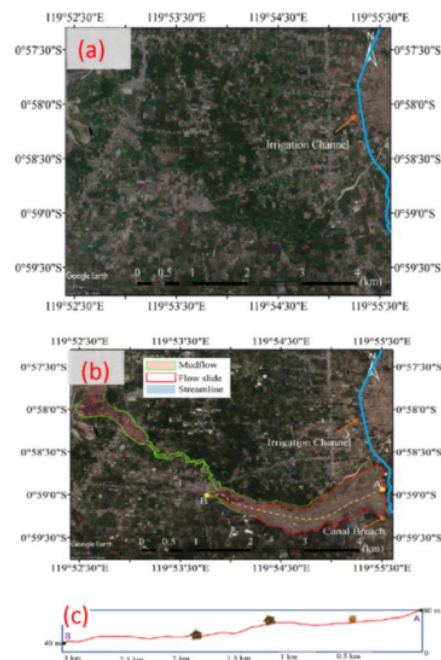
The study area was located in Sigi Regency in Juno Oge village. Fig. 2 shows the condition of the investigated site at Juno Oge before (Fig. 2(a)) and after the event (Fig. 2(b)). The site consisted of agricultural fields with a sparse population and an a very gentle sloping ground of less than 2% (Fig. 2(c)). Furthermore, an irrigation channel was located at the eastern side of failure zone as shown in Fig. 2(b). Due to the presence of irrigation channel, the ground water level was very high ($< 5\text{m}$ from ground surface). This also contributed to the flow failure at the site. Earthquake induced liquefaction triggered massive flow slide which breached the water channel discharging a large volume of water into the already failed zone thereby causing massive mudflow as depicted in Fig. 2(b).

Figure 2: Lateral flow area in Juno Oge due to Donggala Earthquake, (a) before flow failure, (b) after flow failure with mud flow and water channel and (c) slope profile of the flow area (modified from Google Earth).

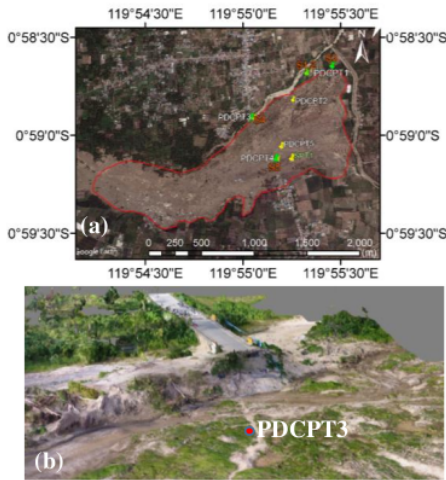
Fig. 3 shows the location of PDCPT tests (PDCPT1 to PDCPT5) and location of soil samples (S1 to S5) collected at depth of 0.5 to 2m. Except PDCPT 1 which was conducted in out of failure zone, the rest of them were conducted within the failure zone.

Fig3. (a) Location of PDCPT tests and soil samples (b) UAV3D map of PDCPT3

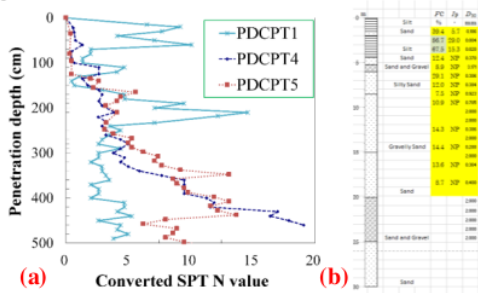
Ground water level was observed within a meter of ground surface in failed zone which indicates high risk of reliquefaction at susceptible areas in the future events. The results of PDCPT 1, 4 and 5 are plotted in Fig. 4(a). Ground water table was seen at depth of 2.3, 0.9 and 0.75

m from ground surface. Results of PDCPT1 (out of flow failure zone) indicates presence of a 2.5 m of layered loose to medium dense sandy soil deposit on top of relatively loose layers (SPT N value <5) of sandy-silt soils.

Comparison between results of field tests at PDCPT1 with that of PDCPT4 and 5 shows similarity between N values for very first 1-2 m of soil below the ground surface at PDCPT 4 and 5 with that of PDCPT1 at depth 2.5m below ground surface. This may explain the possible contribution of underlying loose layer of sandy-silt soil in flow failure of gentle ground. Grain size distribution of soil samples and Scanning Electron Microscopy (SEM) image of sample S2 as representative sample are shown in Fig. 5. All the samples were classified as silt with low liquid limit (ML) according to JGS 0051-2009. Furthermore, specific gravity of samples range between 2.62~2.65.

Fig4. (a) PDCPT test results (b) Soil condition at SPT1

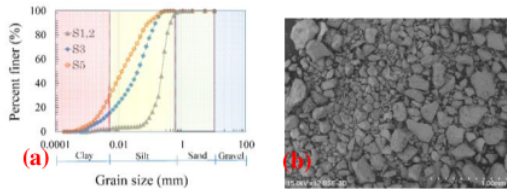
Fig5. (a) grain size distribution of soil samples (b) SEM image of sample S2
