Geo-Disaster Report

# Large distance flow-slide at Jono-Oge due to the 2018 Sulawesi Earthquake, Indonesia

Hemanta Hazarika<sup>a,\*</sup>, Divyesh Rohit<sup>a</sup>, Siavash Manafi Khajeh Pasha<sup>b</sup>, Tsubasa Maeda<sup>a</sup>,  
Irsyam Masyhur<sup>c</sup>, Ardy Arsyad<sup>d</sup>, Sukiman Nurdin<sup>e</sup>

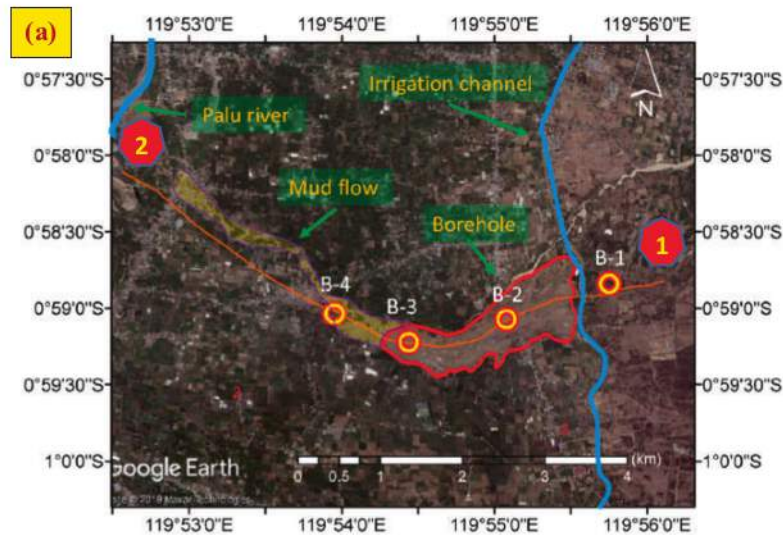
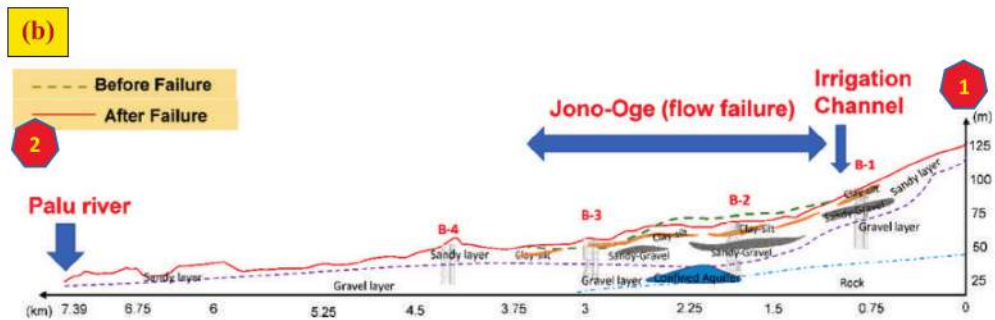
As shown in Fig. 9a and b, the flow-slide in Jono Oge started from the crown next to irrigation channel in eastern edge of Palu valley to the toe deposits on the western side of failure zone. The slide spread over 1.5 km<sup>2</sup> of area with

maximum displacement of 2 km. The slide swept away the residential buildings as well as the connecting roads between the north and south of Jono Oge with huge deposition of residuals on top of the sliding surface. It should be noted that the over 90% of the area where the flow-slide occurred was agriculture farms. A high ground water level and underground water in the surficial sandy layers due the presence of irrigation channel likely exacerbated the ground conditions, and contributed significantly to the large scale flow-slide, which extended over a number of kilometers.

Fig. 9. Satellite imagery and ground profile (a) Flow slide after earthquake (c) Cross section at profile 1–2 (Not to scale).

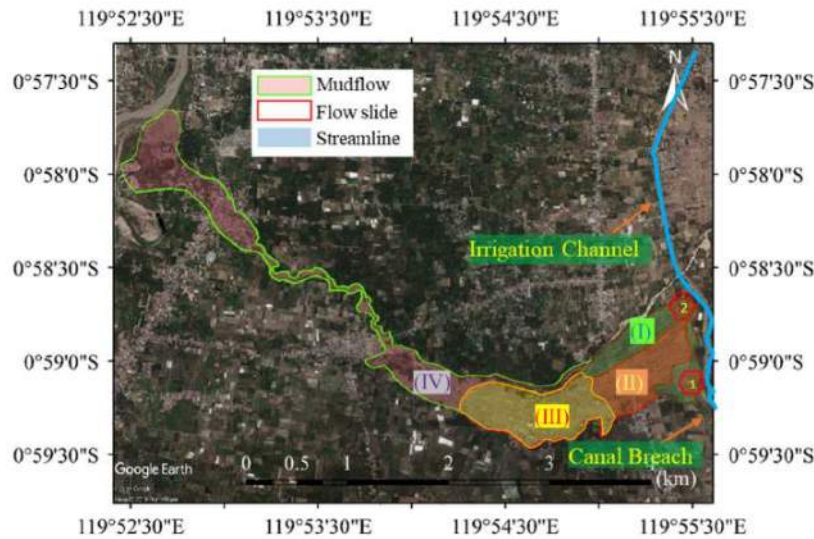
able, the locations of structures and satellite imagery was used to identify those features. The post-earthquake displacements and changes in the morphological features of the area were clearly identified by this combination of formation. The area was categorized into our different zones I, II, III and IV, as shown in Fig. 10.

Fig. 10. Divided zones based on ground displacement in flowslide area.

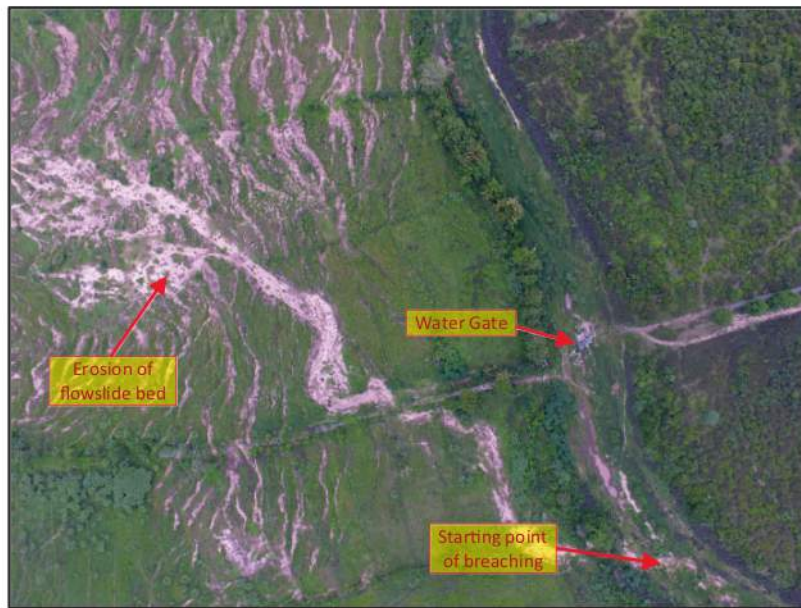
Zone (I): The lands enclosed by Zone (I) are mainly rice and tomato fields with a few numbers of residential buildings. Being the crown (head scrap) of the flow-slide region, Zone (I) extends from northeast side of the failure zone along the western boundary of the irrigation channel to the southeast side, where the failure zone intersects with the channel. The breach of the channel and the destruction of the water gate resulted in the discharge of a huge volume of water, resulting in the scouring of the neighboring fail-

Fig. 11. UAV imagery of channel breaching and water gate destruction in Jono Oge (Location No. 1 of Fig. 10).

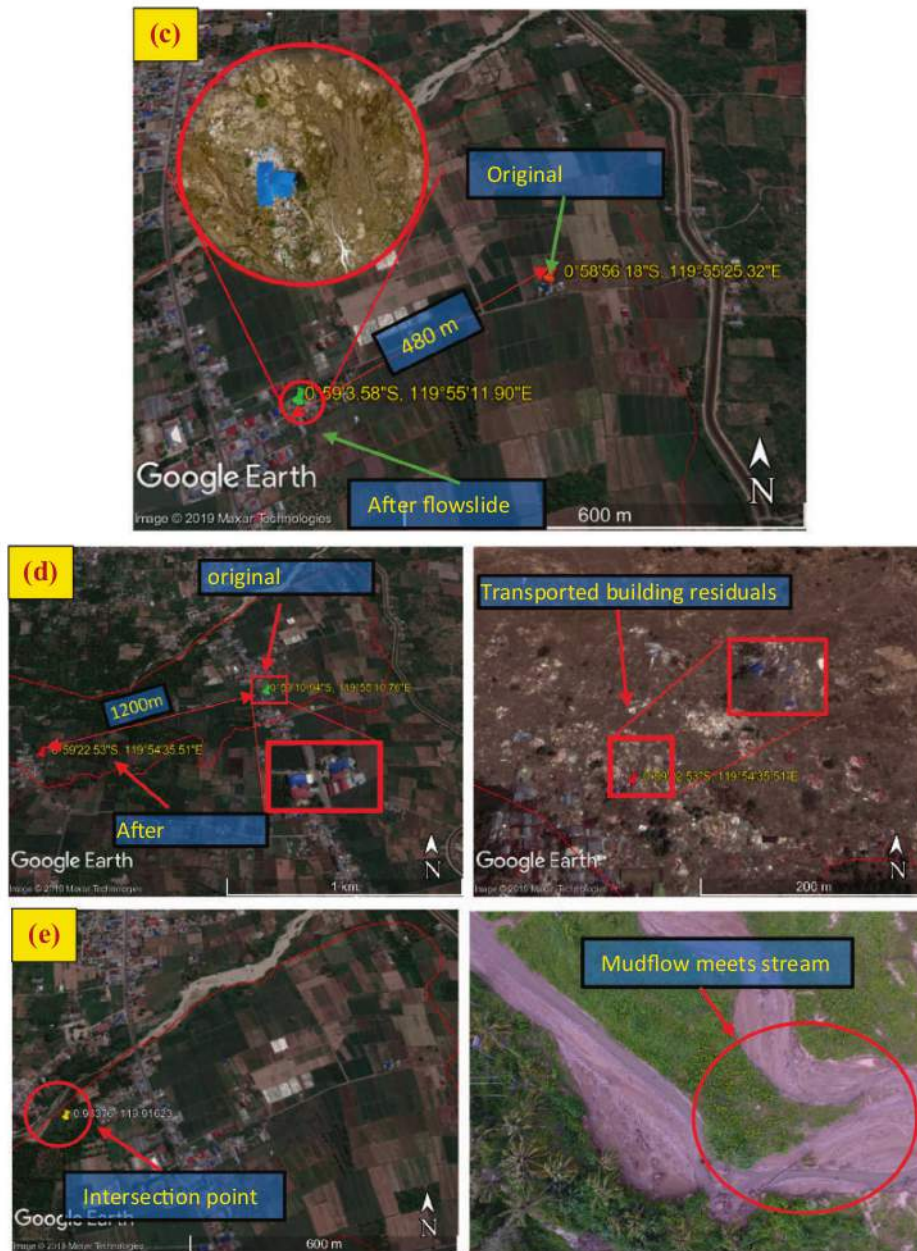
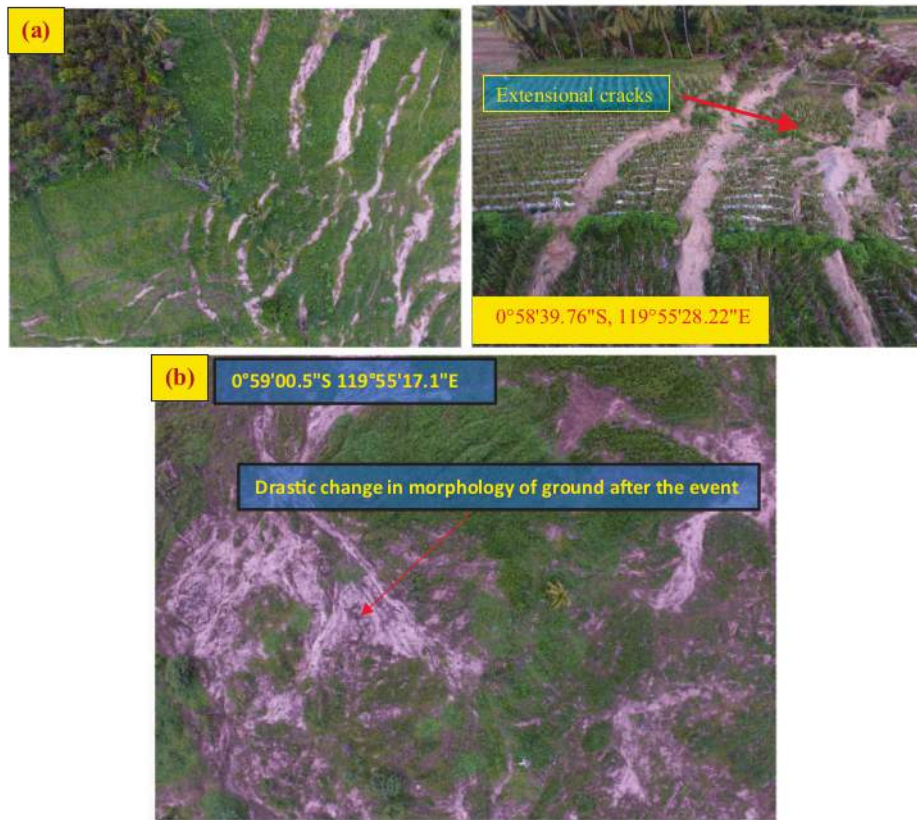
2- Zone (III): The deposits of the flow-slide area were collected in this zone as well as the residuals of the rubble and trees which were transported from Zone (II). The transportation distance of soil deposits from zone (III) to zone (IV) due to the mudflow (yellow colored highlighted area in Fig. 10) is not clear. Some of the structures were carried by 1,200 m from the west of the flow-slide region. The mudflow resulted in the pile-up of runouts deposits a few meters in depth in this region (Fig. 12d).

Fig. 12. Aerial imagery of damage within the failure Zones (a) extensional cracks in Zone (I) (b) flowslide and erosion of ground due to the mudflow Zone (II) (c) displacement of blue house in zone (II) (d) long distance transition of residential buildings after flowslide and mudflow (e) intersection of mudflow and stream.

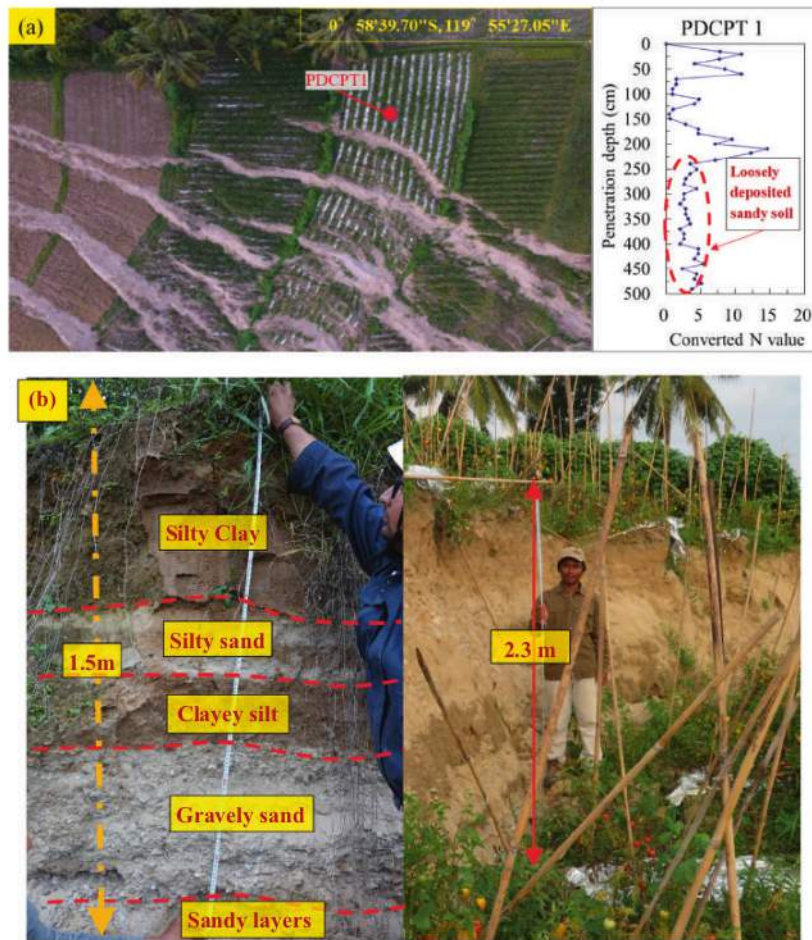
Fig. 14a shows the aerial view of the PDCPT1 location and the resulting N-values, which varied with depth. The test was conducted on an agriculture farm (with paddy fields and a tomato farm). The clear decrease in the N value in the soil layers below 3.5 m is an indication of loose liquefiable layers. The very high ground water level (which

was higher than the water level at the time of testing G. W. L = 2.3 m) also contributes to and increased risk of liquefaction in shallow underground layers.

In order to identify the soil profile of PDCPT1, an image of an extensional crack with depth of around 2.5 m in a nearby cliff is shown in Fig. 14b. The soil stratification is clearly visible and less disturbed due to the downhill flow-slide. The surface layer is composed of 10–20 cm of organic soil followed by 30–40 cm of clay and silty clay

layer. The underlying silty sand layer, which is between 10 and 20 cm in thickness, is sandwiched between the upper clayey layer and the lower clay silt layer, which is between 10 and 20 cm in thickness. Below the silty layer, there were

several layers of sandy and gravelly sand layers which appeared to be affected by liquefaction in the underlying layers. As described in Kokusho (1999), it is possible that the presence of these low permeable layers at the top allowed the formation of a water film between them and the underlying gravelly sand layers. Some soil samples were collected from the exposed parts of extensional cracks, and the basic physical properties of soils in the stratified layers were determined.

Fig. 14. PDCPT conducted within Zone (I) (a) Location and (b) test result at PDCPT1 (c) Profile of exposed soil layers at cliff created by extensional cracks.

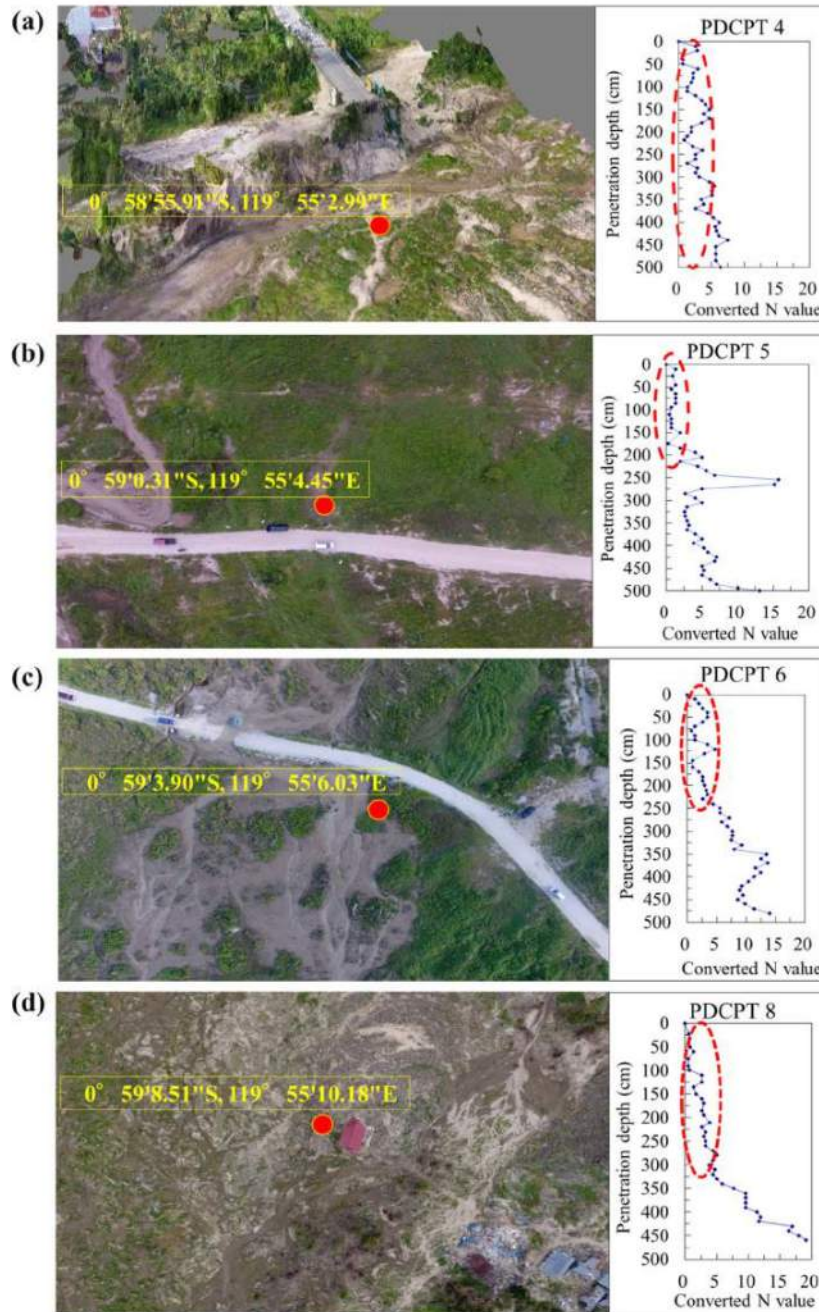
As shown in Fig. 13, the PDCPT 4, 5, 6, 8 were conducted alongside the damaged road that connects the North and South of flow-slide region. The locations and results of PDCPT 4, 5, 6 and 8 are shown in Fig. 15a–d. PDCPT4 was conducted beside the collapsed bridge in the North of Jono-Oge (Fig. 15a). PDCPT5 was conducted within the flow-slide Zone (I) (the tension zone), where there were many soil blocks which had been dragged along and had rafted together in failure area (Zone (II)) (the compression zone) (Fig. 15b). PDCPT6 was conducted in zone (II), where the flow-slide apparently started (Fig. 15c).

PDCPT8 was conducted a few meters from the red building (Fig. 15d) which defied the ground movement and remained in its original position. Even though the building sustained considerable damage, rendering it uninhabitable, it did not experience displacement like the other structures in the flow-slide zone. This structure may have been able to resist the flow slide because of the massive raft foundation elaborated in Kiyota et al. (2020).

The N values obtained from all the PDCPTs for depths less than 5 m ranged between 5 and 10. These values indicate that the soils could be categorized as loose to very loose (USACE, 1994). These N values correspond to the critical  $N_{cr}$  values for soils categorized as potentially liquefiable at this range of depths (Koizumi, 1966). The soils appear to be loosely deposited sand and silty sand layers which were transported from the upstream of the flow-slide region. However, the resultant N-values from PDCPT 8 are greater than 10 beyond the depth of 3.5 m. That is,

the N-values for PDCPT 8, which was conducted close the red house, were higher than for the other tests. A trend similar to PDCPT 8 was observed in the tests conducted by Kiyota et al. (2020) in the same vicinity. The out of trend peak in the results for in PDCPT 5 was attributed to the presence of a gravelly layer at 2.5 m, which appears to have been liquefied. According to historical records, the liquefaction of gravelly soils is rare. However, some cases of liquefaction in gravelly soils were observed in past earthquakes, such as during 1995 Hyogoken Nambu earthquake, Japan, as well as during the 1983 Borah Peak earthquake in the United States, where extensive liquefaction took place in fluvial sandy gravel layers (Kokusho et al., 2004). It should be noted, however, that the lateral displacement and flow-slide in these earthquakes was between only a few meters and tens of meters. In the 2018 Sulawesi earthquake, the displacement of soil blocks was between a few meters to hundreds of meters. This

Fig. 15. Aerial imagery of locations of PDCPT and  $N_{SPT}$  versus depth values (a) PDCPT4 (b) PDCPT5 (c) PDCPT6 (d) PDCPT8.

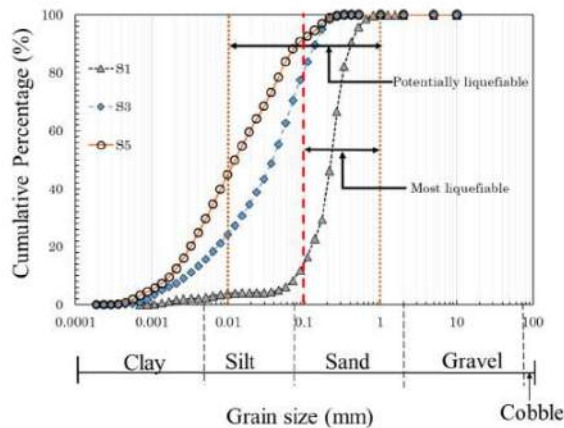
34 were tested to determine the grain size distribution. The grain size distribution of soil samples S1, S3 and S5 are shown in Fig. 16. The soil in sample S1 can be classified as a uniform sand with traces of silt, while the soils in samples S3 and S5 can be classified as non-plastic silt (Japanese Geotechnical Society Standard, 2016). As seen in Fig. 16, soil sample S1 is the most liquefiable among the samples,

Fig. 16. Gradation of soil samples S1, S3 and S5 collected from the site.

whereas the soils in samples S3 and S5 are potentially liquefiable soils, according to the soil classifications proposed by Tsuchida (1970). These soils were either transported by the flow slide, by the succeeding mudflow or deposited as residual soils. According to the handbook of Port and Harbor Research Institute of Japan (PHRI, 1997), the gradation of these soil samples indicates they are potentially liquefiable.

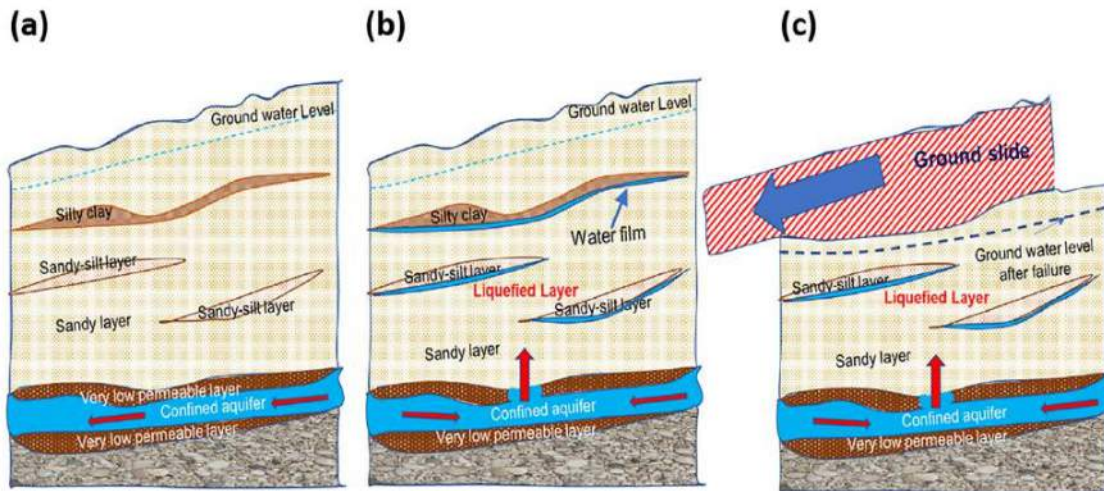
A series of model tests conducted by previous researchers (Kokusho, 1999, 2016; Kokusho and Kojima, 2002), have revealed that liquefaction at a site with sandwiched lithology results in the liquefied soil being trapped below the low permeability cap layer. This creates a thin inter-layer of water referred to as a “water film”. The resulting inhibition of excess pore water pressure dissipation and presence of the water-film reduces the residual shear strength of the sandy soil layer to below the initial static

Fig. 17. The mechanism of flow slide and development of water film under low permeable layers (a) before the earthquake (b) immediately after initiation of liquefaction (c) after the earthquake.

shear stress. Consequently, even on a very gentle slope, lateral flow takes place due to the action of gravitational force until equilibrium is achieved. Note that the results of common laboratory tests have shown that such capping layers may not be continuous and that they do not necessarily spread horizontally across the whole failure zone.
