Conference Paper · November 2019

## *23<sup>rd</sup> Annual National Conference on Geotechnical Engineering*

## Liquefaction Disaster Mitigation and Geohydrology Conditions, Lessons from The Palu Earthquake Magnitude 7.4 $M_w$ 28 September 2018

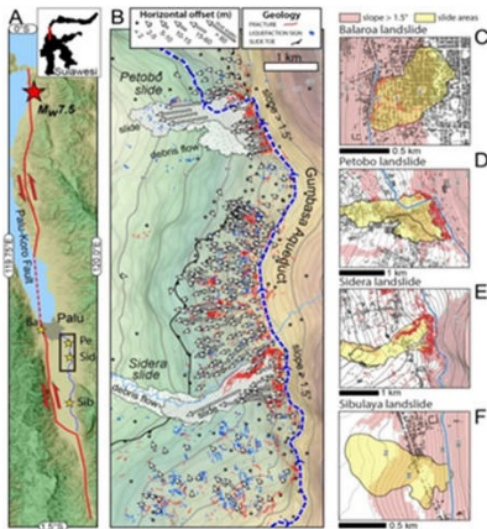
life due to landslides in Palu can be attributed to four landslides that occurred, three of which came from lateral distribution under the Gumbasa Canal (Petobo, Jonoyoge, and Sibalaya), and the fourth in Palu (Balaroo) where waterways were smaller dividing dry land at higher altitudes than failed fertile city land (Fig. 5A, C).

Fig. 5. Map of A Landslide Triggered by An Earthquake in The Palu Valley, Central Sulawesi, Indonesia. (a). Map of The Palu-Koro Fault. (Source: Kyle Bradley et al., 2019)

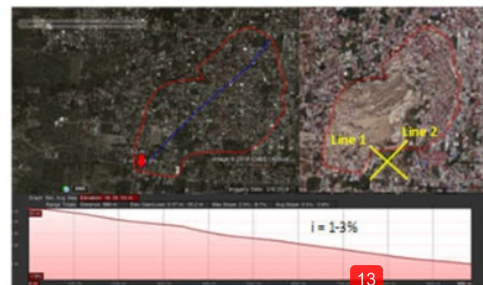
Specifically for conditions in the Balaroo area, it can be seen in Fig. 6a (Citra Ikonos satellite acquisition on 3 September 2018), where the area experiencing liquefaction is a slope with a slope of 1-3.8% with an elevation range of 56 m to 18 m and a track length of 988 m (blue track line). This is what supports the mass movement of material. Satellite image of the acquisition on October 2<sup>nd</sup>, 2018 after liquefaction can be seen in Fig. 6b.

Fig. 6. Balaroo Satellite Imagery (a) Before The Earthquake (b) After The Earthquake and Track 2-D Electrical Resistivity Tomography and Topography Testing

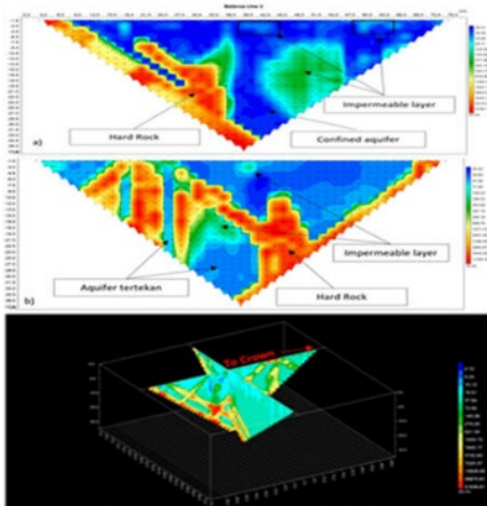
Fig. 7 below shows the resistivity cross-section obtained from iteration 12 with an RMS error value of 1.5%. This resistivity cross-section reaches a depth of 37 m with a value of resistivity range 23.12- 7,922.7  $\Omega$ m. Resistivity values of 23.12 - 34.11  $\Omega$ m in shallow aquifer layers with depth distribution ranging from 1.5-12 m. In addition, it can also be predicted slip fields marked by resistivity contrast seen at the bottom (between red and yellow). At this location, it was also found the phenomenon of a ruptured aquifer that caused increased water content in the soil layers above. This phenomenon is an indicator of increasing liquefaction potential in this area.

Fig. 7. 2 Line of 2-D Electrical Resistivity Tomography Test at Balaroa

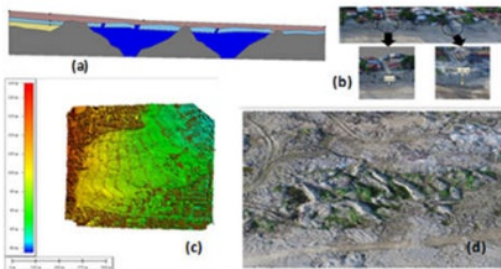
The mechanism of land collapse in the village of Balaroa which is located about 1 km west of the Palu-Koro Fault can be illustrated as shown in Fig. 8a. Where the beginning of the ground movement (crown) is located on Jalan Gunung Gawalise, while the end is located on Jalan Balaroa. The area affected is housing with an area of impact around 34.5 Ha with a circumference of 2.5 km. An aerial view of the damage in Balaroa is presented in Fig. 8d. Direct observations on Jalan Gunung Gawalise where the peak of the landslide began showed that an avalanche took place in the form of a landslide with a slope height after a landslide of around +10 m (Fig. 8b). While the liquid flow (Nalode) triggered by the earthquake began to appear at a distance of about 60 m from the crown of Fig. 8d, where this liquid flow causes the house in the location to sink and move as far as 300-600 m from the original location.

Fig. 8. (a) Model of The Mechanism of The Collapse of Balaroa Liquidation Collapse, (b) Land Slide on The Crown, (c) Digital Elevation Model of Balouroa Contour, (d) Image of Liquefaction Aerial Flow After 15 Days of The Palu Earthquake

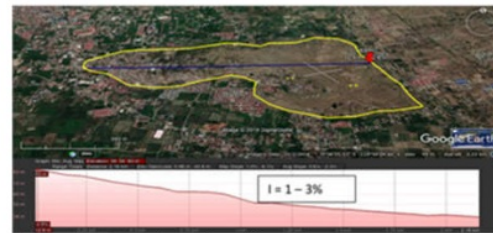
Petobo is a residential area that suffered heavy damage due to liquefaction. This area is about 7.2 km east of the Palu-Koro Fault. Although this area has a slightly sloping ground at the surface, the mass movement from the top slope to the bottom is triggered by liquefaction.

Fig. 9. Petobo Satellite Image After The Earthquake and 2-D Electrical Resistivity Tomography and Topography Test Track

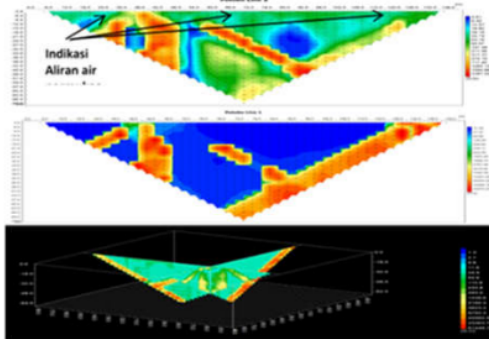
Fig. 10 below shows the resistivity cross-section obtained from iteration 12 with an RMS error value of 1.5%. This resistivity cross-section reaches a depth of 70.4 m with a resistivity range value of 5.61 – 2,387.5  $\Omega$ m. Resistivity values of 5.61 - 42.196  $\Omega$ m in shallow aquifer layers with depth distribution ranging from 3-12 m. In addition, it can also be predicted slip fields marked by resistivity contrast seen at the bottom (between red and yellow). At this location, it was also found the phenomenon of shallow aquifers that were widespread that caused an increase in the level of soil saturation in the area. The source that causes shallow aquifers can be caused by infiltration from the Gumbasa irrigation channel above, or it could also be the influence of aged river seepage, the Niga River whose dukes once flowed in the Petobo subdistrict, but

were closed due to sediment siltation and eventually disappeared due to settlement development. This high level of saturation is an indicator of increasing liquefaction potential in this area.

Fig. 10. Result of 2 Line of 2-D Electrical Resistivity Tomography Test

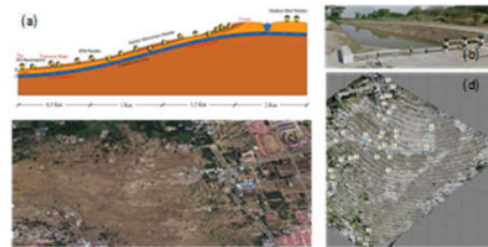
The mechanism of land collapse in the Petobo subdistrict can be described as shown in Fig. 11a. Where the initial ground motion (crown) is located in the western area close to the Gumbasa irrigation primary canal Fig. 10b. while the tip (toe) is located near Dewi Sartika Street. The affected area is housing with a total area of about 180 ha with a total number of affected around 744 houses. An aerial view of the damage at Petobo is presented in Fig. 11c. From direct observation on the crown of the Petobo liquefaction area, where in the crown area there is a lateral movement of land followed by an avalanche with a slope height after a landslide of about +6 m. While the liquefaction flow (Nalodo) triggered by the earthquake began to appear at a distance of about 110 m from the crown of Fig. 11d in a massive sand boiling storm. where debris from the liquefaction flow is expected to go hand in hand when massive sand boils occur. Debris flow is continued by free aquifers that have come out to the surface of the ground.

Fig. 11. (a) Model of The Collapse Mechanism of the Petobo Liquefaction Collapse, (b) Gumbasa Irrigation Canal Before The Earthquake, (c) Image of Liquefaction Aerial Flow 16 Days After The Earthquake, (d) Aerial Contour Image
