EVALUATION OF PONRE-PONRE DAM INSTRUMENTATION

Rita Tahir Lopa and farouk Maricar

ABSTRACT

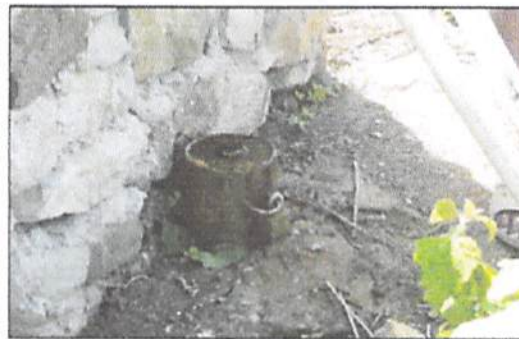
The condition of the water level on SP.4 (on the left side of the weir) is recorded that the ground water in the pipe has overflowed and can not be measured soil water level, can be seen in Figure 4.

Figure 3. Water overflows in SP.4

4. The results of evaluation of instrumentation demonstrate that piezometer equipment, seepage, and settlement survey are in un-maintained condition, requiring routine maintenance and maintenance as well as periodic cleaning.

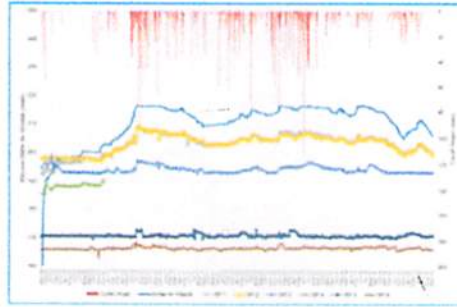
From the graph of MAW-CH-SP (2008-2015) relationship shown in Figure 5, the data shown in SP.4 (blue color) can only be observed to 24th Dec 2009.

Figure 4. Graph relation MAW-CH-SP (2008-2015)

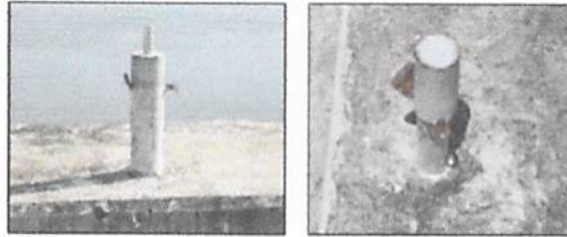
Conditions of Settlement Instrumentation to observe the point of observation of the shear and the reduction of the dam surface mounted at the top of the dam, many of which have no cover and a broken lock, as shown in Figure 6.

Figure 6. The crest Settlement staple cover is not installed and the padlock is broken

1. Many of the settlement settlements are damaged or missing. Where many padlocks is damage. Evaluation results indicate that the open stitch cover may cause the end of the monument to experience a change of position, as it is not protected from the irresponsible dam visitor behavior.

2. It is recommended that it need to improve the cover of the stakes and to need periodic measurements in accordance with the schedule for monitoring settlements.

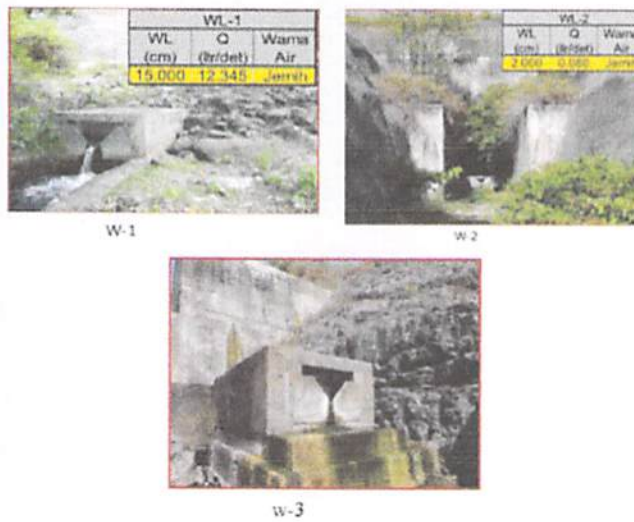
Condition of V-Notch Instrumentation mounted 3 V-Notch pieces, can be seen in Figure 7. Condition of Instrumentations are in good condition on the downstream and diversion works, while in the spillage, there are many moss, and it need maintenance (Figure 8).

Figure 8. Condition of seepage measurement V-Notch Ponre-Ponre Dam

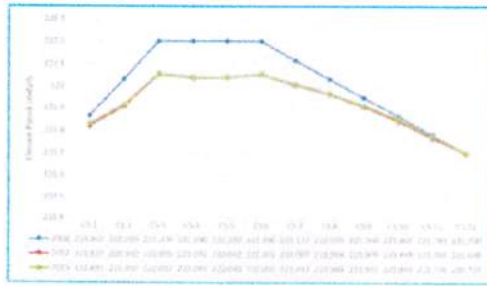
Condition of Crest Settlement Point Instrumentation, cover of many observation points at the top of many nonexistents, only CS-1 and CS-12 attached. Based on Design Review Report Vol 6 annex Design, calculation section 4.2 crest camber is mentioned $<0.25\%$ of Dam height = 14 cm. The graph of settlement measurement as shown in Figure 11.

Figure 11. Settlement at the top of the dam during the Big check

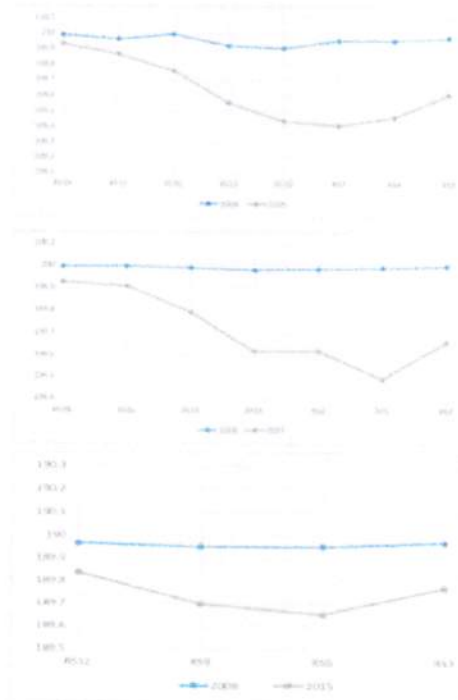
Condition of Rockfill Settlement Point instrumentation occurs weathering on the riprap arrangement on the first, second, and third rows. Benchmarks that are located downstream (RS) should be made permanent road eg trap for survey team / officer to safely perform for measuring. The graph of settlement measurement at the time of the inspection as shown in Figure 12.

Figure 12. Settlement at elevation of downstream dam +210 mdpl, + 200 mdpl, and +190 mdpl during inspection.

3. There is no safety access for surveyors at the observation point in the upstream slope. Evaluation results indicate that the absence of access roads may endanger OP officials in carrying out monitoring. It is recommended to make stairs / traps connecting observation points of settlement at downstream slopes.
