Feasibility evaluation of water supply infrastructure in Luwuk district

S Fatahuddin¹, M Selintung², and B Bakri¹

¹Department of Civil Engineering, Hasanuddin University, Makassar, Indonesia

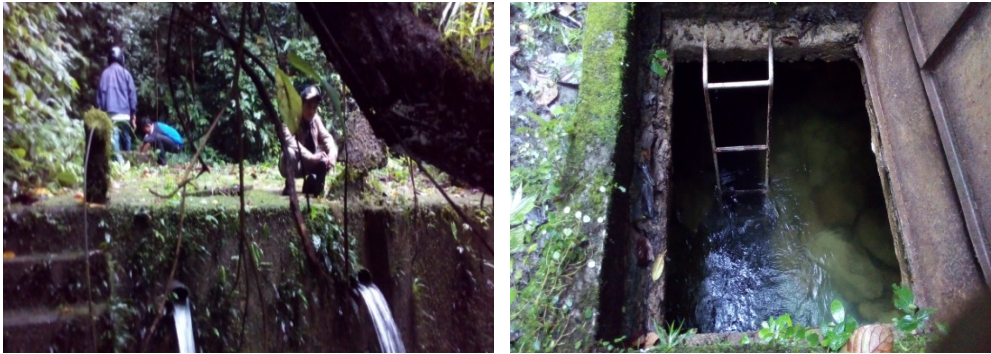
Figure 1. Keles water spring building.

Conditions in the entire building of existing springs can be said to be normal. The infrastructure is still under the planning standards, including safe for pollution, placed in a location that is safe against the carrying capacity of the natural environment. Always, the physical condition of the catchment springs looks not maintained. The results of the assessment of the situation of the water source building are functional categories with more attention to the periodic maintenance of the condition of the building.

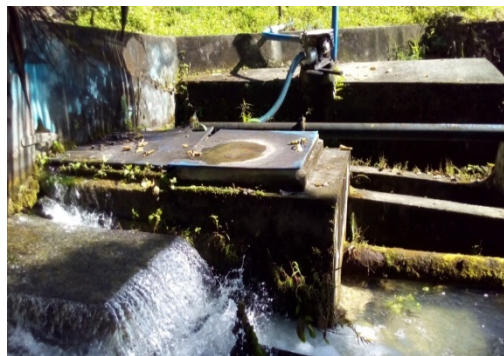
Figure 2. Mangkio water spring building.

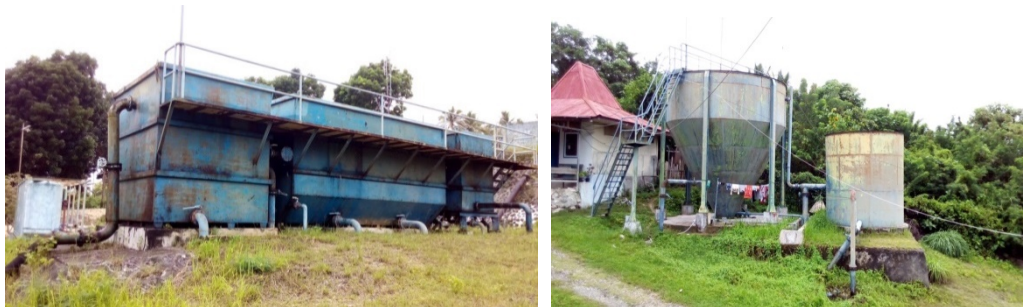
Figure 3. Water Treatment Plants (WTP) of Keles

Besides, although the WTP of Keles has a complete water process system since 2017, several units have no longer functioned. Water entering the WTP only undergoes a sedimentation process without adding any chemicals to the coagulation unit due to limited operational costs. From the aspect of quality, water clarity is only seen physically with the consideration that raw water is sourced from

Based on observations at the location of the water process plant, there is no SOP as a guide for the implementation of work and the limited equipment to support operational activities in the field. The results of the condition assessment result of the Keles Water Process Plant are unfavorable because only part of the construction is by planning standards and is less able to reduce the turbidity of raw water in the rainy season.

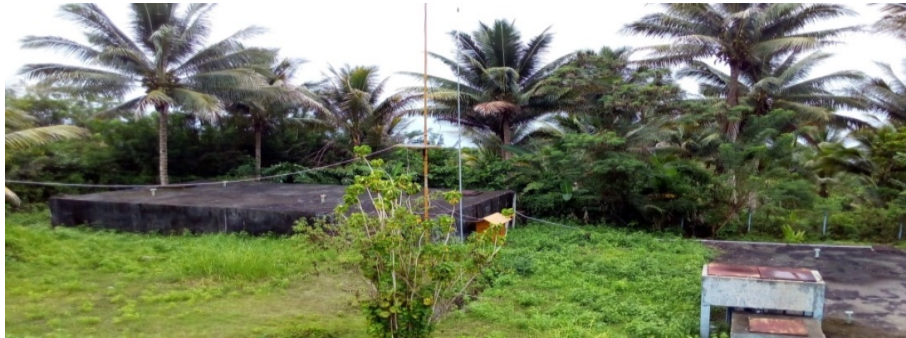
Figure 4. Reservoir Keles.

The dimensions of the two installations are 1100 m³. From the analysis, results for reservoir dimensions are categorized as useful. The condition assessment result of the reservoir is good because of the construction according to the planning standards and clean physical conditions.

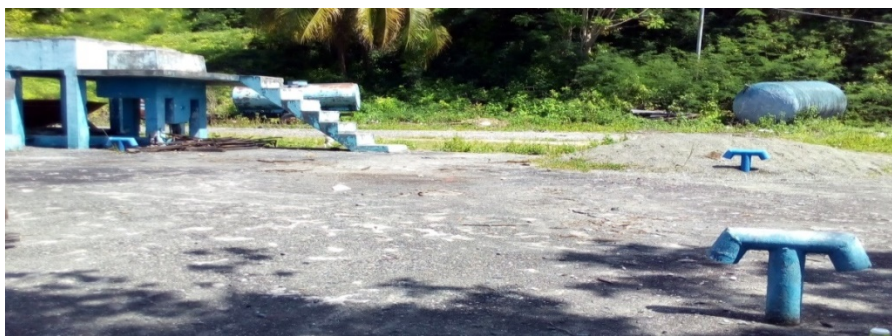
Figure 5. Reservoir Mangkio.
