Performance of pre-stressed concrete sheet pile after long-term exposure in the marine splash environments

Abstract. Pre-stressed concrete (PC) sheet piles are commonly used for river revetment, retaining wall, etc. However, it has not been used in port and harbor structure due to corrosive environmental conditions, which is severe for steel corrosion in concrete structure. Performances of PC sheet piles were evaluated after 12 years exposure in the marine splash environment. An evaluation of mechanical properties, carbonation depth, porosity, chloride content and PC steel condition were carried out. Overall, all specimens showed satisfactory performance: only a few concrete corner and edge chips, low chloride content and low rate of corrosion were observed. Investigation results indicated that BS5 (B = GGBFS, S = steam curing, and cover thickness of 5 cm) showed the best performance (more durable), even though its strength was lower than the other.

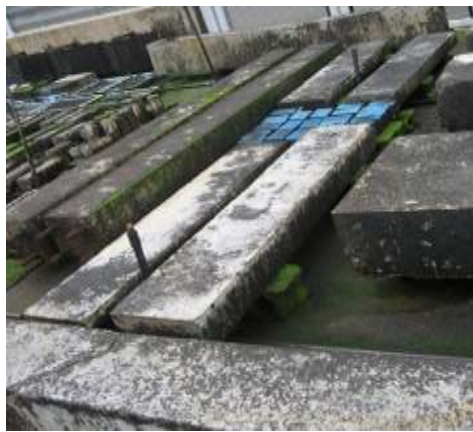
Fig. 2 Sheet pile specimen

Furthermore, specimens were placed in an open space and exposed to seawater splashing. The specimens were subjected to 2 cycles of wetting and drying a day. One cycle was seawater splashing for 4 hours and drying for 8 hours; during 12 years. Figure 2 and 3 show sheet pile specimens in the exposure site and condition when seawater is splashing.

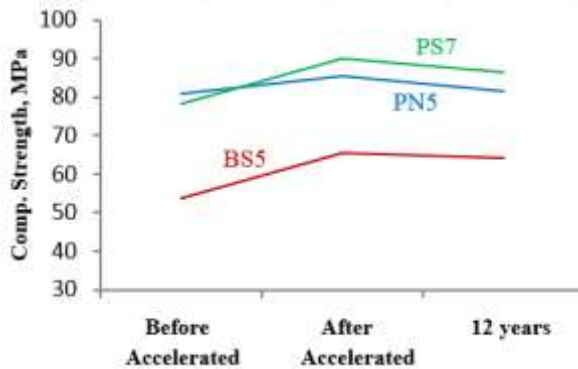
Fig. 4 Compressive strength of concrete

Compressive strength of concrete specimens after 12 years exposure in the marine splash environment is shown in Figure 4. The value is based on average of 6 core samples for each specimen. It is found that strength of concrete decreased slightly. Decrement in strength was observed in all specimens with maximum 4.7% reduction (in case of PN5). There is no significant difference in strength decreasing between steam and water curing.

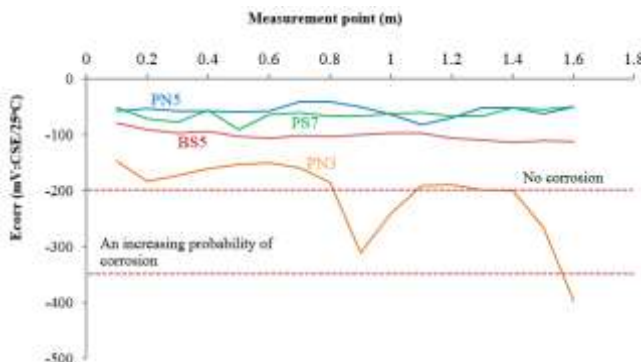
Fig. 10 Natural electrode potential

Natural Electrode Potential Test: Figure 10 shows the natural electrode potential after 12 years exposure in the marine splash environment. Significant change in natural electrode potential of strands occurred in PN3 and showed increasing potential for corrosion. On the other hand, irrespective of cement type, PC sheet pile height of 11 and 15 cm have potential value in the range of -56 to -101 mV:CSE/25°C. According to ASTM C876-91 (1999), potential less negative than -200 mV:CSE indicates 90% probability of no corrosion.

As comparison, PN3 with thickness of 7 cm is used. From the Figure 10, it can be seen that the potential value decreased sharply in some points. Then potential value in the range of -150 to -400 mV:CSE/25°C, indicates an increasing probability of corrosion. This is caused

by the presence of small cracks in some parts of sheet pile as a result of the strand corrosion development on the edge whose no cover concrete. It can be concluded that PC sheet pile with thickness of 7 cm only has a 20-year service life, and it is recommended to increase the thickness to 11 cm to improve the durability.

from both anodic polarization curve and natural electrode potential test showed that PN3 has started to corrode after 12 years exposure.

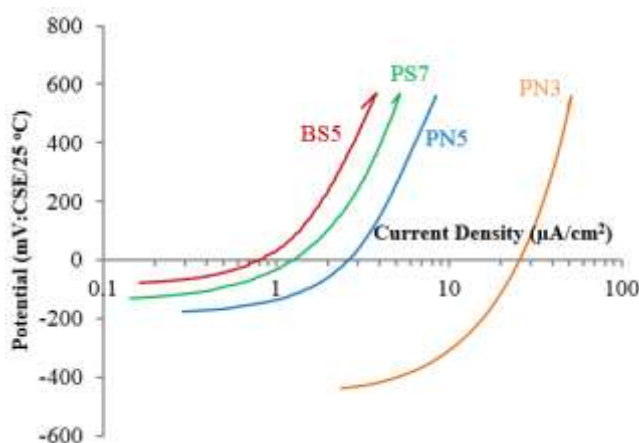
Fig. 11 Anodic polarization curve

Polarization Curve: Anodic polarization curve of each specimen is shown in Figure 11. PC strands were embedded in concrete exhibited various polarization curve with potential between 0.2 and 0.6 V, and current density were the range between 1 to 10 μA/cm², and 10 to 100 μA/cm². Based on the passivation film associated with anodic polarization curve, BS5<PS7<PN5 can be classified into grade 3 and PN3 is grade 1 as a degree of passivity exist [2].

Average of corrosion potential is sequenced as BS5<PS7<PN5<PN3 with values ranging from -125 to -370 mV:CSE. Irrespective of the cement types and curing conditions at the early life of concrete, for the same cover thickness, PN5 exhibited more potential corrosion compared to BS5. It shows that GGBFS is a good barrier against chloride-induced due to compactness of microstructure, hence it can reduce the risk of corrosion. In addition, results
