Structural ductility of RBS on castellated beam subjected to cyclic loading

N H Aswad¹, H Parung², R Irmawaty², A A Amiruddin² and Fakhruddin²

Abstract. RBS placement on a castellated beam on exterior connection structure with RBS position from column face refers to Prequalified Connection for Special and Intermediate Moment Frames for Seismic Application AISC 358-10, Article 5.8. The column beam test aims to evaluate structural ductility of the RBS on the castellated beam flange from the column face. The study was expected to explain the effect on column beam joints to provide input for planning earthquake-resistant building structures. The results show that the castellated test beam with RBS could withstand a load of 12.05 kN with a value of 4.2 structural ductilities.

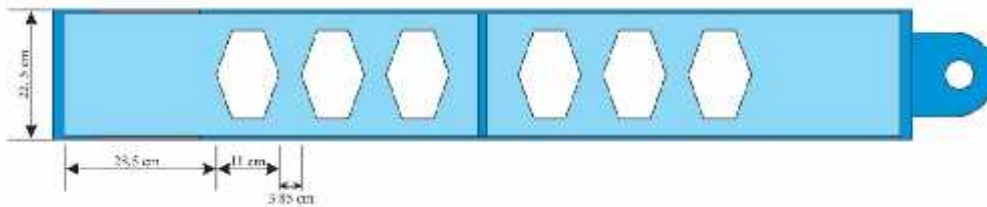
The detailed dimension used in the cyclic behaviour test beam is shown in figure 2. The beam was a solid type IWF 150 x75 mm and converted into 225 x75 mm castellated beam with a distance of 22.5 cm from the face of the column.

Figure 2. Location of castellated beam opening distance.

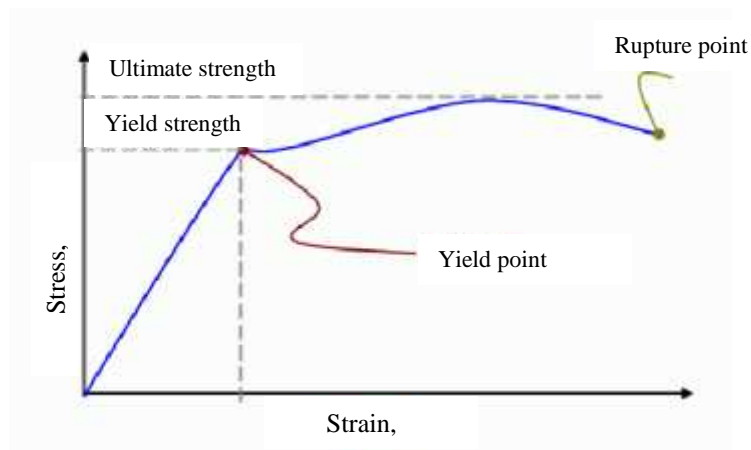
Figure 4. The relationship between stress and strain.

If a load (P) reaches the yield point or yield strength and then passed over the linear line, then it is called the elastic boundary. When the force is continued, the strain increases to the boundary strength i.e. the ductility value of a beam. Then the strength decreases while strain continues to increase as shown in figure 4. (Phase values are elastic/linear and inelastic/collapse).

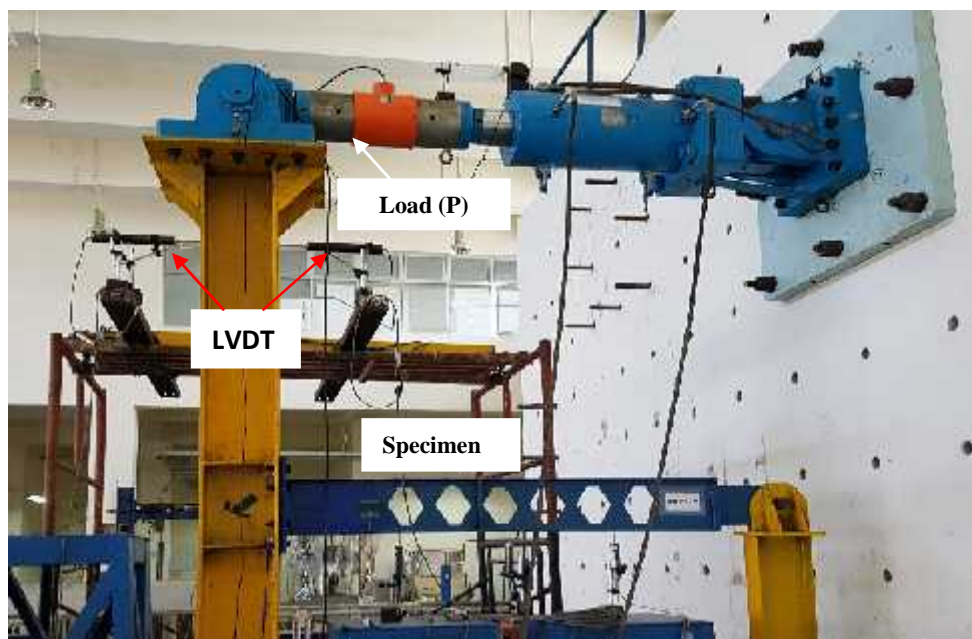
In the experiment, it was assumed that the lateral force was very dominant compared to the gravity load for which the test method was presented with cyclic loading given in displacement-controlled form (P) Actuator (horizontal jack) that moved back and forth with an LVDT (Linear Variable Displacement Transducer) with 0.01 accuracy as the control of displacement value at the upper end of the beam. The amount of deformation and the number of cycles were adjusted with the pretest analysis results to determine the yield displacement, then it was connected to the computer data logger and switching box to record data measured by a strain gauge, LVDT, and load cell simultaneously and automatically. The data were also collected by visual observation of test beam failures such as welding damage, flange bending, web bending, and observing the types of failures that determined the failure of beam structural elements. Loading basis used the ATC-24 loading cycle [6]. Figure 5 displays the actuator test equipment and castellated column beam specimen.

Figure 5. The instrument of the castellated beam-column testing.

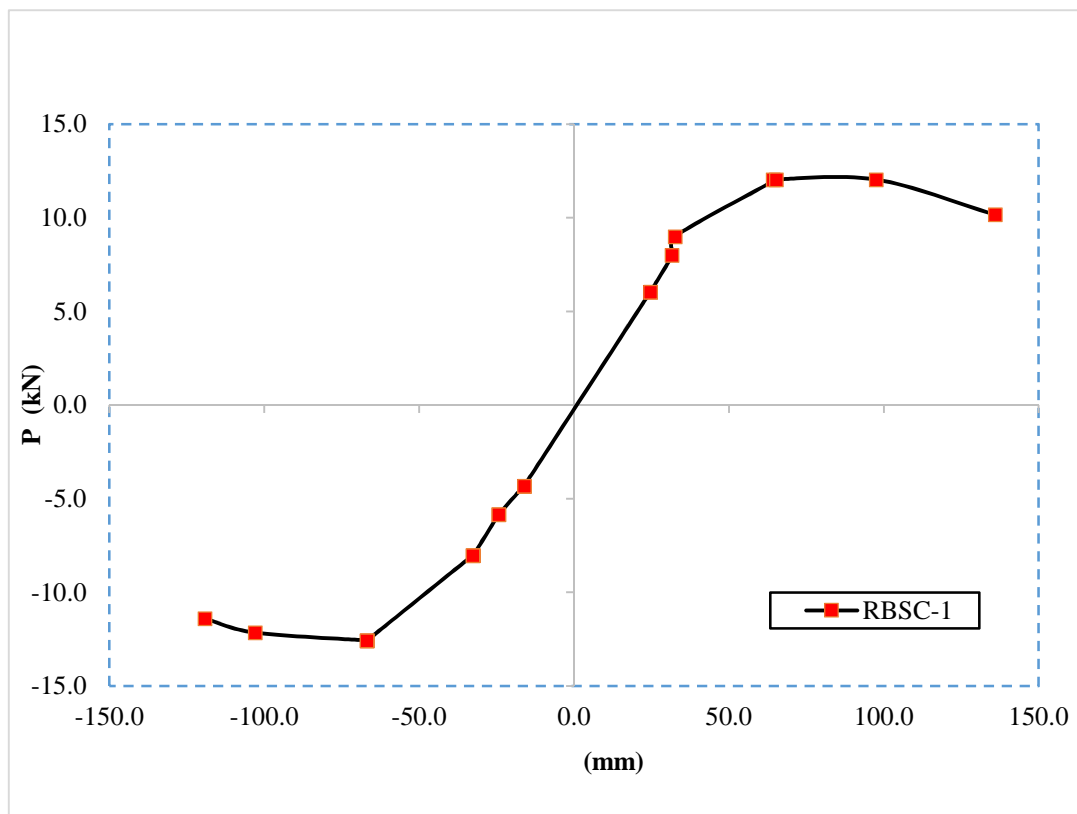
**Figure 6.** Backbone curve of the relationship between lateral loads and displacement.

Figure 6 shows that the structure achieved ductility, where it was deformed during loading until it reached the ultimate boundary. Furthermore, the steel beam reached 97.5 mm deflection at peak load. When the loading was continued until it reached the plastic limit, the ductility reached 4.2-4.3 with strength decreased to 10.9 kN and deflection increased to 136.5 mm.

The results show that the peak load of the RBSC-1 specimen was in a positive direction of 12.0 kN with displacement value of 97.5 mm while the peak load was in a negative direction of 12.57 kN and displacement of 66.8 mm, which was resulted in ductility resistance of the steel frame structure of 4.2 in both directions. This shows that the beam can withstand partial ductility. The yield point was reached at 8.0 kN load in both positive and negative points. [4] reported that an experiment of the castellated beam with an opening distance of 15 cm from the column face without RBS can deform to 100 mm deflection and withstand a load of 12.5 kN. When to loading was continued, the specimen had a 12.8% decrease of strength, with deflection reached 136.5 mm. With a load of 10.9 kN, the obtained ductility value was 4.1, which means that the castellated beam with RBS had a partial ductility.

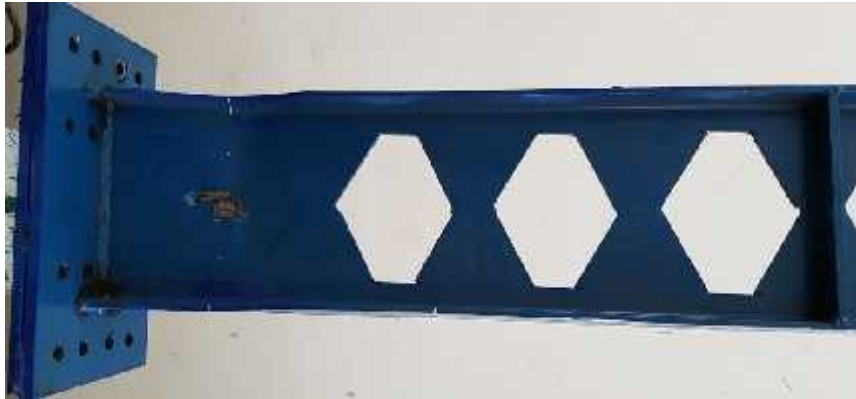
Figure 7 shows that the failure occurred due to the bending of the beam. The flange area experienced buckling with no visible fracture at the weld meeting between the endplate and the beam. During the cyclic loading, the loss of lateral capacity was followed by a slight reduction in the strength of the specimen resulting in the curve decreased at 10.9 kN load. The first yield moment (yield) occurred in the outermost fiber that reached the yield stress at 8 kN load on the upper flange, then it continued to the lower flange. When the load reached a value of 12.05 kN (maximum) while the loading was

continued, the lateral strength continued to decrease creating the reaction to deviate from linearity, which is commonly known as the ductility property of the steel. The ductility property decreases as the load increases until the specimen was collapsed.

Figure 7. Damage on the specimen that was subjected to cyclic loading.
