Wood museum biodeterioration of karaeng patingalloang benteng somba opu, Gowa regency

A Arif, Syahidah and M M Ilyas

Forestry Faculty, Hasanuddin University, Makassar

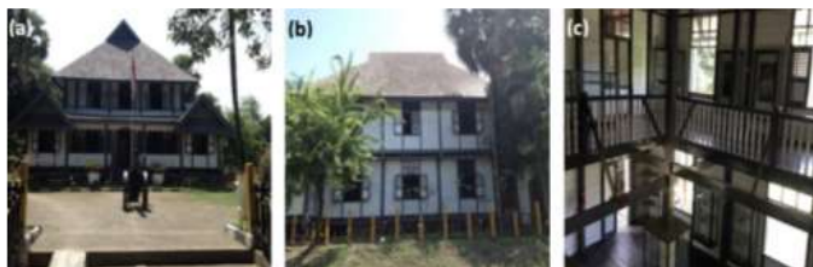
This research was carried out at the Karaeng Pattingalloang Museum, Gowa Regency. The museum building was dominated by wood base material, as shown in figure 1.

Figure 1. Karaeng Pattingalloang Museum Building: (a) front view, (b) side view, (c) inside building

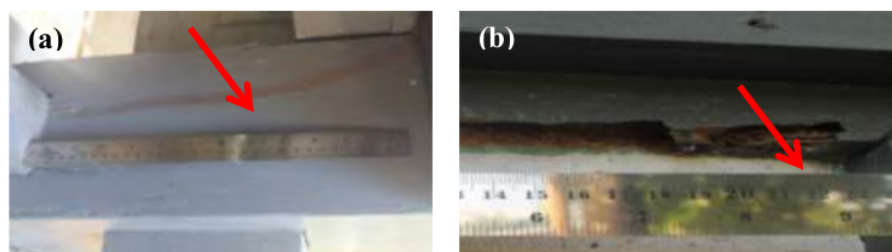
Figure 2. Signs and characteristics of damage caused by soil termites: (a) a single tunnel trail on a pole, and (b) a window frame gallery

Figure 2 proves the traces of a support pole tunnel, even though the soil that was commonly used by termites to make tunnels look cleared. The presence of wandering trails on the surface of objects, such as house buildings [15] and wooden objects [1] demonstrated that the wood component was attacked by subterranean termites. The number of tunnels as traces of an attack can be determined by the type of surface that was passed by termites. Lee's study (2018) presented that suitable surface roughness can positively contribute to browsing speed. Ground termites use this tunnel as a means to reach the object to be attacked [16]. In addition, this tunnel also serves to maintain the environmental humidity needed by termites in carrying out their roaming activities. Soil termites can reach the object of attack even if the object is not directly related to the ground, by building a protective pipe from the ground to the target object through the gaps in the foundation and walls. Soil termites also attack wood by making wood burrows. The form of damage that is often found in wood is attacked by soil termites such as "honey comb" with the characteristic of the presence of soil particles in the burrow [17].

The existence discovery of the termite traces attacked on the wooden components of the museum's pillars and window frames was due to appropriate environmental conditions and allowed the colony to

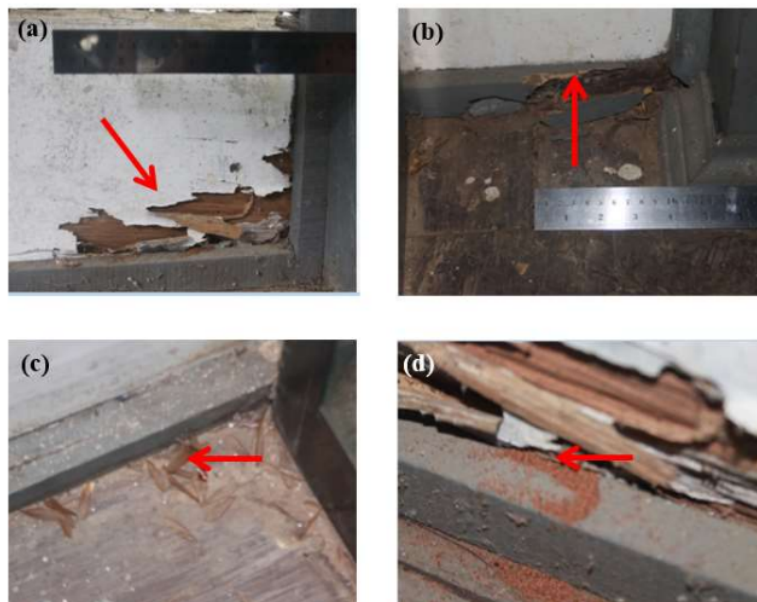
Besides the [1] termites, building components from the Karaeng Pattingalloang Museum were also attacked by dry wood termites. Dry wood termites are a group of termites from the Kalotermitidae family, which live in a place that is not related to the soil and lives throughout its life in its food source. This termite is a pest of dry structural sawn wood and wood furniture [22]. In this study, parts of the building that were attacked by termites were window frames and window boards. Damage to the window frame on the upper floor (2nd floor) due to dry-wood termite attack was indicated damage to the wood parts and the presence of coarse brown granules on the floor coming from the underside of the damaged wood. In addition, the laronic wings were also observed around the affected wood and on the surface of the affected wood leaving a layer of wood thick as veneer. The damage sign presents in Figure 3.

Figure 3. Signs and damage characteristics caused by dry wood termites: (a) very thin remaining wood surface layers, (b) loss of wood surface, (c) moths wings, and (d) coarse brown granules.

Although no termite specimens were found at the time of the research, the damage to the window frames on the upper floors of the building was thought to be caused by termites *Cryptotermes cynocephalus* through the signs and characteristics of the damage caused. This is according to what

was stated by Nandika et al. (2003) that attack marks such as wood become porous, there is a thin layer of wood left on the surface of the wood, the presence of small brownish excrement items that often fall on the floor or around attacked wood is a sign of attack from dry wood termites (*Cryptotermes cynocephalus*) [23].

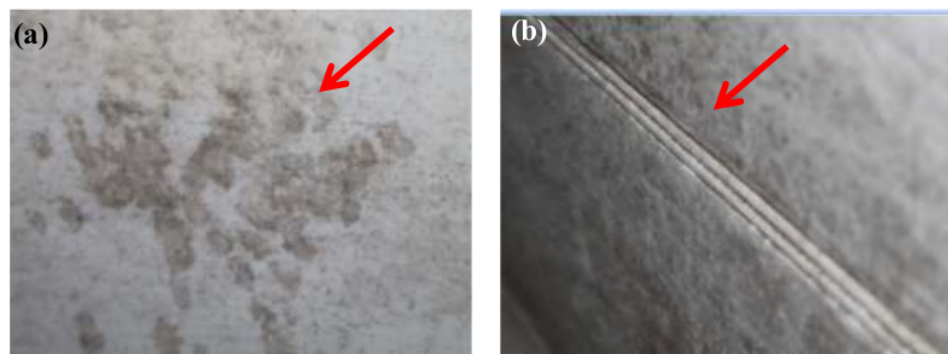
Fungus is an important biodeterioration agent and can easily be found to colonize material in cultural heritage [24]. In the Karaeng Pattingalloang Museum building, the presence of these microorganisms was presented on the walls and was recognized as a coloring fungus. This fungus usually attacks material, especially the surface of a lignocellulose material, which is moist. Colonization of this dye fungus was indicated by the presence of black spots found (Figure 4).

Figure 4. Characteristics of coloring fungus attacks: (a) spots or stains on the wall surface, and (b) the appearance of coloring on the wood surface.

The identification results of fungal specimens taken on the walls of the affected building (Figure 4a) indicated that the attack was caused by coloring fungi, which belonged to the *Aspergillus niger* species. The characteristics of *Aspergillus niger* which has a large conidial head, round and black, brown or black brown [25]. This fungus grows quickly using nutrients around it. *Aspergillus niger* is one of the most common and easily identified species of the *Aspergillus* genus. This fungus grows optimally in the temperature range between 24 and 37°C, water activity >0.95, and pH levels between 4 and 6.5 [26].

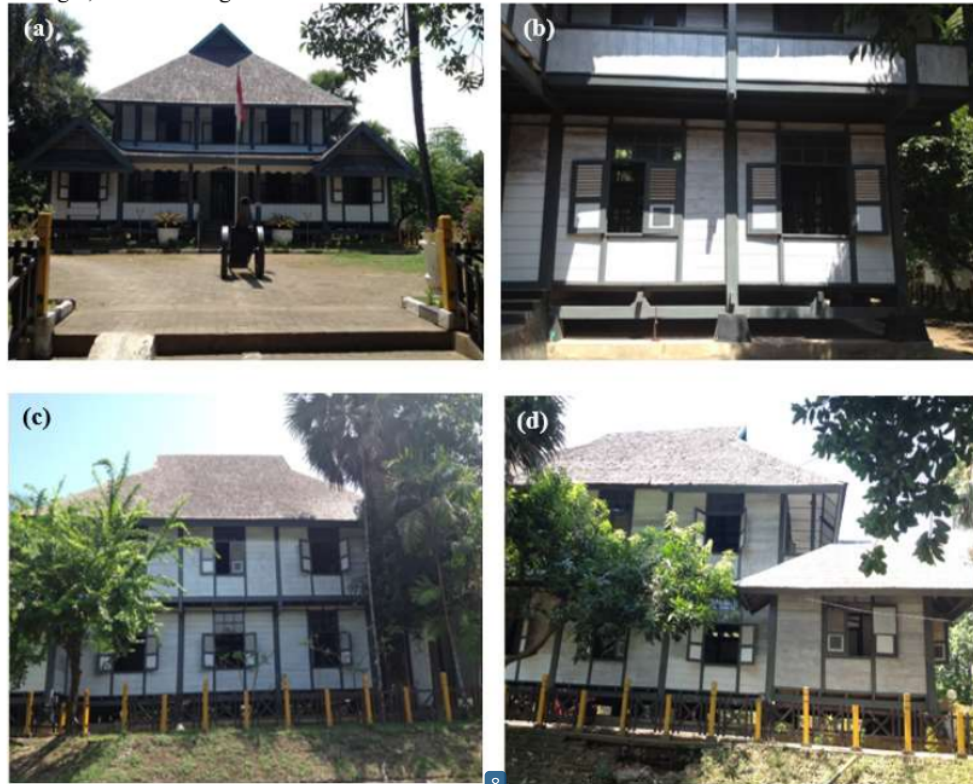
humidity found in the field are 32°C and 64%. Basically, most molds like environments with temperatures between 15 °C and 30°C, although there are also species that grow below and above that temperature [29]. The presence of mold in buildings leads to Sick Building Syndrome such as health problems and damage to building materials, books, clothing, and stored food; whose growth is influenced by humidity, nutrition, light, oxygen, and temperature [30]. In addition, in this study the incidence of an attack by a coloring fungus was found on the left side of the building, where in the building part it received shade from a large mango tree (*Mangifera indica*), so it did not get direct sunlight, as seen in Figure 5d.

Figure 5. Building surrounding conditions: (a) front, (b) rear, (c) right side, and (d) left side

Figure 5 displays that environmental factors also play a role in causing the wood damage in the Karaeng Pattingalloang museum component. This is supported by the statement of Muin (2012) that environmental conditions such as the level of temperature, light, and humidity accelerate the damage to building wood, which impact to the used-age of wood to be shorter.
