Coastal Environment and Ancient Tomb Damage: A Case Study of The Tomb of the King and Hadat Banggae at Majene West Sulawesi Indonesia

Khadijah Thahir Muda^{1,*}, Yusriana Yusriana², Nur Ihsan D.³, Erwin U. Saraka⁴,
Muhammad Nur Zulfikar⁵, Destania Destania⁶

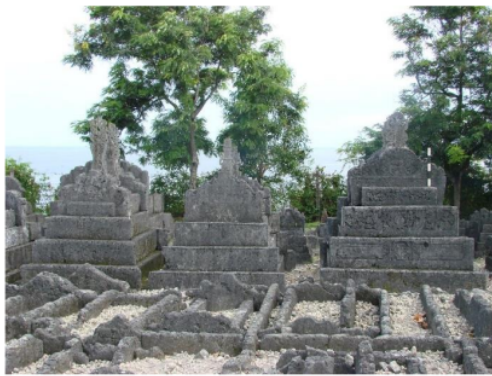
The movement of water and wind that carries salt elements, considering the level of salination of the coastal environment is quite high and the media that carries salt elements or other damaging chemicals. The site for the ancient tombs of the Kings of Hadat Banggae suffered some damage due to the high level of salination (salt).

Besides being able to cause postula on the rock, salt can also corrode, high salt levels can make the rock more brittle, experience degradation.

Figure 1 Physical damage of ancient tombs (Doc. Andi Oddang, 2020)

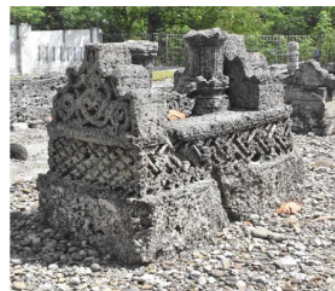
Degradation of materials on cultural heritage objects due to the potential for the environment and climate that carries destructive elements. This destructive factor triggers other damage, such as when the salt content in the rock increases, the salt is carried by water or wind. When the temperature is high, the salt carried by the water enters through the pores of the rock. Salt that has entered the body of cultural heritage objects, if the temperature around the salt is low, then the salt will turn solid in crystalline form. This condition is if the salt has increased the temperature inside the object, then the salt will find a way out through the pore. The pressure of salt will form postules on the surface, a kind of boil or bubble on the surface of the object. If this happens repeatedly and there is no rescue treatment, the postules will break, leaving a trail of holes in the object (see figure 2). The rock surface in the tomb looks rough and in some parts there are holes. Severe cracks in the wall of the mesh.

Figure 2 Physical damage to large cracks in the tomb (Doc. Andi Oddang, 2020)

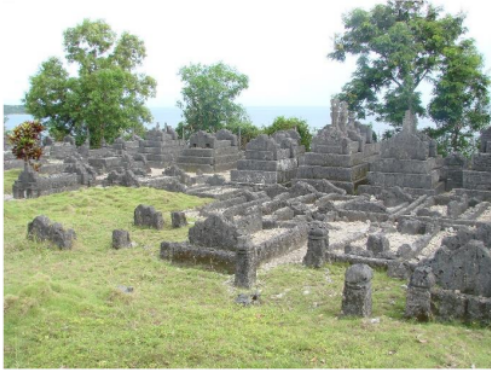
Biological weathering of the stone tombs, some graves are attacked by moss, algae, lichen, and are overgrown with several lower plants. This condition can exacerbate the damage to those previously damaged, both in the unstable position of the tomb and the feeding condition that tends to have degraded material. Damage to graves that have weathered due to moss [11].

Figure 3. Biological Weathering of the ancient tombs (Doc. Andi Oddang, 2020)

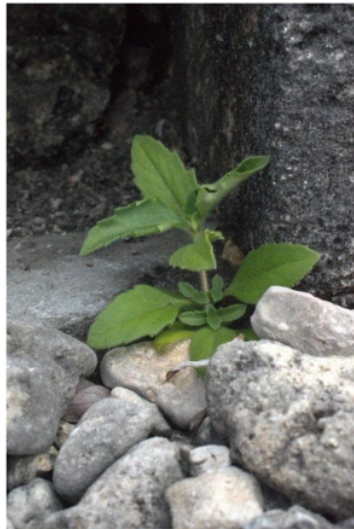
Figure 4 Biological weathering on the stone tombs overgrown with low-level plants (Doc. Andi Oddang, 2020)

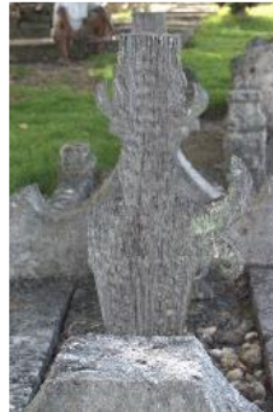
Vandalism in the form of beatings (in the process of making /forming work) can also result in the cracking of the work or the loss of some material. The scavenging and shrinkage caused by temperature can alter the physical properties of brick materials. Heat fertilization or movement can produce a force strong enough to cause a rift [1]. Fractured objects or wakes can be caused by two things, firstly, the shift in the center of gravity of some building components so that there is a shift in the weight force to achieve a new balance, and secondly, due to a decrease in the carrying capacity of the building. under the structure. The shape of the cracks due to the movement of the structure of the building is usually large at the top and smooth at the bottom [1]. This can happen in both stone and wood objects. In addition, uncontrolled human activity factors can be the most fatal cause of damage to cultural reserves. Observations at the tomb complex showed that 37 headstones had suffered mechanical damage in the form of damage and obliqueness. The observable form of damage is fractures and 7 oblique headstones. The damaged part of the headstone is the trunk on the legs and shoulders, as well as the head of the headstone. In addition, on the headstone part is also found fragments of ornaments.

Figure 5 cracks in the wooden headstone (Doc. Andi Oddang, 2020)

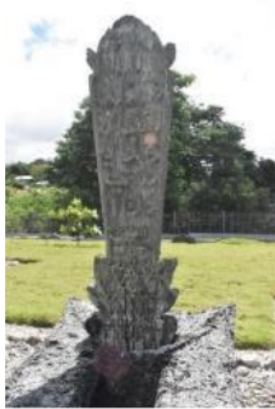
The use on the surface of the wood causes the surface to become slippery so that it is no longer visible. Observations on the headstone show the worn part is found on the motif so that the shape and writing on the headstone is not clearly visible. There are nine worn wooden tombstones.

Figure 6 Wear on the surface of the wooden headstone (Doc. Andi Oddang, 2020)

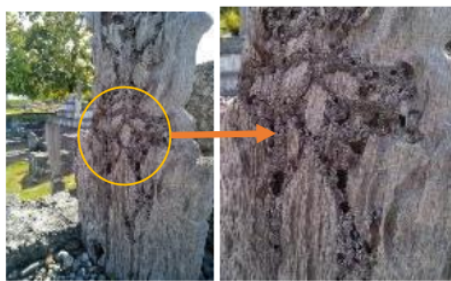
Based on observations, there is a wooden headstone that suffered a termite attack on the body of the headstone. This tombstone is in the first sector area.

Figure 7 One of the wooden gravestones that was attacked by termite insects (Doc. Yusriana, 2020)

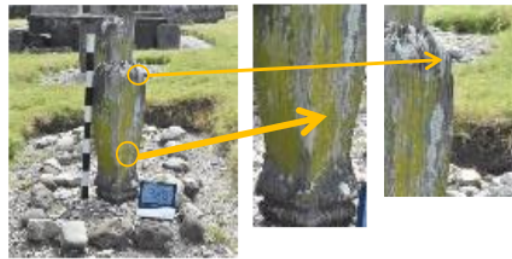
Based on observations, a total of 64 wooden headstones were overgrown with moss. The impact of fungal growth is the removal of stains on the surface of the wood. The resulting stains are green, bright green and blackish. The further impact of fungal growth is to cause weathering. According to the information, the wood material used for the manufacture of the headstone is Sappu wood (Mandarnese language) or ulin. The environmental condition of the headstone is four meters from the ketapang tree.

Figure 8 Moss on the surface of a wooden headstone (Doc. Andi Oddang, 2020)

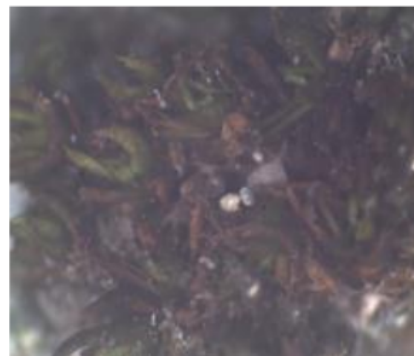
Figure 9 Laboratory identification results of Bryopsida (Source:: Muda, 2020)

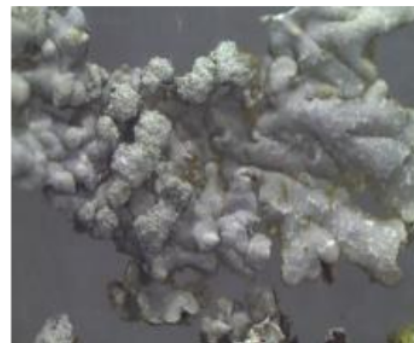
Figure 10 Laboratory identification results of Lichens
(Source: Muda, 2020)
