Analysis of plant root properties, texture and porosity that affects landslides in Tangka Sub-Watershed

A Afriawan, A Ahmad, and S Gusli

Abstract. Tangka Sub-Watershed in West Sinjai District is one of the sub-watersheds in South Sulawesi, which often experiences landslides. Factors causing landslides were divided into control factors and trigger factors. One of the triggering factors for landslides is the characteristics of soil and plant properties. Several previous research results stated that soil characteristics greatly affect the occurrence of landslides, while plant roots help stabilize soil bonds and slopes. This study aims to determine the triggering factors of the soil (soil texture and porosity) and the distribution of plant roots that affect the occurrence of landslides. Soil texture analysis using hydrometer method. Soil porosity and moisture content using gravimetric and pycnometer methods. The results showed that the soil texture was dominated by silty clay loam impact on low soil cohesion. Intensive land use decreases soil porosity to <50% and increases soil bulk density to 1.4 g/cm³. The soil quickly becomes saturated and could induce the rotting of plant roots.

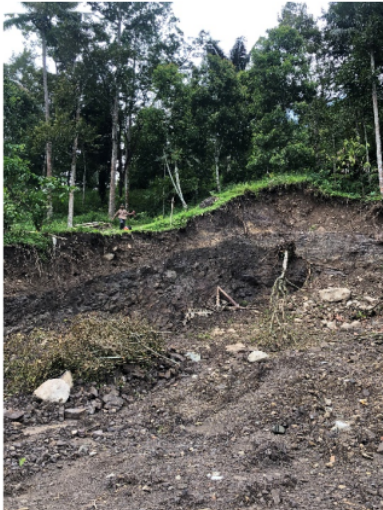
Figure 2. T1 (5°13'6"S 120°0'36"E)

At the research location in the Tangka Sub-watershed, West Sinjai District, there are two points where land landslides occurred and at the same time become a point for carrying out plant debris parameters in the landslide field which are then coded T1 and T2 (Figures 1 and 2). Both landslides have a concave slip plane, with the landslide material in the form of soil and rock with a slump model.

The land cover plants at the location of the first landslide (T1) contained several types of woody plants which on average had taproots that grew vertically into the soil (Figure 5). In (Figure 2), it can be seen that the roots of a taprooted woody plant which have an average root length of 60-90 cm and an average diameter of 4-5 mm allow stabilizing the slopes and have a sufficiently large soil grip, but landslides still occur due to another factor, namely the physical properties of the soil, one of which is the texture of dusty clay loam at the landslide point. Hairiah in 2020, said that higher soil silt and clay content and lower water content led to higher soil shear strength because it allowed rotting of tree roots [9].

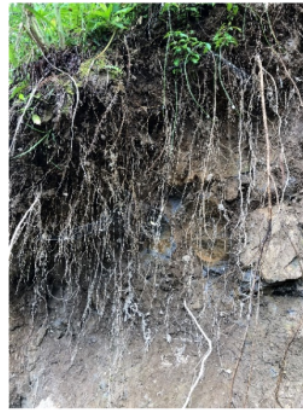
**Figure 6.** Plant Roots in Landslide Field (T2)

The land cover plants at the location of the second landslide (T2) are grasses that have fibrous roots that grow vertically into the soil (Figure 6 and Figure 3). In (Figure 2), it can be seen that fibrous roots which have an average root length of 25-30 cm and an average diameter of 0.8-1 mm are considered to be unable to stabilize slopes and have low soil gripping power. The shear strength of the soil depends on the soil texture and soil moisture content, and we found spread in shear strength with low root length.

Sample Code	Root Type	Root Length (cm)	Root Diameter (mm)
T1	Ride vertical	60 -90	4 - 5
T2	Fiber Vertical	25 - 30	0.8 - 1
