Evaluation of reduced beam section (RBS) on castellated beam subjected to a seismic load

N H Aswad¹, H Parung², R Irmawaty², and A A Amiruddin²

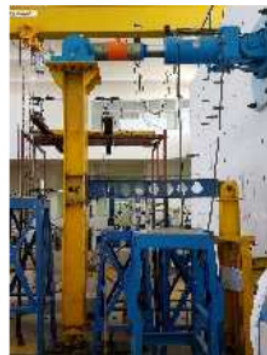
Figure3.The testing instrument of castellated beam and RBS.

Figure 3 illustrates the relationship between the loads received at each phase starting from the elastic region to the inelastic, and continuing in the necking phase (collapsing). The result shows that the melting first occurred in the flange section of the beam. An experimental test of the RBS castellated beam is displayed in tables, graphs/curves, and figures. The detail of the failure on the beams explained the failure effect and caused classified by each phase of structural failure.

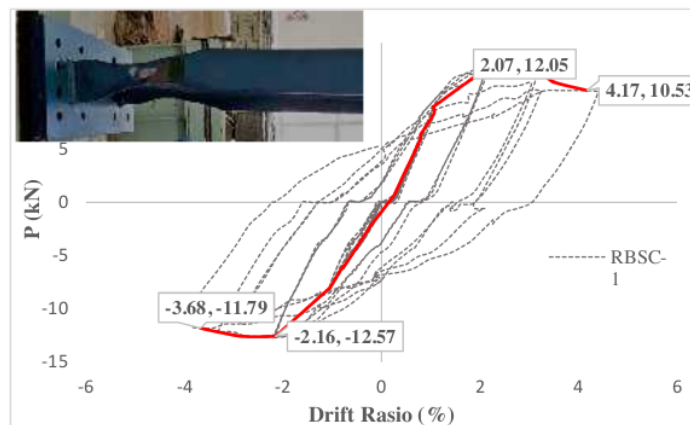
Figure 4. Graph of the load against drift ratio at each phase

As can be seen in figure 4, the lateral load capacity increased as the lateral displacement rose. The difference between positive and negative maximum loads was possible due to the different movement of load cell pads to each side that affected the lateral deflection of the beam. Figure 3 also displays the four phases of the RBSC-1 test specimen. In the first phase, the load and the initial drift ratio were 0 – 8 kN. The response was the linear region called elastic phase that generated a 1.05% drift ratio. The second phase occurred at a load rate of approximately 8 – 9 kN, namely the plastic stage. In this phase, the specimen was plastic or inelastic with a drift ratio of 2.07%. The third phase occurred on the load and the drift ratio at the load rate of approximately 9 kN to the peak of 12 kN at 3.20% drift ratio, which the specimen had an inelastic response called the strain hardening. Furthermore, in the fourth phase, the curve decreased when the load capacity was reduced to 10.53 kN, at 4.17% drift ratio, which was called the necking phase. On the lower area of the curve, the drift ratio was -3.68% obtained at 11.79 kN load. Each of the flange surfaces showed a failure pattern (bending) located in the RBS area in the beam, where new bending moments were formed on the upper and lower surfaces on both sides at the same time. As the cyclic lateral load continued to increase, the formation of a new bending yield was visible on the surface of the paint undergoing shedding along with the area of RBS seen on the outside with a bent pattern. In addition, when the load exceeded the capacity of 12.05 kN as in the post-peak response with a 4.17% drift level, it is interesting to note that the load had exceeded the maximum capacity and the capability decreased to 16.7% on average in both directions, which indicates that the specimen tended to achieve its bending capacity.
