Structural ductility of RBS on castellated beam subjected to cyclic loading

To cite this article: N H Aswad *et al* 2020 *IOP Conf. Ser.: Earth Environ. Sci.* **419** 012151

N H Aswad¹, H Parung², R Irmawaty², A A Amiruddin² and Fakhruddin²

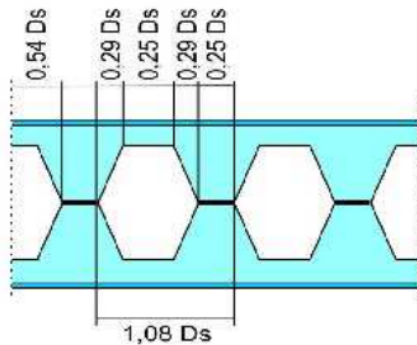
Figure 1. Standard of the castellated beam.

The properties of the material used in the cyclic behavior test is shown in table 1. The specimen was a type H 25 x 25 column and a castellated beam type IWF 225 x75. Figure 1 shows the dimensions of the RBS on the castellated beam.

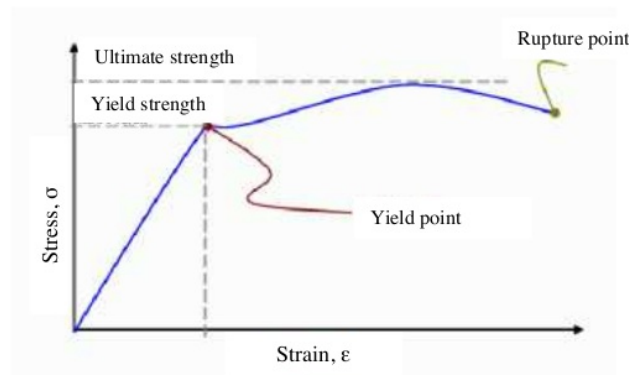
Figure 4. The relationship between stress and strain.

If a load (P) reaches the yield point or yield strength and then passed over the linear line, then it is called the elastic boundary. When the force is continued, the strain increases to the boundary strength i.e. the ductility value of a beam. Then the strength decreases while strain continues to increase as shown in figure 4. (Phase values are elastic/linear and inelastic/collapse).

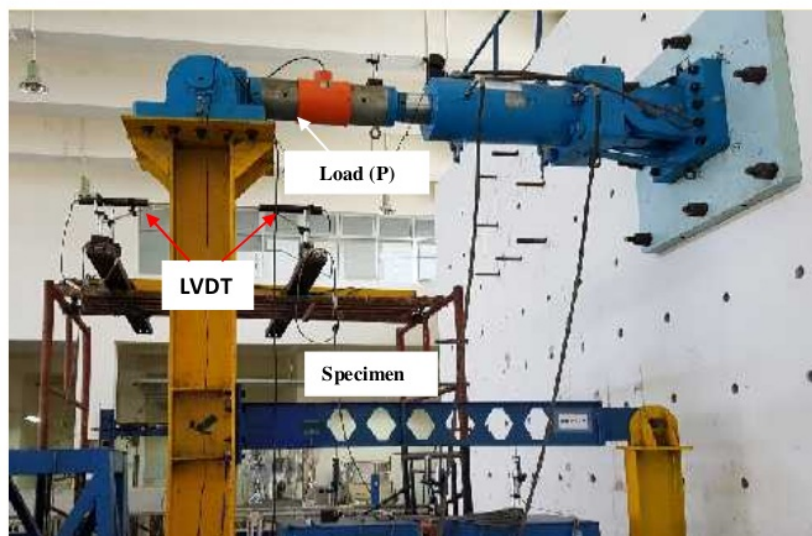
Figure 5. The instrument of the castellated beam-column testing.

In the experiment, it was assumed that the lateral force was very dominant compared to the gravity load for which the test method was presented with cyclic loading given in displacement-controlled form (P) Actuator (horizontal jack) that moved back and forth with an LVDT (Linear Variable Displacement Transducer) with 0.01 accuracy as the control of displacement value at the upper end of the beam. The amount of deformation and the number of cycles were adjusted with the pretest analysis results to determine the yield displacement, then it was connected to the computer data logger and switching box to record data measured by a strain gauge, LVDT, and load cell simultaneously and automatically. The data were also collected by visual observation of test beam failures such as welding damage, flange bending, web bending, and observing the types of failures that determined the failure of beam structural elements. Loading basis used the ATC-24 loading cycle [6]. Figure 5 displays the actuator test equipment and castellated column beam specimen.

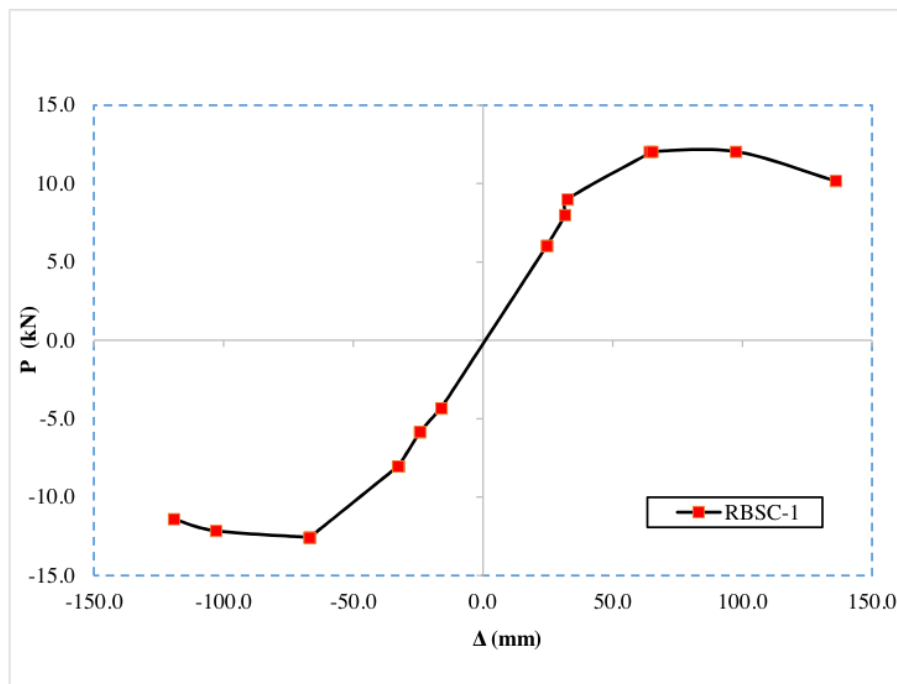
**Figure 6.** Backbone curve of the relationship between lateral loads and displacement.

Figure 6 shows that the structure achieved ductility, where it was deformed during loading until it reached the ultimate boundary. Furthermore, the steel beam reached 97.5 mm deflection at peak load. When the loading was continued until it reached the plastic limit, the ductility reached 4.2-4.3 with strength decreased to 10.9 kN and deflection increased to 136.5 mm.

The results show that the peak load of the RBSC-1 specimen was in a positive direction of 12.0 kN with displacement value of 97.5 mm while the peak load was in a negative direction of 12.57 kN and displacement of 66.8 mm, which was resulted in ductility resistance of the steel frame structure of 4.2 in both directions. This shows that the beam can withstand partial ductility. The yield point was reached at 8.0 kN load in both positive and negative points. [4] reported that an experiment of the castellated beam with an opening distance of 15 cm from the column face without RBS can deform to 100 mm deflection and withstand a load of 12.5 kN. When loading was continued, the specimen had a 12.8% decrease of strength, with deflection reached 136.5 mm. With a load of 10.9 kN, the obtained ductility value was 4.1, which means that the castellated beam with RBS had a partial ductility.

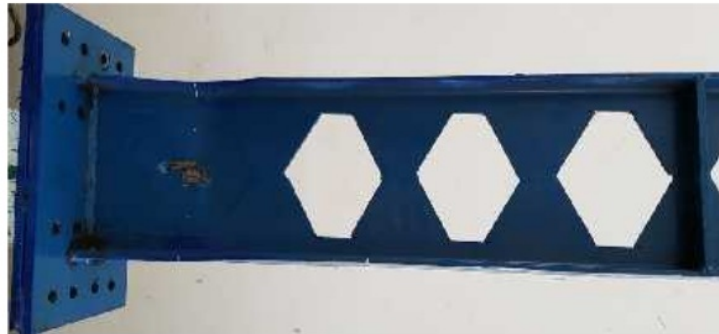
Figure 7 shows that the failure occurred due to the bending of the beam. The flange area experienced buckling with no visible fracture at the weld meeting between the endplate and the beam. During the cyclic loading, the loss of lateral capacity was followed by a slight reduction in the strength of the specimen resulting in the curve decreased at 10.9 kN load. The first yield moment (yield) occurred in the outermost fiber that reached the yield stress at 8 kN load on the upper flange, then it continued to the lower flange. When the load reached a value of 12.05 kN (maximum) while the loading was

continued, the lateral strength continued to decrease creating the reaction to deviate from linearity, which is commonly known as the ductility property of the steel. The ductility property decreases as the load increases until the specimen was collapsed.

Figure 7. Damage on the specimen that was subjected to cyclic loading.
