Feasibility evaluation of water supply infrastructure in Luwuk district

S Fatahuddin¹, M Selintung², and B Bakri¹

¹Department of Civil Engineering, Hasanuddin University, Makassar, Indonesia

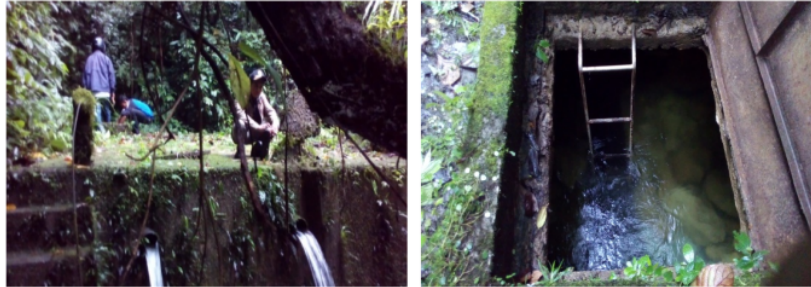
Figure 1. Keles water spring building.

Conditions in the entire building of existing springs can be said to be normal. The infrastructure is all under the planning standards, including safe for pollution, placed in a location that is safe against the carrying capacity of the natural environment. Always, the physical condition of the catchment springs looks not maintained. The results of the assessment of the situation of the water source building are functional categories with more attention to the periodic maintenance of the condition of the building.

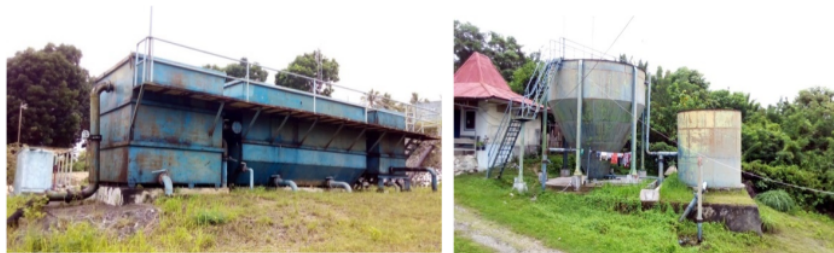
Figure 3. Water Treatment Plants (WTP) of Keles

Besides, although the WTP of Keles has a complete water process system since 2017, several units have no longer functioned. Water entering the WTP only undergoes a sedimentation process without adding any chemicals to the coagulation unit due to limited operational costs. From the aspect of quality, water clarity is only seen physically with the consideration that raw water is sourced from

Based on observations at the location of the water process plant, there is no SOP as a guide for the implementation of work and the limited equipment to support operational activities in the field. The results of the condition assessment result of the Keles Water Process Plant are unfavorable because only part of the construction is by planning standards and is less able to reduce the turbidity of raw water in the rainy season.

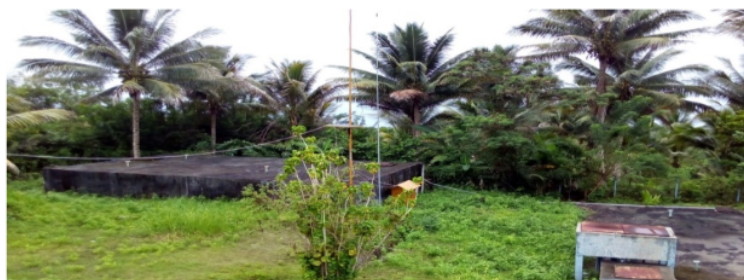
Figure 4. Reservoir Keles.

The dimensions of the two installations are 1100 m³. From the analysis, results for reservoir dimensions are categorized as useful. The condition assessment result of the reservoir is good because of the construction according to the planning standards and clean physical conditions.
