# Performance of pre-stressed concrete sheet pile after long-term exposure in the marine splash environments

Rita Irmawaty<sup>1\*</sup>, Daisuke Yamamoto<sup>2</sup>, Hidenori Hamada<sup>2</sup>, and Yasutaka Sagawa<sup>2</sup>

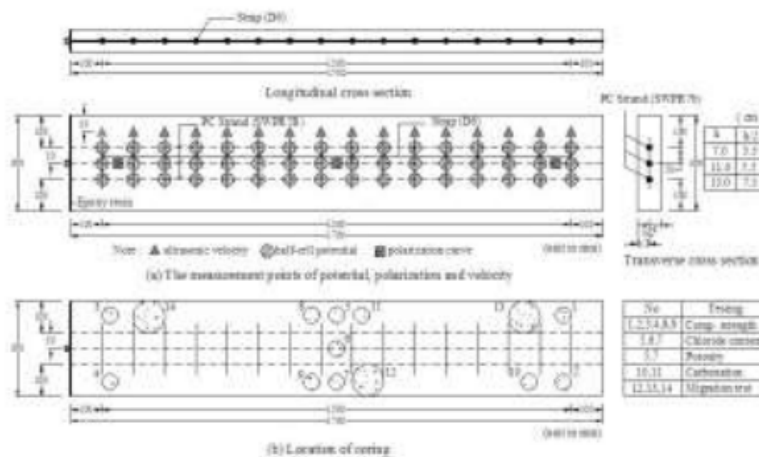
**Fig. 1** Sheet pile specimen model geometry and measurement point

Figure 1 shows sheet pile specimen model geometry and measurement points of half-cell potential, polarization curve, ultrasonic pulse velocity and core sampling. As shown in this figure, PC sheet pile dimension in 1,700 mm x 300 mm, and height varies from 70, 110 and 150 mm with cover thickness is 30, 50 and 70 mm, respectively. The variation in

thickness aims to evaluate the effect of cover depth as natural protection on concrete to chloride ion penetration. In center line of specimen, three PC strands (SWPR7B) with distance of 100 mm from the edges were embedded. In order to fix the position of strands, 16 straps were placed with spacing of 100 mm.

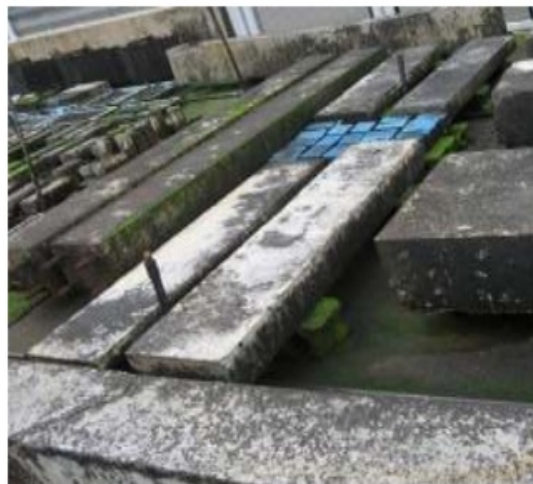
**Fig. 2** Sheet pile specimen

Furthermore, specimens were placed in an open space and exposed to seawater splashing. The specimens were subjected to 2 cycles of wetting and drying a day. One cycle was seawater splashing for 4 hours and drying for 8 hours; during 12 years. Figure 2 and 3 show sheet pile specimens in the exposure site and condition when seawater is splashing.

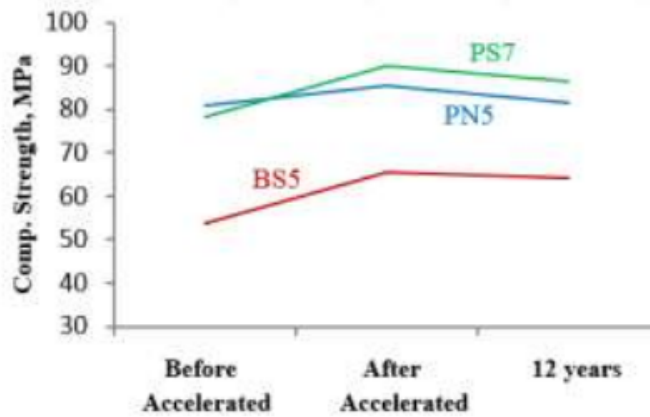
Fig. 4 Compressive strength of concrete

Compressive strength of concrete specimens after 12 years exposure in the marine splash environment is shown in Figure 4. The value is based on average of 6 core samples for each specimen. It is found that strength of concrete decreased slightly. Decrement in strength was observed in all specimens with maximum 4.7% reduction (in case of PN5). There is no significant difference in strength decreasing between steam and water curing.

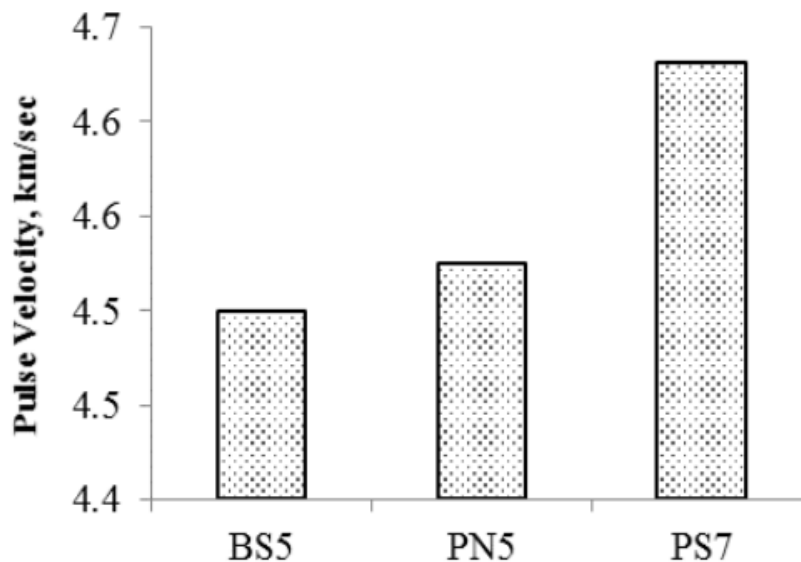
Fig. 5 Pulse Velocity after 12 years exposure

The pulse velocity varies between 4.50 and 4.63 km/s with coefficient of variation of 0.81 to 1.44% as shown in Figure 5. A good correlation between compressive strength and pulse velocity value is found, where the higher of strength, the higher value of pulse velocity are observed. On the contrary, from Figure 6, it is found that the elastic modulus of concrete increased (maximum 11%) after 12 years exposure, and no significant variation between compressive strength and elastic modulus data was observed. It confirms that the degradation of concrete properties in macroscale is not significantly occurred.

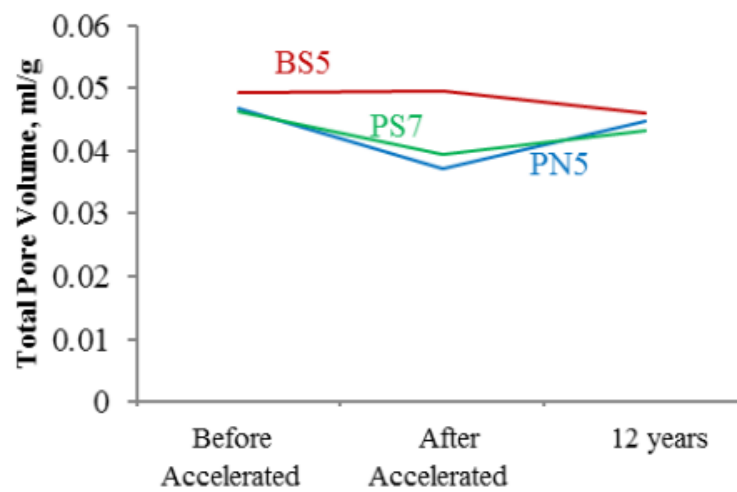
Fig. 7 Pore volume

14 Pore volume and pore size distributions of the mortar samples collected at 32-40 mm depth of the specimens are shown in Figure 7 and Figure 8 where porosity and pore size distribution in a certain range show almost the same trend for all specimens. It is found that porosity of PN5 and PS7 increase after 12 years exposed to a corrosive environment, and vice versa in BS5 as shown in Figure 7. It seems that partial replacement of cement by GGBFS causes a reduction in the pore volume, and may also cause a reduction in the connectivity of the capillary pore. The capillary pore defined here is the porosity of pores whose diameter ranging from 0.01 to 5  $\mu\text{m}$  [10]. In addition, the capillary pore distribution was slightly higher for BS5 than the other, but it did not affect significantly.

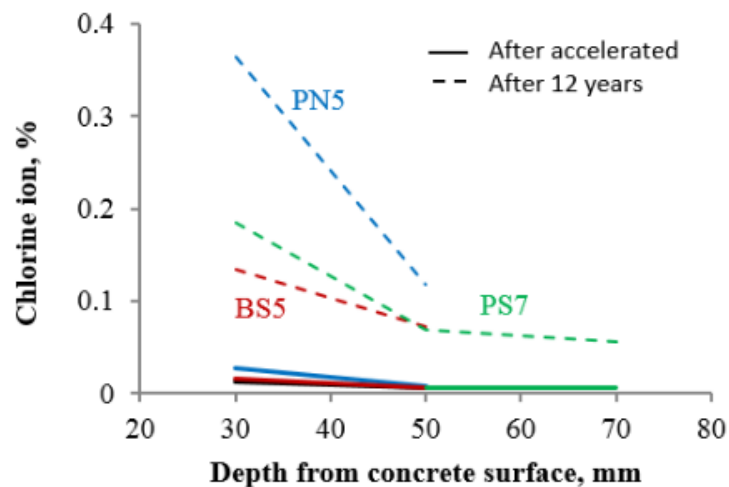
**Fig. 9** Average of chloride ion in concrete

Total amount of chloride ion as a percentage of cement mass at 30, 50 and 70 mm depth from the surface of specimen is shown in Figure 9. The amount of chloride content varied between 0.134% and 0.365% at the depth of 30 mm, whereas at 50 mm depth showed a little amount which varies between 0.069% and 0.118%. It is found that sheet pile composed of GGBFS shows the lowest amount of chloride content compared with others at the same depth. It indicates that the microstructure of concrete using GGBFS is significantly improved and can provide a good barrier against chloride-inducement.

Numerous studies have shown that when present in sufficient quantities, chloride ions will promote the corrosion of steel in concrete [1], [2]. If the chloride content of 0.4% (by mass of cement) in the concrete is assumed as a threshold value for the initiate of steel corrosion, nowadays position of 0.4% chloride content in specimens of BS5, PN5, and PS7 are in the depths of 1.12cm, 2.7cm and 2.02 cm respectively from the surface.

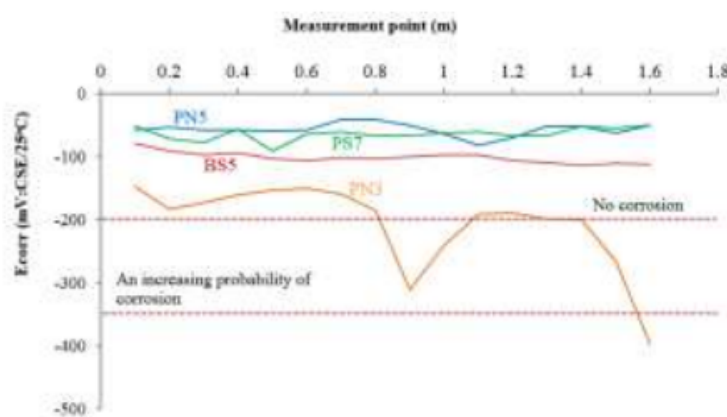
**Fig. 10** Natural electrode potential

*Natural Electrode Potential Test:* Figure 10 shows the natural electrode potential after 12 years exposure in the marine splash environment. Significant change in natural electrode potential of strands occurred in PN3 and showed increasing potential for corrosion. On the other hand, irrespective of cement type, PC sheet pile height of 11 and 15 cm have potential value in the range of -56 to -101 mV:CSE/25°C. According to ASTM C876-91 (1999), potential less negative than -200 mV:CSE indicates 90% probability of no corrosion.

As comparison, PN3 with thickness of 7 cm is used. From the Figure 10, it can be seen that the potential value decreased sharply in some points. Then potential value in the range of -150 to -400 mV:CSE/25°C, indicates an increasing probability of corrosion. This is caused

by the presence of small cracks in some parts of sheet pile as a result of the strand corrosion development on the edge whose no cover concrete. It can be concluded that PC sheet pile with thickness of 7 cm only has a 20-year service life, and it is recommended to increase the thickness to 11 cm to improve the durability.

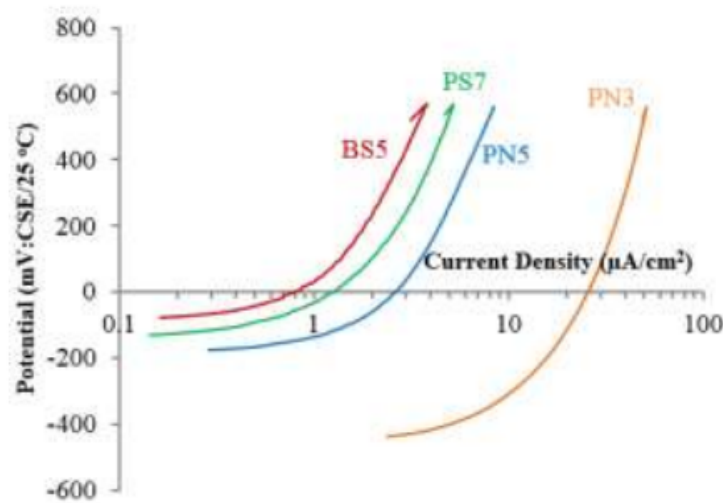
**Fig. 11** Anodic polarization curve

*Polarization Curve:* Anodic polarization curve of each specimen is shown in Figure 11. PC strands were embedded in concrete exhibited various polarization curve with potential between 0.2 and 0.6 V, and current density were the range between 1 to  $10 \mu A/cm^2$ , and 10 to  $100 \mu A/cm^2$ . Based on the passivation film associated with anodic polarization curve, BS5<PS7<PN5 can be classified into grade 3 and PN3 is grade 1 as a degree of passivity exist [2].

Average of corrosion potential is sequenced as BS5<PS7<PN5<PN3 with values ranging from -125 to -370 mV:CSE. Irrespective of the cement types and curing conditions at the early life of concrete, for the same cover thickness, PN5 exhibited more potential corrosion compared to BS5. It shows that GGBFS is a good barrier against chloride-induced due to compactness of microstructure, hence it can reduce the risk of corrosion. In addition, results

from both anodic polarization curve and natural electrode potential test showed that PN3 has started to corrode after 12 years exposure.

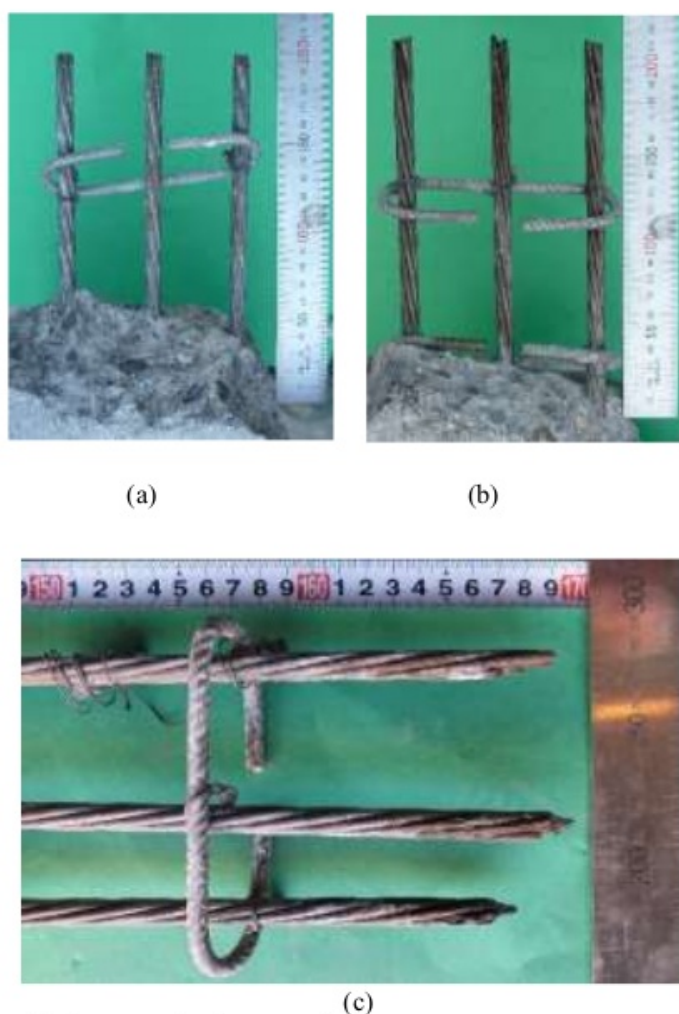
**Fig. 22** Verification of rebar corrosion by removing cover concrete  
(a) BS5; (b) PN5; (c) PN3

*Verification of Rebar Corrosion:* From Figure 12, it can be seen that there was a little corrosion on the ends of strand caused by the absence of cover concrete and was characterized by the presence of leaching of rebar rust in the concrete. However, this little corrosion did not affect the whole strand. While in PN3 as shown in Figure 12 (c), on the edge of strand whose no cover, strand was corroded along the 5 to 7 cm and the ends of strand have been ruined. Total area of corrosion was observed after removing all concrete is approximately 1.01%.
