## ENVIRONMENTAL ASSESSMENT METHOD FOR A SMALL-RIVER RESTORATION PLAN

R. LOPA & Y. SHIMATANI

Department of Urban and Environmental Engineering, Kyushu University, Japan.

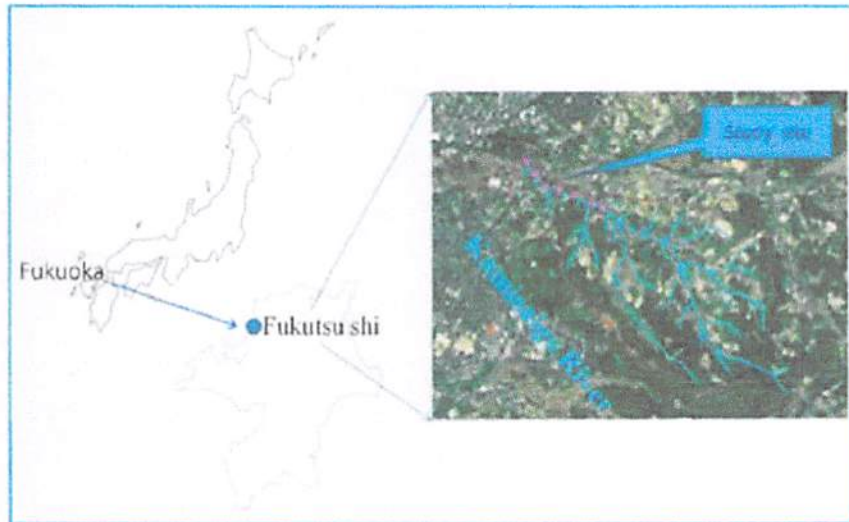
Figure 1: Study site: Kamisaigo River, Fukuoka, Japan.

The second-order Kamisaigo River, in Fukutsu, Fukuoka Prefecture, Japan ( $33^{\circ}45'24.29''$  to  $33^{\circ}45'40.16''$ N,  $130^{\circ}29'55.52''$  to  $130^{\circ}29'25.15''$ E; Fig. 1) has a water surface width of 2.4 to 6.8 m and depths ranging from 11 to 30 cm. The study area was an 800-m reach located at the confluence with the Saigo River. The primary use of this river is irrigation, and the majority of surrounding land is dedicated to residential and commercial uses. The river has been canalized and lined with concrete; this action has damaged the physical and biological functions of the river.

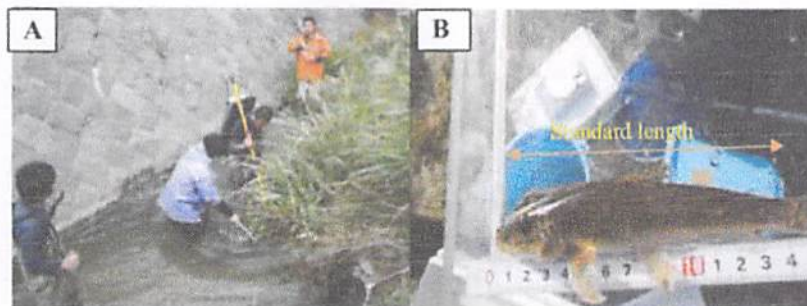
Figure 2: Fish sampling. (A) netting fish after they had been shocked; (B) weighing and measuring the length of fish.

In the autumn (October–November) of 2009, we conducted a fish survey along the 800-m reach using a backpack electro-fisher (LR-24 Smith-Root, Vancouver, WA, USA). Seven 50-m stretches were each blocked with seine netting to enclose populations. The fish that were caught were measured (total number of fish, length, weight) and released alive (Fig. 2).

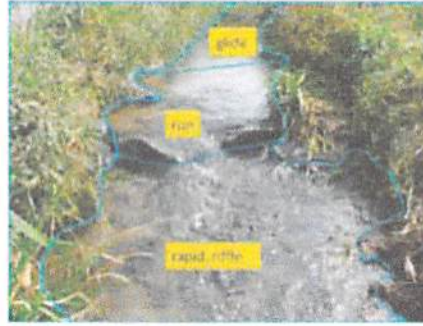
Figure 3: Flow ecological mapping.

We drew habitat maps of the river showing rapid riffles, runs, glides, slack shallows, and scour pools. We recorded the number of pools, glides, riffles, and rapids at each station and took photographs (Fig. 3).

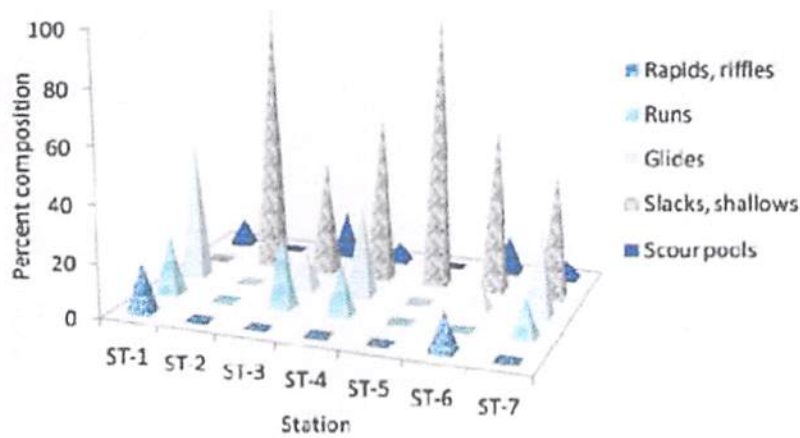
Figure 4: Composition of the flow ecology in the Kamisaigo River.

The composition of flow ecology in the Kamisaigo River (Fig. 4) allowed us to define the characteristics of the river's natural environment. From the calculations in Table 4, we graphed the results (Fig. 5).

**Station 1.** This station consisted predominantly (91%) of fast-current shallow habitats (2 riffles/rapids, 4 runs, 6 glides) and very few slow-current habitats (pools) about 16 cm in mean depth. Some vegetation occurred in approximately 90% of the channel. We found 15 species at this station: *Anguilla japonica* (3 individuals), *Carassius auratus langsdorfi* (2), *Zacco platypus* (109), *Zacco temmincki* (32), *Rhinogobius* sp. CB (95), *Rhinogobius* sp. OR (4), *Cyprinus carpio* (3), *Rhinogobius giurinus* (11), and one each of *Phoxinus oxycephalus*, *Pseudogobio esocinus*, *Cobitis matsubarae*, *Carassius auratus buergeri*, *Misgurnus anguillicaudatus*, *Odontobutis obscura*, and *Gymnogobius petschiliensis*. This station was considered to be in good condition, as all metrics exceeded the average values (Fig. 5), with the exception of metrics 2 (exotic species) and 16 (species that spawn in bivalves).

**Station 2.** This station consisted entirely of slow-current shallow habitats (slacks or shallows) with uniform conditions (Fig. 4). Overhanging vegetation, root wads, and aquatic vegetation were absent. *Cobitis matsubarae* (31 individuals) was the only species present at this site. As a result, the index scores for station 2 were low, and it was considered to be in poor condition.

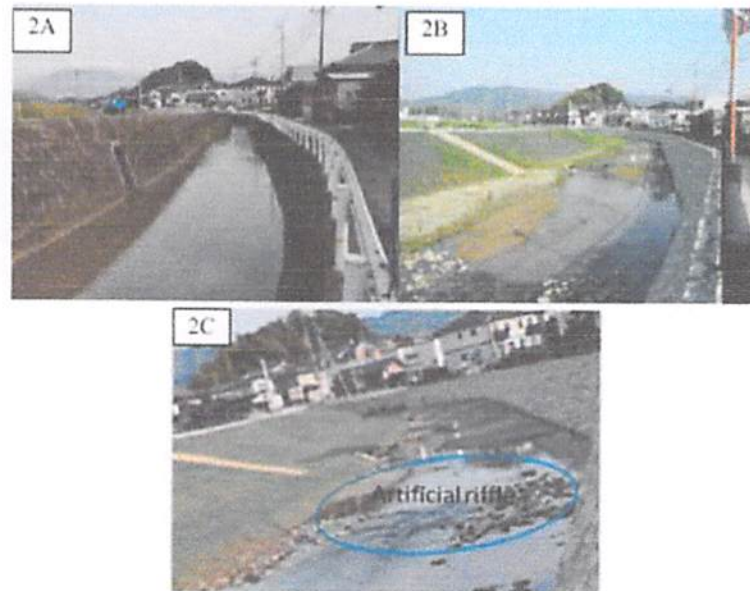
Figure 6: Station 2 condition. (A) Before restoration: a straight river lined with concrete. (B) Improvement of hydro-morphological status by re-meandering of the river and improvement of the river banks. (C) Two months after restoration; installation of artificial riffle.

Station 2 was restored by re-meandering of the river. The wavelength at the meander was assumed to be about 120 m, which would allow a more natural river flow. The roadside river bank was improved by the addition of a porous revetment in front of the hard bank (rap stone method). Porous banks provide good habitat [1]. The opposite bank was improved by removal of the concrete revetment and sodding of the bank to prevent erosion (Fig. 6A, B). Natural stones placed in the stream reproduced riffles (Fig. 6C).

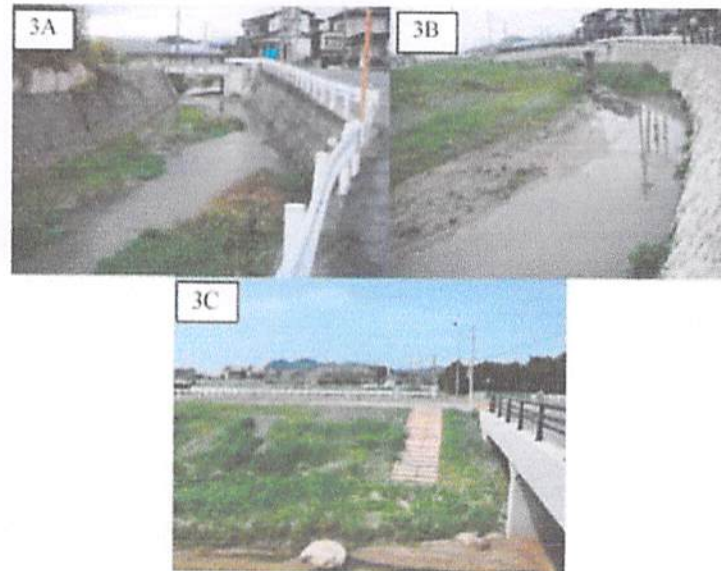
Figure 7: Station 3 condition. (A) Before restoration: concrete banks isolate the movement of organisms. (B, C) Three months after restoration: floodplain restored.

Station 3 was restored by a porous revetment on the right bank and vegetation cover on the left bank (Fig. 7).

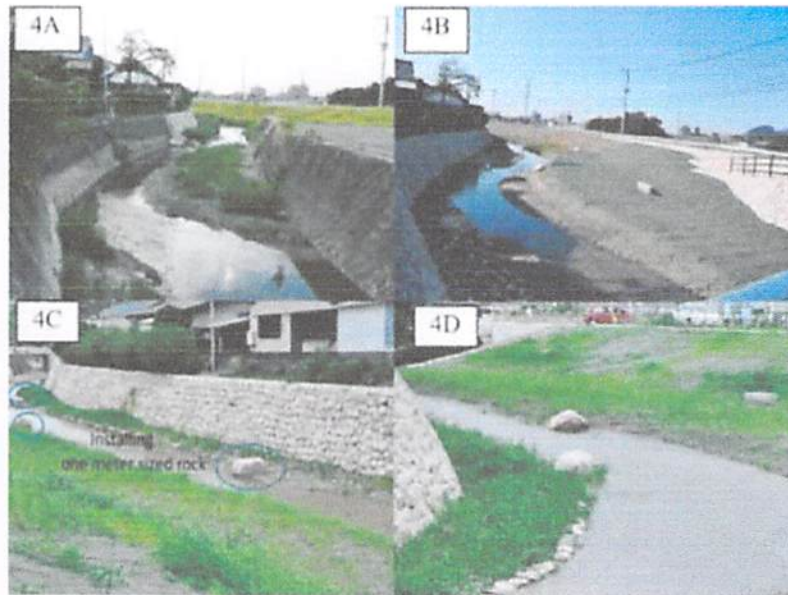
Figure 8: Station 4 condition. (A) Before restoration: the banks were lined by concrete. (B) Two months after restoration: revetments removed and river width doubled. (C) Installation of 1-m boulders. (D) Moderate bank slope.

Station 4 was restored to enhance stream naturalness and environmental functions. The concrete revetment was removed, doubling the stream width. The stream was connected to the riparian zone via a sloped river bank (Fig. 8), restoring the ecotone and continuity between land and water. Flow conditions were varied by the placement of 1-m rocks (Fig. 8). The moderate bank slope invites visitors down to the water [1].
