EFFECT OF TWO SUCCESSION CHECK DAMS ON DEBRIS FLOW DEPOSITION

FAROUK MARICAR^(*), HARUYUKI HASHIMOTO^(*), SHINYA IKEMATSU^(*) & TOMOHIRO MIYOSHI^(*)

This paper describes the effect of two successive check dams on the debris flow event which occurred on 21 July, 2009 in Hofu City, Yamaguchi Prefecture, Japan. The debris flow event caused sediment deposition in the check dams in the Tsurugi and Hachimandani River. In the former river with two successive closed-check dams, driftwood did not accumulate in the check dams but in the central region of the river bend. In the latter river with two successive open-check dams, driftwood accumulated in the opening of the check dams so that the accumulation obstructed the sediment transport to the downstream direction. The upstream check dams in these rivers have sediment deposition profile of around 2°, whereas the downstream ones have deposition profile of around 1.3°. The ratio of sediment deposition volume in the downstream check dams to that in the upstream ones is 0.3 : 1. The total amount of sediments trapped by the two successive check dams can be estimated at around 9,500 m³ in each river. Specific sediment runoff volume from the mou

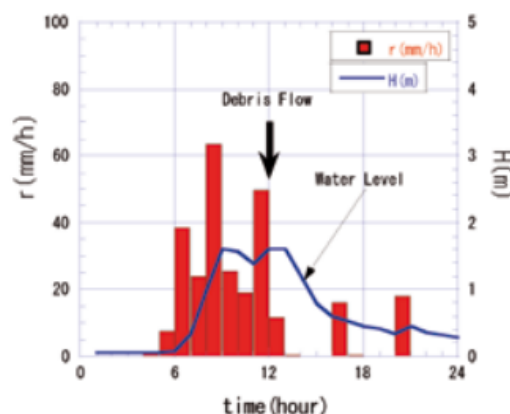
Fig. 2 - Rainfall at the Hofu station & water level of the Mate River in the downtown of Hofu City

Hofu City area had heavy rainfall on July 21, 2009. The situation of the rainfall is shown in Figure 2. This figure also shows the time-varying water level of the small river in Hofu City. The accumulated rainfall was 240.5mm from 4 a.m. to 1 p.m. The hourly rainfall had two times of peak of 65 mm from 8 to 9 a.m and 49.5 mm from 11 to 12 a.m. This rainfall caused flood flows in every river in Hofu City area. The flood water level of the small rivers had also two times of peak, as shown in Figure 2.

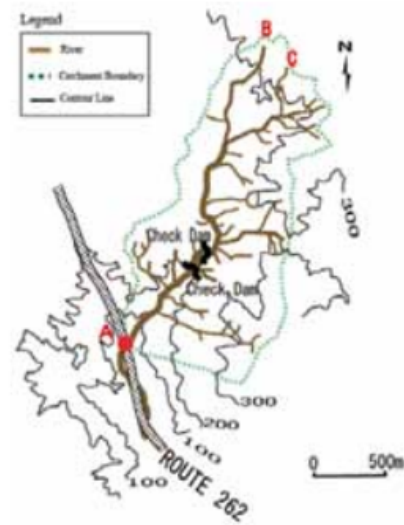
Fig. 4 - Catchment of the Tsurugi River

Figure 4 depicts the plan view of the Tsurugi River catchment. Figure 5 shows the longitudinal profile of the river. The distance from the upstream end (Position B) to the downstream end (Position A) is 2,700 m and its catchment area is about 2 km². River slope is 3.5° at position A in the vicinity of the national road and 14.2° at position B in the vicinity of the landslide location. On the other hand, river slope is 2.7° in the vicinity of the two successive check dams. An aerial photo shows that there are about 90 shallow landslides in this catchment area.

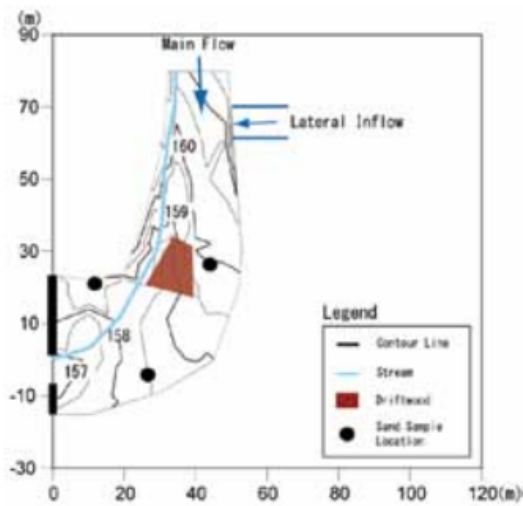
Fig. 7 - Contour map of river bed configuration behind the upstream check dam in the Tsurugi River

the contour map of the river bed elevation. This river reach has a curvature and an inflow of another debris flow from the left-hand side. It can be seen that the river bed has higher part in the outer region and lower part in the inner region of the river bend. Driftwood did not arrive at the check dam but stopped in the central region of the river at $x=50$ m. Here x is defined as distance measured along the centre line in the upstream direction from the check dam.

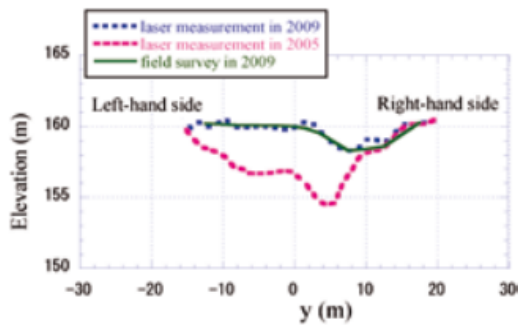
Fig. 8 - Cross section of the river bed profile in the upstream check dam ($x=50\text{ m}$)

the river bed at $x=50\text{m}$. The solid line in this figure denotes the field measurements after the debris flow event. For comparison, the laser measurements before and after the debris flow event are also shown by the dashed lines in this figure. The laser measurements were made by the Ministry of Land, Infrastructure, Transport and Tourism on April 14 to 16, 2005 and on August 17 to 19, 2009. It is confirmed that the field measurement coincides with the laser measurement. The right-hand side within the river bed after the event has depression at around $x=50\text{ m}$. The formation of this depression represents serious sediment deposition in the outer region (left-hand side) and less sediment deposition in the inner region (right-hand side) of the river bend during the event. From such a figure of the field measurements we obtain the maximum and minimum elevation of the river bed at each section.

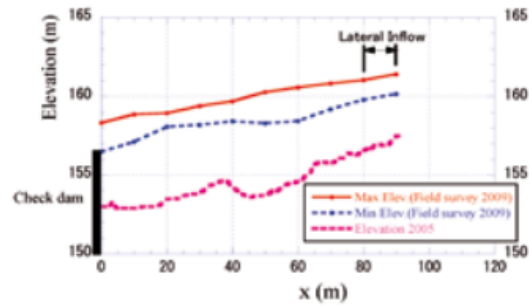
Fig. 9 - Longitudinal profile at the upstream check dam in the Tsurugi River

at each section yields a longitudinal river bed profile behind the check dam, as shown in figure 9. In this figure, we omitted the laser measurement in 2009, because the field measurement approximated to the laser measurement after the debris flow event.

The longitudinal river bed slope after the debris-flow event can be estimated as 1.9° from the field measurement in 2009, while the slope of the river bed before the event is 3.3° from the laser measurement in 2005.

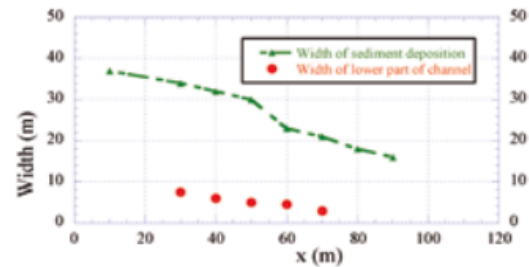
Fig. 10 - Width of sediment deposition and the lower part of channel in the storage region of the upstream check dam

In addition, Figure 10 shows a change in width of sediment deposition zone with distance x from the check dam. The width of the sediment deposition zone changes with distance ranging from 37 m to 16 m, whereas the width of the lower part of the river bed ranges from 7.5 m to 3 m and its depth from 1.5 m to 2 m. Using the measurements of river bed before and after the debris flow event, we can estimate the volume of deposited sediment as $7,400\text{ m}^3$

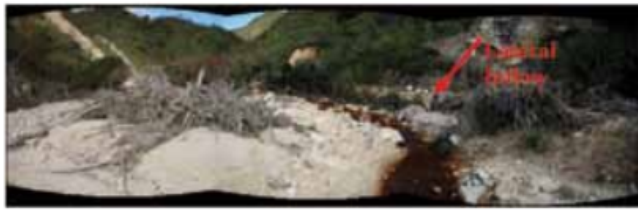
Fig. 11 - Sediment deposition caused by the downstream check dam on the Tsurugi River (View from downstream to upstream direction on December 8, 2009)

Figure 11 is a photo of sediment deposition at the downstream check dam in the Tsurugi River. Figure 12 shows the contour map of the river bed elevation behind the check dam. There is a lateral inflow upstream immediately from the check dam. The other

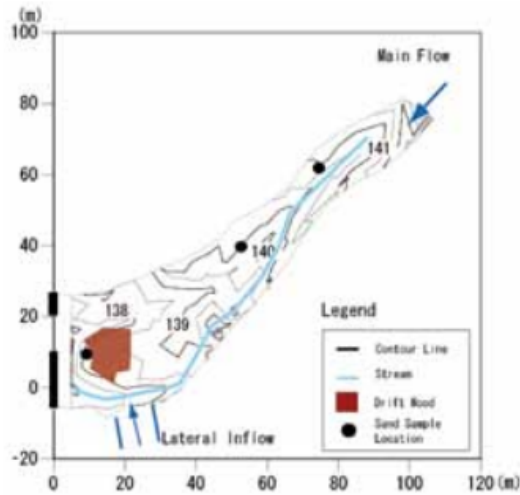
Fig. 12 - Contour map of river bed configuration behind the downstream check dam in the Tsurugi River

debris flow moved into the main river from the left-hand side. This inflow resulted in significant sediment deposition and driftwood accumulation.

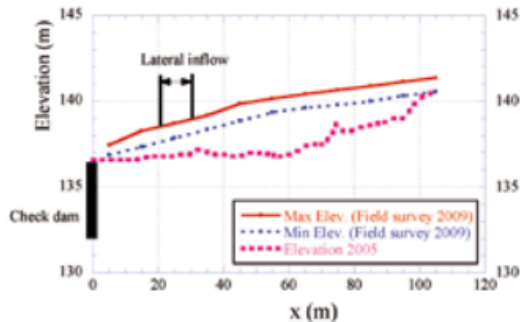
Fig. 13 - Longitudinal profiles at the downstream check dam in the Tsurugi River

Using the maximum and minimum bed elevation at each cross section yields a longitudinal river bed profile behind the check dam, as shown in figure 13. This longitudinal profile becomes convex upward. The bed slope is steeper in the region such that $0 < x < 50$ m than in the other region. This is attributed to the lateral inflow of the other debris flow. However, no effect of

the lateral inflow can be seen in the river region at $x > 50$ m. The longitudinal slope of the sediment deposition profile is 3.4° in the region with the effect of lateral inflow. The longitudinal slope of the sediment deposition profile is 1.4° in the region without the effect of lateral inflow, while the slope of river bed based on the laser measurements in 2005 indicates 4.5° . This approximated to the river bed slope before the debris flow event.

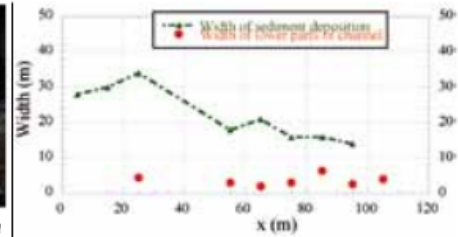
Fig. 14 - Width of sediment deposition and the lower part of channel in the storage region of the downstream check dam

Figure 14 shows the change in width of sediment deposition zone with distance x from the check dam. The width of sediment deposition zone decreases from 34 m to 14 m. On the other hand, the width of the lower part of the bed decreases from 6.4 m to 2 m and its depth is 1.0 m. The volume of sediment trapped in the check dam can be estimated as $2,200 \text{ m}^3$.

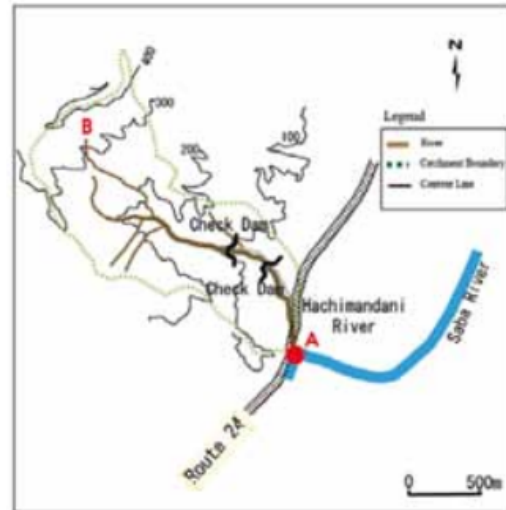
Fig. 15 - Catchment of the Hachimandani River

Figure 15 depicts the plan view of the Hachimandani River catchment. Figure 16 shows the longitudinal profile of the river. The distance from the upstream

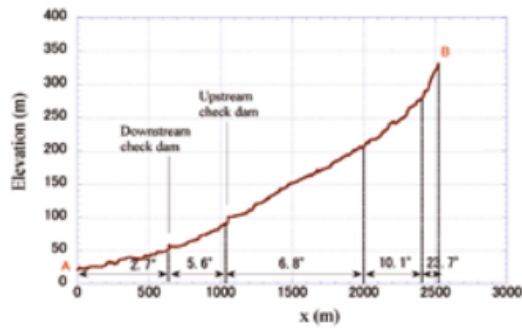
Fig. 16 - Longitudinal profile of the Hachimandani River

end (Position B) to the downstream end (Position A) is 2,500 m, and the catchment area is about 1.7 km². River slope is 2.7° at the confluence with the Saba River (position A) and 23.7° at position B in the vicinity of the landslide location. On the other hand, the river slope is 5.6° in the vicinity of the two successive check dams. An aerial photo shows that there are about 10 shallow landslides in this catchment area.

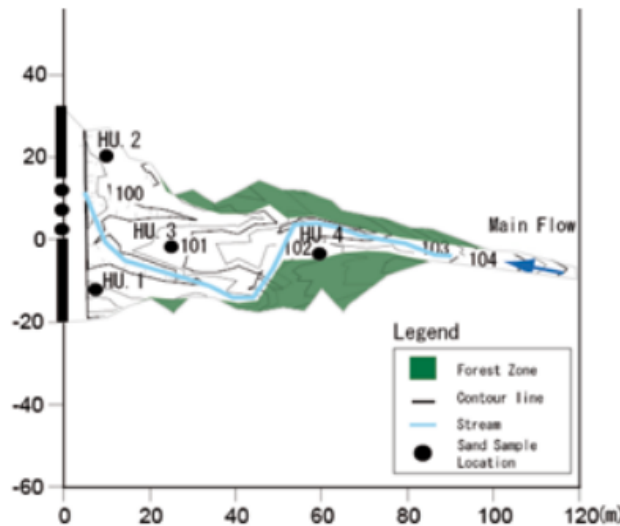
Fig. 18 - Contour map of river bed configuration behind the upstream check dam in the Hachimandani River

Figure 17 is a photo of situation of sediment deposition caused by the upstream check dam on the Hachimandani River. Figure 18 shows the contour map of the river bed configuration behind the check dam. Figure 19 are the photos of the open-type check dam. We found that driftwood had accumulated in the opening of the check dam. However we did not find larger size of sediment such as boulders in the opening of the check dam or in the sediment deposition area. The accumulation of driftwood obstructed the sediment transport in the downstream direction. Figure 20 shows grain size distribution of deposited sediment behind the check dam. We find the 50% diameter $d_{50} = 1.38 \text{ mm}$ on the average. Since there are no boulders in the sediment deposition area, $d_{50} = 1.38 \text{ mm}$ is typical of the deposited sediment.

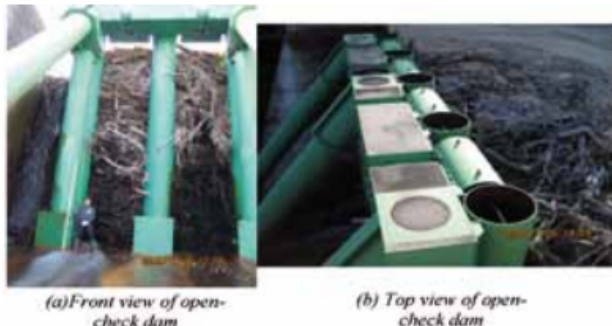
Fig. 19 - Sediment and driftwood at the upstream check dam in the Hachimandani River

Driftwood accumulated above the river bed surface near the region of river bend and lateral inflow in the Tsurugi River, whereas it accumulated in the opening of the open-check dams in the Hachimandani River. The accumulation of driftwood in the opening of the check dams obstructed the transport of the whole sizes of sediment to the downstream direction.

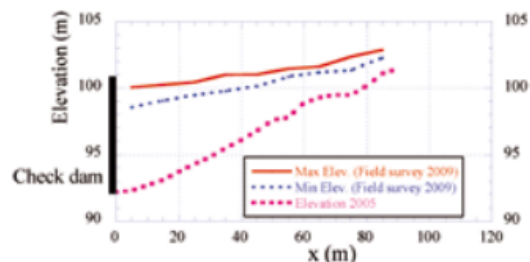
Fig. 21 - Longitudinal profiles at the upstream check dam in the Hachimandani River

Using the maximum and minimum bed elevation at each cross section yields a longitudinal river bed profile behind the check dam, as shown in figure 21. Figure 22 shows the change in width of sediment deposition zone with distance x from the check dam. The longitudinal slope of sediment deposition zone before and after the debris flow event is 6.3° and 2.0°, respectively. The width of the sediment deposition zone varies

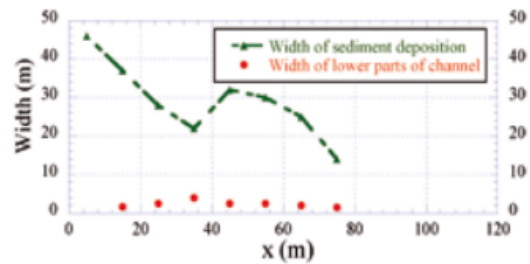
Fig. 22 - Width of sediment deposition and the lower part of channel in the storage region of the upstream check dam

from 14 m to 46 m. The width of lower part of the river bed is from 1.5 m to 4 m and its depth is from 0.5 m to 1.5 m. The volume of the trapped sediment can be estimated as 7,300 m³.

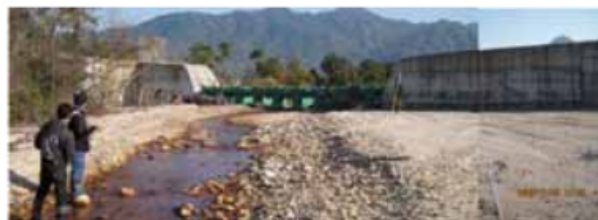
Fig. 23 - Sediment deposition caused by the downstream check dam on the Hachimandani River (View from upstream to downstream direction on November 25, 2009)

Figure 23 is the photo of sediment deposition caused by the downstream check dam on the Hachimandani River. Figure 24 show the photos of the open-type check dam. Figure 25 shows the contour map of the river bed configuration behind the check dam. We found the driftwood accumulated in the slit part of the check dam. However we did not find larger size of sediment such as boulders in the opening of check dam or in the sediment deposition area. The accumulation of the driftwood obstructed the sediment transport to the downstream direction. Figure 26 shows grain size distribution of deposited sediment behind the check dam. We find the 50% diameter $d_{50} = 0.99 \text{ mm}$ on the average. Since there are no boulders in the sediment deposition area, $d_{50} = 0.99 \text{ mm}$ is typical of deposited sediment.

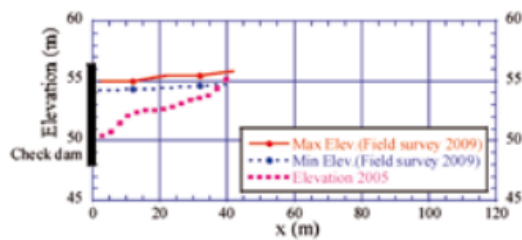
Fig. 27 - Longitudinal profile at the downstream check dam in the Hachimandani River

Using the maximum and minimum bed elevation at each cross section yields a longitudinal river bed profile behind the check dam, as shown in figure 27. Figure 28 shows the change in width of sediment deposition zone. The longitudinal slope of sediment deposition zone before and after the debris flow event is 7.1° and 1.3° , respectively. The width of the sediment deposition zone varies from 19m to 35m. The width of lower part of the river bed is from 2m to 4m and its depth is from 0.5m to 1.0m. Using the results, we can estimate the volume of the trapped sediment as $2,200 \text{ m}^3$.
