Geo-Disaster Report

Large-scale flowslide in Sibalaya caused by the 2018 Sulawesi earthquake

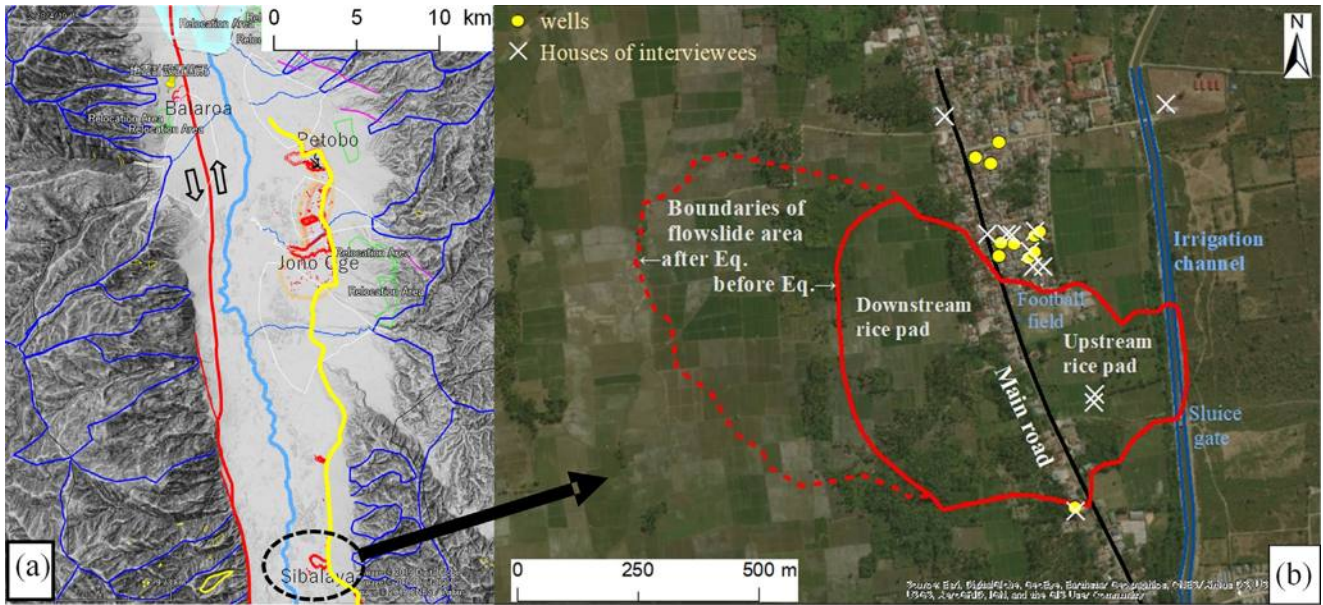
A main road passed through the area. There were approximately 60 houses built along this road. Fig. 1(b) shows the locations of the houses where the interviewed residents were living in during the earthquake. A total of 23 residents (ten male and thirteen female), agreed to take part in our survey. All the interviewees felt a strong ground shaking that lasted 10 to 20 s, which is consistent with the acceleration recorded at the observatory near Balaroa. Shortly after the shaking ceased, about several to ten seconds, almost all interviewees felt a sudden drop. This vertical movement after the main shock, was not recorded with the accelerometers near Balaroa, but felt by many people near the flowslide areas on the eastern side of the Palu River, including not only Sibalaya but also the Petobo and Jono Oge areas (Kiyota et al., 2020, GEER, 2019). Then, after about less than a minute, almost all the interviewees heard an extremely loud sound, like structure breaking or thunder. Meanwhile, eight interviewees who stayed close to the flowslide area saw houses and coconut trees moving downslope toward the Palu River at a rate faster than the average walking speed, which lasted about one minute, while soil dust covered the area. Considering the flowslide distance at this site (approximately 350 m), the flowslide speed was likely to be of the order of 20 km/h, which corresponds with that observed in Petobo and Jono Oge (Kiyota et al., 2020). Several interviewees witnessed water from the broken irrigation canal flowing downhill immediately after the movement ceased. All these events occurred within a few minutes. The water continued to flow for almost a day until a canal gate located 8.35 km upstream was closed and the channel dried up.

Information of the ground water level is a key when investigating the liquefaction potential. We found eleven wells at the locations shown in Fig. 1(b) and interviewed their owners. Fig. 2(a) shows a photograph and a schematic illustration of well #1, whose internal diameter and depth were 1 m and 10 m, respectively. Its water level before the earthquake was 5.6 m below the ground surface with small seasonal variations (in the order of a few tens centimeters), which was confirmed through the trace left on the inside wall of the well. Soon after the earthquake, the owner noticed that water overflowed from the well; this overflowing lasted two days. Thereafter, the water level gradually lowered and the well completely dried up in the next two weeks. Although outside the flowslide area, some features typical to areas of liquefaction-induced lateral spreading were detected near the well, including cracks on house walls and fences, house subsidence, as well as sand ejecta on the ground surface. All the other wells, wells #2 - #11, had a similar structure, as shown in Fig. 2(b); a 12-m-long pipe was installed at the bottom of a 4–5.5 m-deep excavated well, through which water was pumped up. They did not observe any water at the bottom of the excavated well before the earthquake, indicating that the ground water level was lower than 5 m in the neighbor-

Fig. 1. Locations of major flowslide and houses of interviewed eyewitnesses in Sibalaya. (a) Locations of major flowslide and earthquake fault and irrigation channel (after Kiyota et al., 2020), (b) Satellite image before the earthquake with locations of houses of interviewees, surveyed wells, main road, irrigation channel and flowslide affected area.

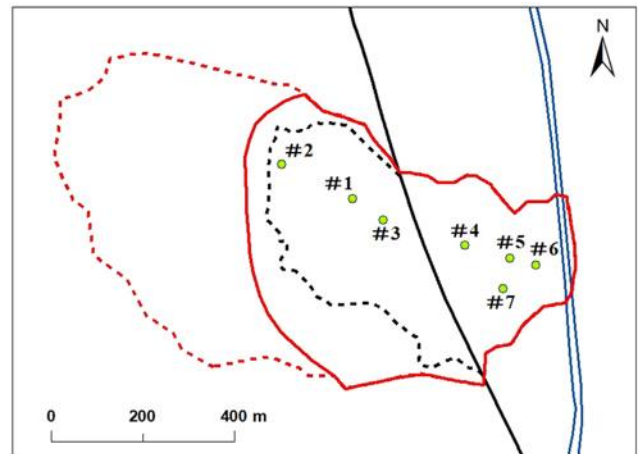
Fig. 8. Locations of excavated trench.

Totally seven trenches were excavated in the flowslide as indicated in Fig. 8. Tree trenches, #1 to #3, were excavated in the area where ground surface originally existed upstream side before is resting on the underlying original layers after the earthquake. In this area, shallower soil

was expected to be highly disturbed and mixed with immediately above and below soil layers. Large trenches, with dimensions approximately being 20-m-long and 5-m-wide, were excavated more than 5 m deep until encountering a non-liquefied layer. While for the trench locations from #4 to #7, where most of the original shallower soil layers had left, eroded by the following flooding and flood sediments deposited on the surface, smaller trenches were excavated until a non-liquefied original soil layer was encountered. The observations of all the trenches are described below, with an exception of trench #7 of which location was apart from the mainstream of flowslide.

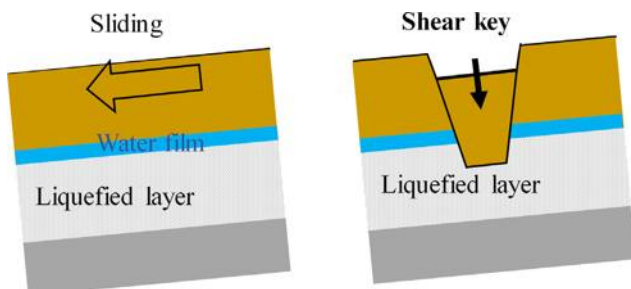
- The water interlayer should be smooth and continuous over the flowslide area. However, as shown in Fig. 10, the soil blocks dropped into the liquefied layer were present, which made the water interlayer discontinuous and obstructed the soil sliding deformation above the layer as *shear keys*, as illustrated in Fig. 16. The existence of many similar tensile cracks suggested the existence of similar shear key blocks.

Fig. 16. Schematic illustrations of shear key effects of a part of sliding soil block submerged into an underlying liquefied layer.
