Geo-Disaster Report

Large distance flow-slide at Jono-Oge due to the 2018 Sulawesi Earthquake, Indonesia

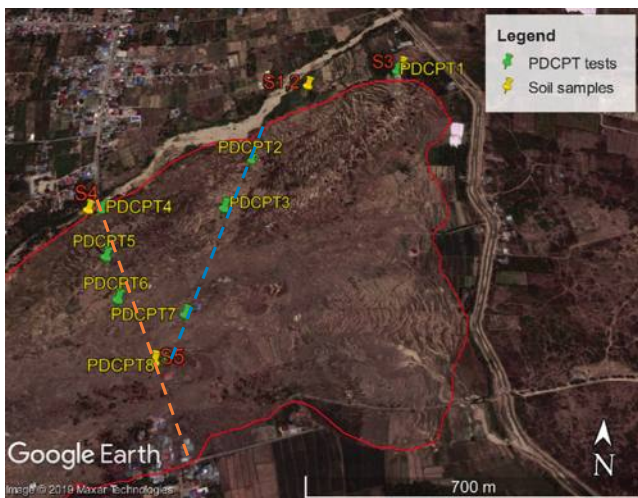
Fig. 13 shows the locations of the sites where soil samples were collected and PDCPT were conducted. As can be seen from the figure, the locations for the PDCPTs (PDCPT1, PDCPT4, PDCPT5, PDCPT6, PDCPT8) were selected such to ensure various locations with different characteristics were included: within the flow-slide zones

Fig. 13. Locations of the PDCPT and collected soil samples at Jono-Oge.
