# EVALUATION OF PONRE-PONRE DAM INSTRUMENTATION

Rita Tahir Lopa and farouk Maricar

**Keywords:** Dam security, instrument, Ponre-Ponre Dam.

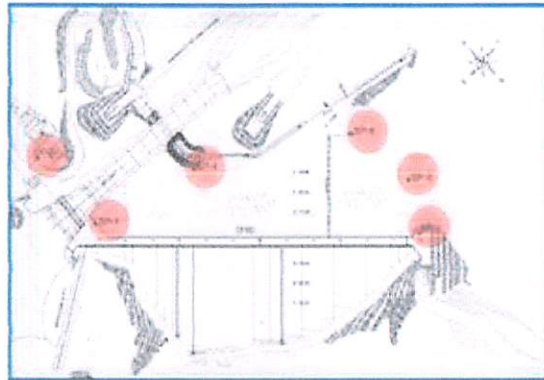
**Figure 3.** Location of Standpipe Piezometer Ponre- Ponre Dam Instrumentation

Condition of Measurement Instrumentation Standpipe Piezometer mounted at 6 points in good condition except SP4 as shown in Table 2 and Figure 3 below.

The condition of the water level on SP.4 (on the left side of the weir) is recorded that the ground water in the pipe has overflowed and can not be measured soil water level, can be seen in Figure 4.

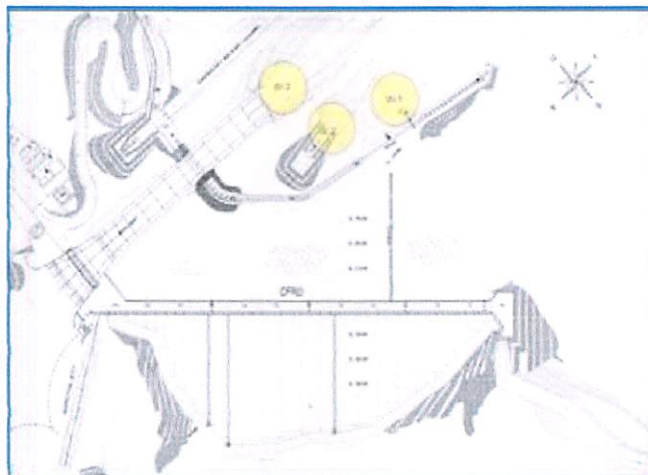
Figure 7. Location of V-Notch Ponre-Ponre Dam Instrumentation

Condition of V-Notch Instrumentation mounted 3 V-Notch pieces, can be seen in Figure 7. Condition of Instrumentations are in good condition on the downstream and diversion works, while in the spillage, there are many moss, and it need maintenance (Figure 8).

4. The results of evaluation of instrumentation demonstrate that piezometer equipment, seepage, and settlement survey are in un-maintained condition, requiring routine maintenance and maintenance as well as periodic cleaning.

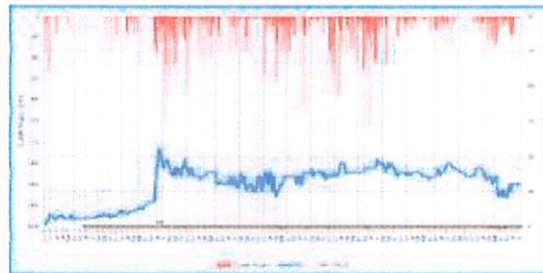
**Figure 9.** Rainfall and V-Notch discharge

The graph shows the V-notch discharge affected by the rainfall shown in Figure 9 and, the Graph shows the V-notch discharge influenced by the Water Reservoir shown in Figure 10.
