EVALUATION OF PONRE-PONRE DAM INSTRUMENTATION

Rita Tahir Lopa and farouk Maricar

ABSTRACT

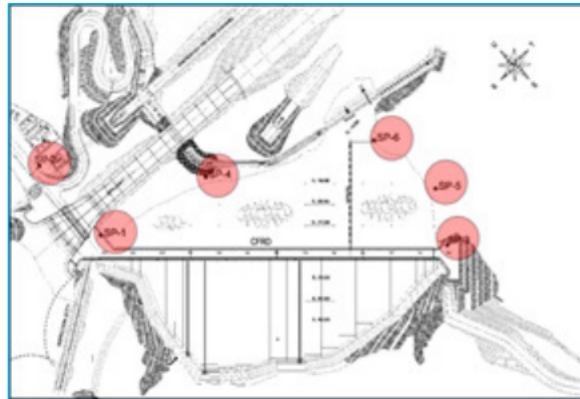
Figure 3. Location of Standpipe Piezometer Ponre- Ponre Dam Instrumentation

Condition of Measurement Instrumentation Standpipe Piezometer mounted at 6 points in good condition except SP4 as shown in Table 2 and Figure 3 below.

The condition of the water level on SP.4 (on the left side of the weir) is recorded that the ground water in the pipe has overflowed and can not be measured soil water level, can be seen in Figure 4.

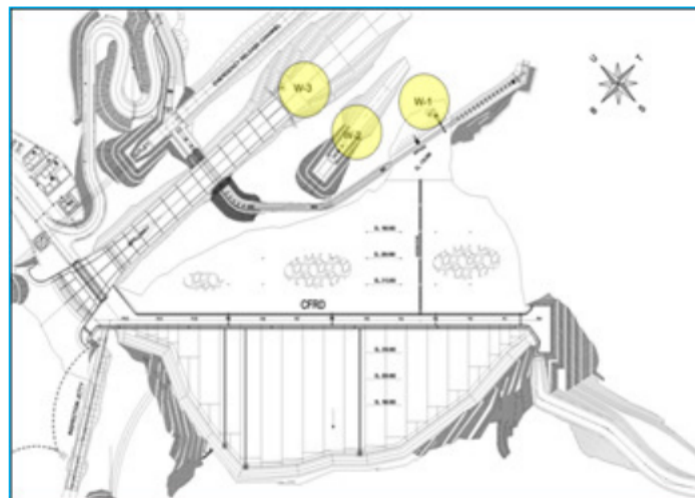
Figure 7. Location of V-Notch Ponre-Ponre Dam Instrumentation

Condition of V-Notch Instrumentation mounted 3 V-Notch pieces, can be seen in Figure 7. Condition of Instrumentations are in good condition on the downstream and diversion works, while in the spillage, there are many moss, and it need maintenance (Figure 8).

4. The results of evaluation of instrumentation demonstrate that piezometer equipment, seepage, and settlement survey are in un-maintained condition, requiring routine maintenance and maintenance as well as periodic cleaning.

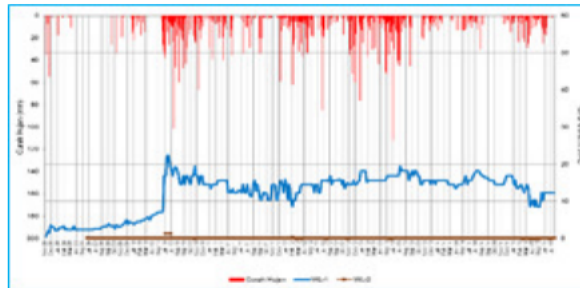
Figure 9. Rainfall and *V-Notch* discharge

The graph shows the *V-Notch* discharge affected by the rainfall shown in Figure 9 and, the Graph shows the *V-Notch* discharge influenced by the Water Reservoir shown in Figure 10.
