Geo-Disaster Report

Large-scale flowslide in Sibalaya caused by the 2018 Sulawesi earthquake

Mitsu Okamura^{a,*}, Kohei Ono^a, Ardy Arsyad^b, Utari S. Minaka^a, Sukiman Nurdin^c

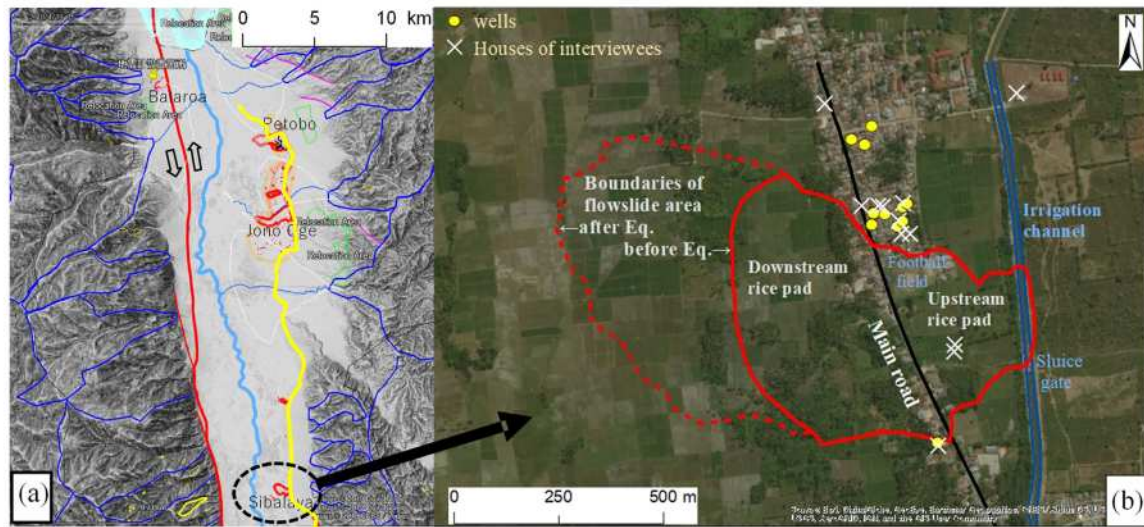
A main road passed through the area. There were approximately 60 houses built along this road. Fig. 1(b) shows the locations of the houses where the interviewed residents were living in during the earthquake. A total of 23 residents (ten male and thirteen female), agreed to take part in our survey. All the interviewees felt a strong ground shaking that lasted 10 to 20 s, which is consistent with the acceleration recorded at the observatory near Balaroa. Shortly after the shaking ceased, about several to ten seconds, almost all interviewees felt a sudden drop. This vertical movement after the main shock, was not recorded with the accelerometers near Balaroa, but felt by many people near the flowslide areas on the eastern side of the Palu River, including not only Sibalaya but also the Petobo and Jono Oge areas (Kiyota et al., 2020, GEER, 2019). Then, after about less than a minute, almost all the interviewees heard an extremely loud sound, like structure breaking or thunder. Meanwhile, eight interviewees who stayed close to the flowslide area saw houses and coconut trees moving downslope toward the Palu River at a rate faster than the average walking speed, which lasted about one minute, while soil dust covered the area. Considering the flowslide distance at this site (approximately 350 m), the flowslide speed was likely to be of the order of 20 km/h, which corresponds with that observed in Petobo and Jono Oge (Kiyota et al., 2020). Several interviewees witnessed water from the broken irrigation canal flowing downhill immediately after the movement ceased. All these events occurred within a few minutes. The water continued to flow for almost a day until a canal gate located 8.35 km upstream was closed and the channel dried up.

Information of the ground water level is a key when investigating the liquefaction potential. We found eleven wells at the locations shown in Fig. 1(b) and interviewed their owners. Fig. 2(a) shows a photograph and a schematic illustration of well #1, whose internal diameter and depth were 1 m and 10 m, respectively. Its water level before the earthquake was 5.6 m below the ground surface with small seasonal variations (in the order of a few tens centimeters), which was confirmed through the trace left on the inside wall of the well. Soon after the earthquake, the owner noticed that water overflowed from the well; this overflowing lasted two days. Thereafter, the water level gradually lowered and the well completely dried up in the next two weeks. Although outside the flowslide area, some features typical to areas of liquefaction-induced lateral spreading were detected near the well, including cracks on house walls and fences, house subsidence, as well as sand ejecta on the ground surface. All the other wells, wells #2 - #11, had a similar structure, as shown in Fig. 2(b); a 12-m-long pipe was installed at the bottom of a 4–5 m-deep excavated well, through which water was pumped up. They did not observe any water at the bottom of the excavated well before the earthquake, indicating that the ground water level was lower than 5 m in the neighbor-

Fig. 1. Locations of major flowslide and houses of interviewed eyewitnesses in Sibalaya. (a) Locations of major flowslide and earthquake fault and irrigation channel (after Kiyota et al., 2020), (b) Satellite image before the earthquake with locations of houses of interviewees, surveyed wells, main road, irrigation channel and flowslide affected area.

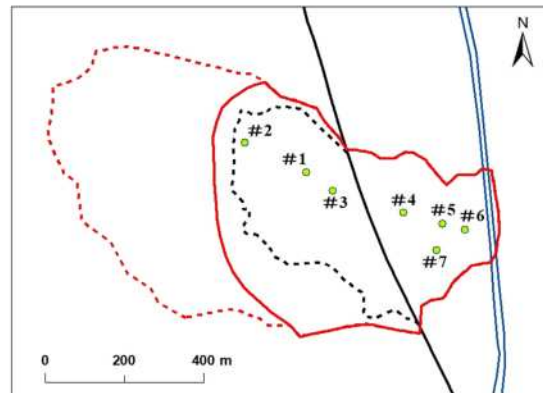
Totally seven trenches were excavated in the flowslide as indicated in Fig. 8. Tree trenches, #1 to #3, were excavated in the area where ground surface originally existed upstream side before is resting on the underlying original layers after the earthquake. In this area, shallower soil

Fig. 8. Locations of excavated trench.

was expected to be highly disturbed and mixed with immediately above and below soil layers. Large trenches, with dimensions approximately being 20-m-long and 5-m-wide, were excavated more than 5 m deep until encountering a non-liquefied layer. While for the trench locations from #4 to #7, where most of the original shallower soil layers had left, eroded by the following flooding and flood sediments deposited on the surface, smaller trenches were excavated until a non-liquefied original soil layer was encountered. The observations of all the trenches are described below, with an exception of trench #7 of which location was apart from the mainstream of flowslide.
