Geo-Disaster Report

# Large distance flow-slide at Jono-Oge due to the 2018 Sulawesi Earthquake, Indonesia

Hemanta Hazarika<sup>a,\*</sup>, Divyesh Rohit<sup>a</sup>, Siavash Manafi Khajeh Pasha<sup>b</sup>, Tsubasa Maeda<sup>a</sup>,  
Irsyam Masyhur<sup>c</sup>, Ardy Arsyad<sup>d</sup>, Sukiman Nurdin<sup>e</sup>

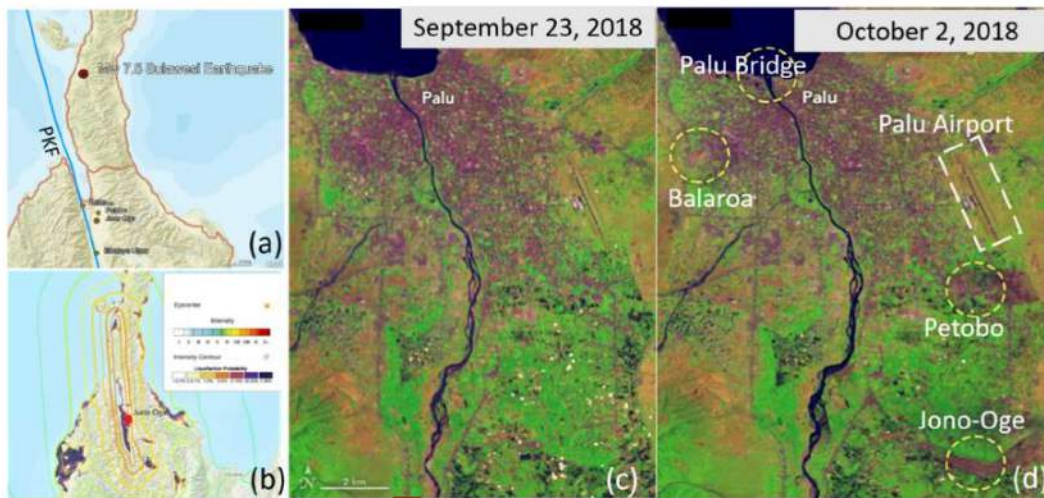
Fig. 2. Intensity Map and ground failures associated with Mw 7.5 Palu earthquake (a) Epicenter of The 2018 Sulawesi earthquake along locations of flow failure and alignment of Palu-Koro fault (b) Intensity contour with liquefaction probability map of Palu city (USGS, 2018), (c) Landsat 8 image taken on September 23, 2018 and (d) Landsat 8 image taken on October 2, 2018 (showing the sites with major flow failure damages; USGS, 2018).

(brown and tan). On observing both Fig. 2c & d, the mud flow and debris can be easily identified which occurred due to liquefaction induced flow failure. Furthermore, the images in Fig. 2c & d indicate that there was no notable damage to Palu airport, which is located near the flow

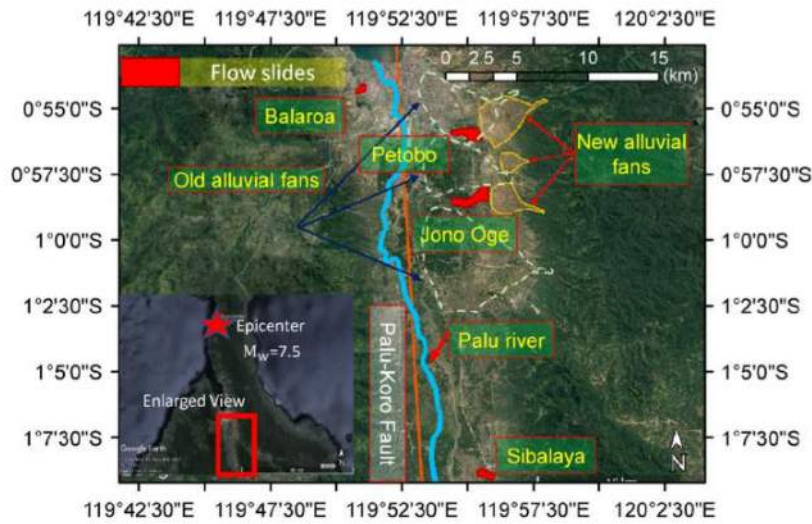
The 2018 Sulawesi earthquake triggered four large scale flow-slides (Balaroa, Petobo, Jono Oge and Sibalaya) which are located in the vicinity of Palu city (Fig. 8). The slide areas are all located along the edges of Palu valley, where the new alluvial fans meet the old alluvial fan deposits of Palu river. The landslide in Balaroa (northwest side of Palu valley) was on gentle ground with average slope of 4% and partially or fully damaged approximately 2,969 residential buildings. The other three flow-slides in Petobo, Jono Oge and Sibalaya were in the east side of Palu valley within the 25 km of Palu city. According to reports and the damage mapping provided by Copernicus Emergency Management Service, flow-slides damaged or destroyed more than 300 buildings in Jono-Oge and 3,000 buildings in Petobo. More than 140 buildings in Sibalaya were damaged.

Fig. 8. Locations and extent of flowslides in different areas of Palu valley.

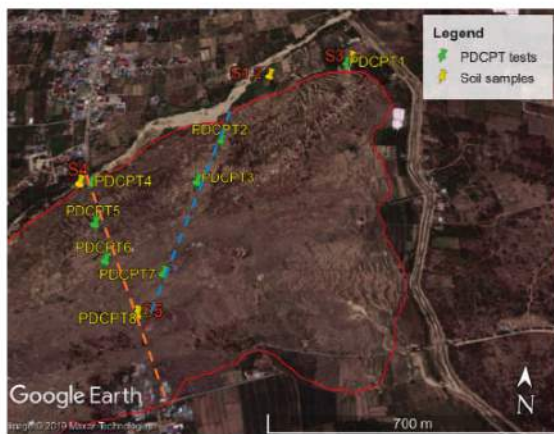
Fig. 13 shows the locations of the sites where soil samples were collected and PDCPT were conducted. As can be seen from the figure, the locations for the PDCPTs (PDCPT1, PDCPT4, PDCPT5, PDCPT6, PDCPT8) were selected such to ensure various locations with different characteristics were included: within the flow-slide zones

Fig. 13. Locations of the PDCPT and collected soil samples at Jono-Oge.

As shown in Fig. 13, the PDCPT 4, 5, 6, 8 were conducted alongside the damaged road that connects the North and South of flow-slide region. The locations and results of PDCPT 4, 5, 6 and 8 are shown in Fig. 15a–d. PDCPT4 was conducted beside the collapsed bridge in the North of Jono-Oge (Fig. 15a). PDCPT5 was conducted within the flow-slide Zone (I) (the tension zone), where there were many soil blocks which had been dragged along and had rafted together in failure area (Zone (II)) (the compression zone) (Fig. 15b). PDCPT6 was conducted in zone (II), where the flow-slide apparently started (Fig. 15c).
