EVALUATION OF PONRE-PONRE DAM INSTRUMENTATION

Rita Tahir Lopa and farouk Maricar

ABSTRACT

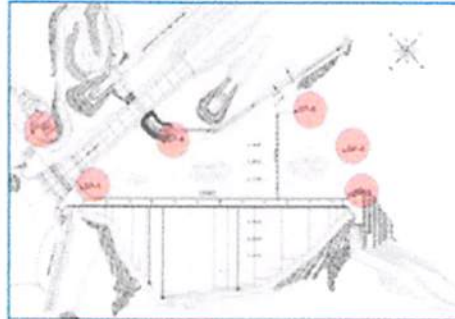
Figure 3. Location of Standpipe Piezometer Ponre- Ponre Dam Instrumentation

Condition of Measurement Instrumentation Standpipe Piezometer mounted at 6 points in good condition except SP4 as shown in Table 2 and Figure 3 below.

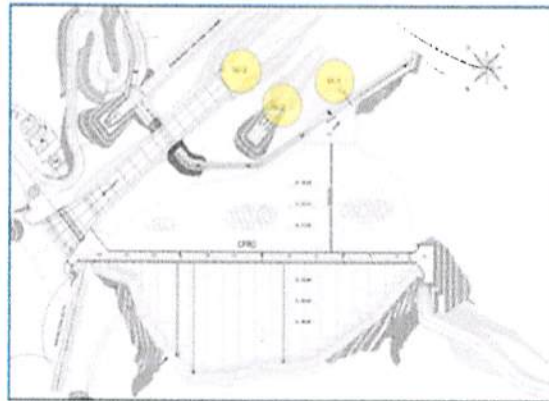
Figure 7. Location of V-Notch Ponre-Ponre Dam Instrumentation

Condition of V-Notch Instrumentation mounted 3 V-Notch pieces, can be seen in Figure 7. Condition of Instrumentations are in good condition on the downstream and diversion works, while in the spillage, there are many moss, and it need maintenance (Figure 8).

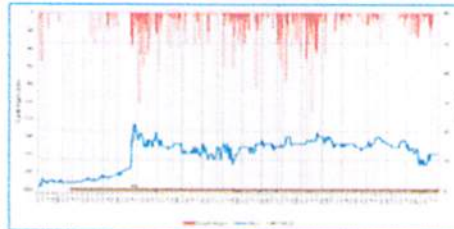
Figure 9. Rainfall and V-Notch discharge

The graph shows the V-notch discharge affected by the rainfall shown in Figure 9 and, the Graph shows the V-notch discharge influenced by the Water Reservoir shown in Figure 10.
