## **Applying a fish biological integrity index to a restoration plan in a small-sized river: case study in the Kamisaigo River**

R. Lopa<sup>1</sup>, H. Hayashi<sup>2</sup>, Y. Shimatani<sup>2</sup> & J. Nakazima<sup>2</sup>

*<sup>1</sup>Department of Urban and Environmental Engineering,  
Graduate School of Engineering, Kyushu University, Japan*

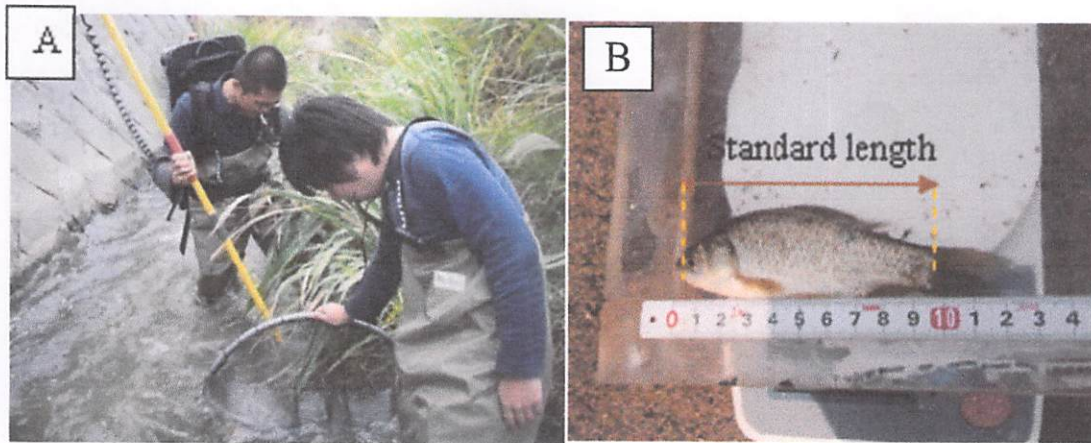
Figure 2: Fish sampling. A. Netting fish after they had been shocked; B. Weighing and measuring the length of fish.

In the autumn (October–November) of 2009, fish assemblages were sampled along the 800 m reach of the river using a backpack electro fisher (LR-24 Smith-Root, Vancouver, WA, USA). Every 50 m stretch was blocked with (seine) netting to ensure population enclosure. To maximize the capture of fish, we attempted to sample equally both river lines and a variety of habitat types. We used intermittent shocking when approaching structures such as downed trees, and patches of vegetation. Once captured, fish were measured (total number of fish, length, weight) and then released alive. Fish standard length was measured to the nearest millimetre and weight was measured to the nearest gram. All fish >20 mm standard length collected within the sample reach were identified to species (or subspecies) (Figure 2).
