Evaluating the Road Damage of Flexible Pavement Using Digital Image

Ida Ayu Ari Angreni¹, Sakti Adji Adisasmitha², M. Isran Ramli³, Sumarni Hamid⁴

^{1,2,3,4}Departement of Civil Engineering
University Hasanuddin, Jl. PorosMalino Km. 6, Gowa, INDONESIA

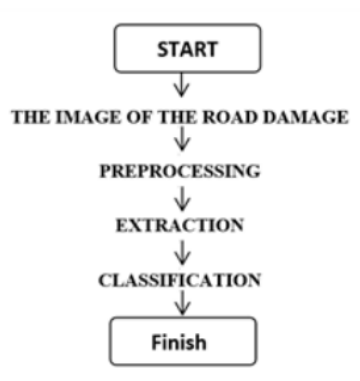
Fig. 1 The flow chart of research method stages.

The research was conducted in Depok area. The object was road damage including cracks, crocodile skin cracks and holes. Data retrieval of images from road damage, using a Canon 550D digital camera. The steps of research method as shown in Figure 1.

The preprocessing stage includes the process of digital image selection. the next stage is delivering the resolution of each image to the same size of 480 × 640 pixels.
