# Neglected Double J Stent

## Case report

## Neglected double-J stent with giant bladder stone: a case report

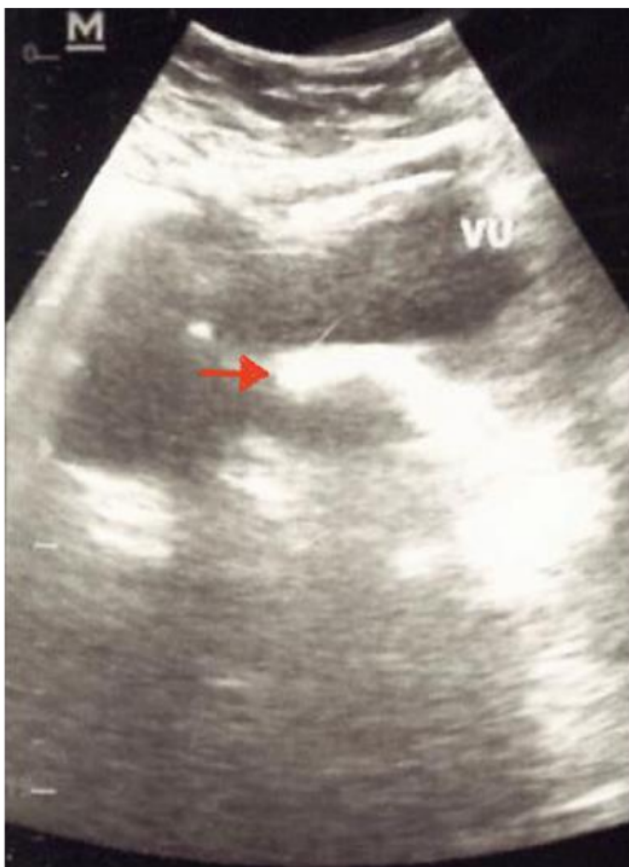
**Figure 1:** urologic ultrasonography showed a hyperechoic image in the bladder with sizes of 175 mm x 125 mm (red arrow)

**Diagnostic assessment:** examination with urologic ultrasonography (USG) showed a hyperechoic structure in the bladder with sizes of 175 mm x 125 mm (Figure 1). The size of the left kidney was normal, but dilatation of Pelvi calyceal system (PCS) was detected at the right kidney without stone formation. A photograph of the kidney, ureter, and bladder (KUB) showed a radiopaque image at the pelvic cavity with a size of 45x30 mm and an image of the double-J stent in the right thoracic paravertebral space (Figure 2). A urological computed tomography (CT) scan showed stone density in her bladder with a size of 48x 21x23 mm and the inserted stent in the right ureter (Figure 3). Her blood components were in normal limits.

**Figure 1:** urologic ultrasonography showed a hyperechoic image in the bladder with sizes of 175 mm x 125 mm (red arrow)

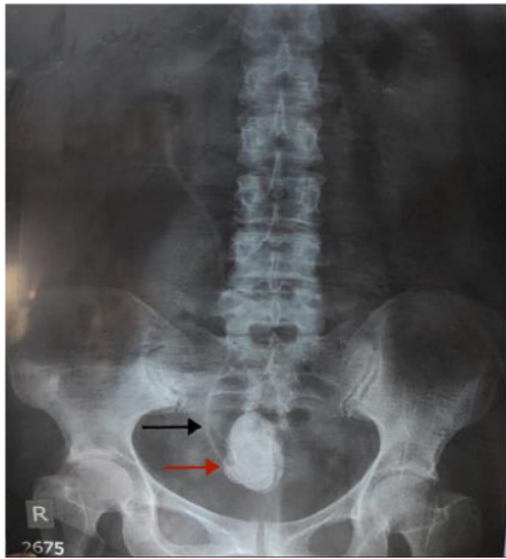
**Figure 2:** a kidney, ureter, and bladder X-ray showed a radiopaque image in the pelvis with a size of 45 mm x 30 mm (red arrow) and a stent image (black arrow) in the right paravertebral space of the pelvic cavity

**Figure 2:** a kidney, ureter, and bladder X-ray showed a radiopaque image in the pelvis with a size of 45 mm x 30 mm (red arrow) and a stent image (black arrow) in the right paravertebral space of the pelvic cavity

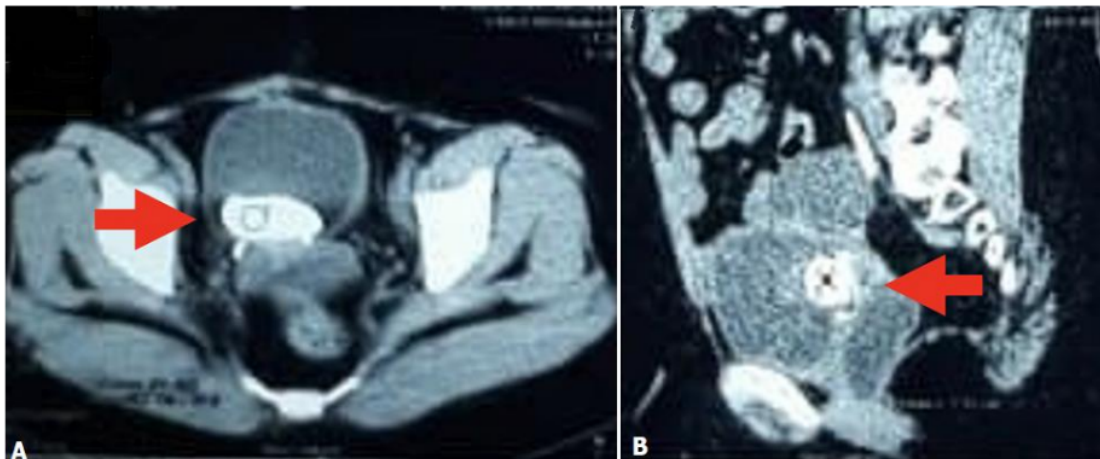
**Figure 3:** urological computed tomography scan (A, B) showed density of stone in the bladder (arrow) with size of 48 mm x 21 mm x 20 mm and the right ureteral stent in the pelvic cavity

**Figure 3:** urological computed tomography scan (A, B) showed density of stone in the bladder (arrow) with size of 48 mm x 21 mm x 20 mm and the right ureteral stent in the pelvic cavity

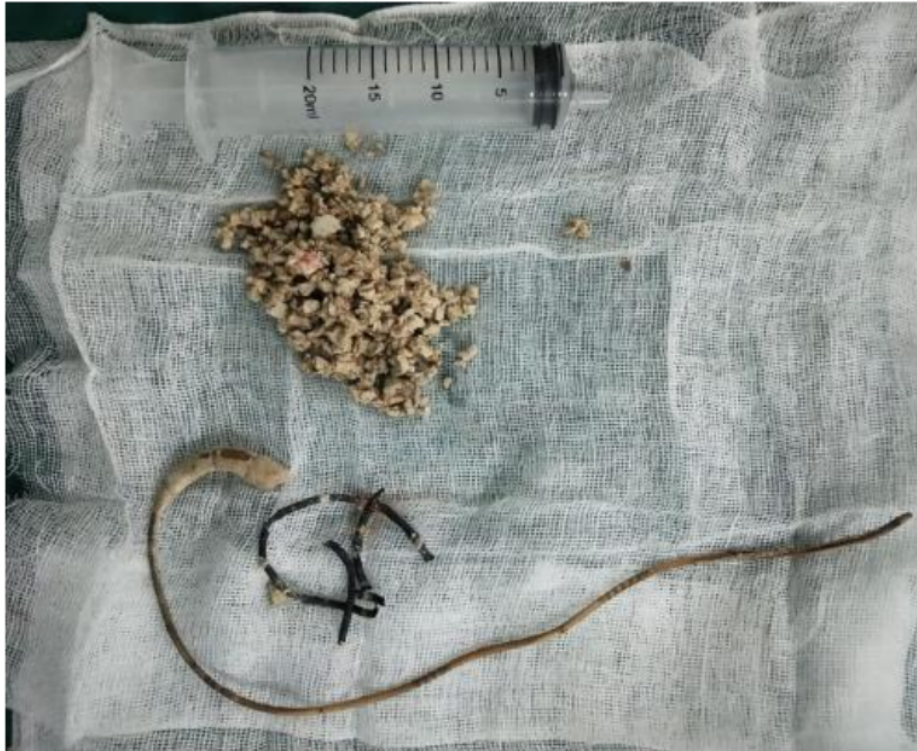
**Figure 4:** endoscopic removal of the double-J stent and the crushed fragments of bladder stone

**Therapeutic interventions:** transurethral cystolithotripsy was mechanically conducted, and endoscopic removal of the DJ stent was carried out with spinal anesthesia (Figure 4). During the operation, two stones were found with whitish yellow color.

**Figure 4:** endoscopic removal of the double-J stent and the crushed fragments of bladder stone
