A REVIEW ON IMAGE PROCESSING TECHNIQUES FOR DAMAGE DETECTION ON PHOTOVOLTAIC PANELS

ANDI NAJIAH NURUL AFIFAH¹, INDRABAYU², ANSAR SUYUTI¹ AND SYAFARUDDIN^{1,*}

Universitas Hasanuddin

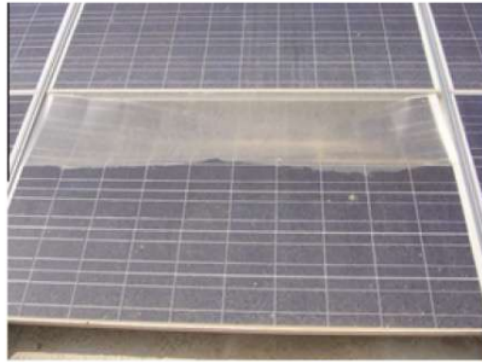
Delamination highly potentially occurs in hot and humid temperatures. If the problem appears in the edge of panels, it will be more severe not only because of the power losses but it is dangerous due to potential electrical risks of panels and the area of installation. Figure 2 shows an image of the worse delamination that could damage the PV panel when the defect appeared. Delamination is also correlated with light transmittance loss entering the panel surface as materials do not respond optically coupled with the loss part of sunlight [10].

FIGURE 2. A PV module with delamination [10]

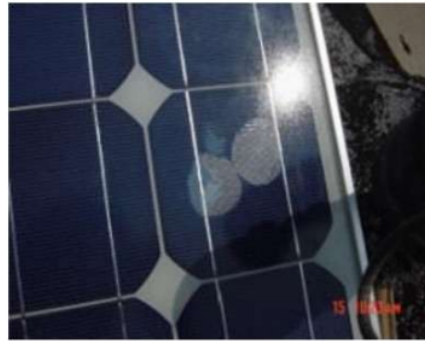
2.2. **External soiling & shading.** Total or partial shading of irradiance that occurs in the PV module surface as in Figure 6 can be a critical issue in PV array operations. The shading can be from the other parts of building, trees, snow and other light blocking objects. Shading causes significant reduction of panel output power and can even make the modules with defects if not properly solved.

FIGURE 6. Partial shading of a PV module [7]
