Applying a fish biological integrity index to a restoration plan in a small-sized river: case study in the Kamisaigo River

R. Lopa¹, H. Hayashi², Y. Shimatani² & J. Nakazima²

Abstract

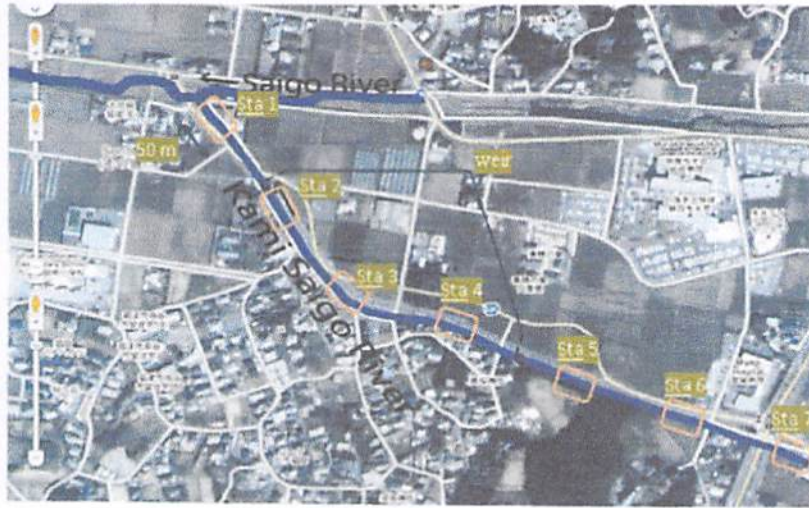
Figure 1: Study area (Kamisaigo River in Fukuoka, Japan).

The Kamisaigo River, a small tributary (second order: $33^{\circ}45'24.29$ and $33^{\circ}45'40.16$ N and $130^{\circ}29'55.52$ and $130^{\circ}29'25.15$ E; Figure 1) is characterized by a water surface width of 2.4-6 m and water depths ranging from 11.2-30.2 cm. The study area was an 800 m reach of the river located at the confluence with the Saigo River, in Fukutsu, Fukuoka Prefecture, Japan. The primary use of this river is irrigation, and the majority of surrounding land is dedicated to residential and commercial uses. The river has been canalized and

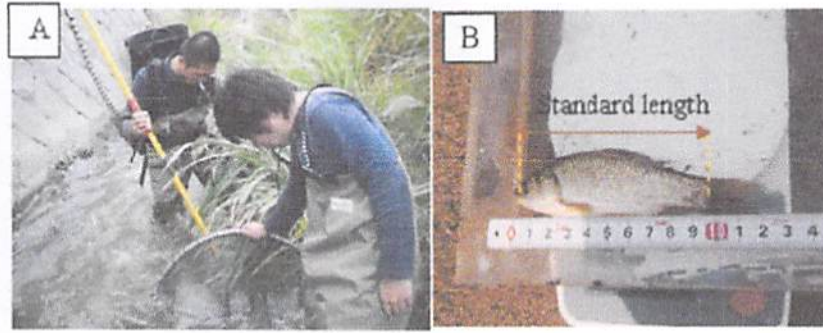
In the autumn (October–November) of 2009, fish assemblages were sampled along the 800 m reach of the river using a backpack electro fisher (LR-24 Smith-Root, Vancouver, WA, USA). Every 50 m stretch was blocked with (seine) netting to ensure population enclosure. To maximize the capture of fish, we attempted to sample equally both river lines and a variety of habitat types. We used intermittent shocking when approaching structures such as downed trees, and patches of vegetation. Once captured, fish were measured (total) number of fish, length, weight) and then released alive. Fish standard length was measured to the nearest millimetre and weight was measured to the nearest gram. All fish >20 mm standard length collected within the sample reach were identified to species (or subspecies) (Figure 2).

Figure 2: Fish sampling. A. Netting fish after they had been shocked; B. Weighing and measuring the length of fish.

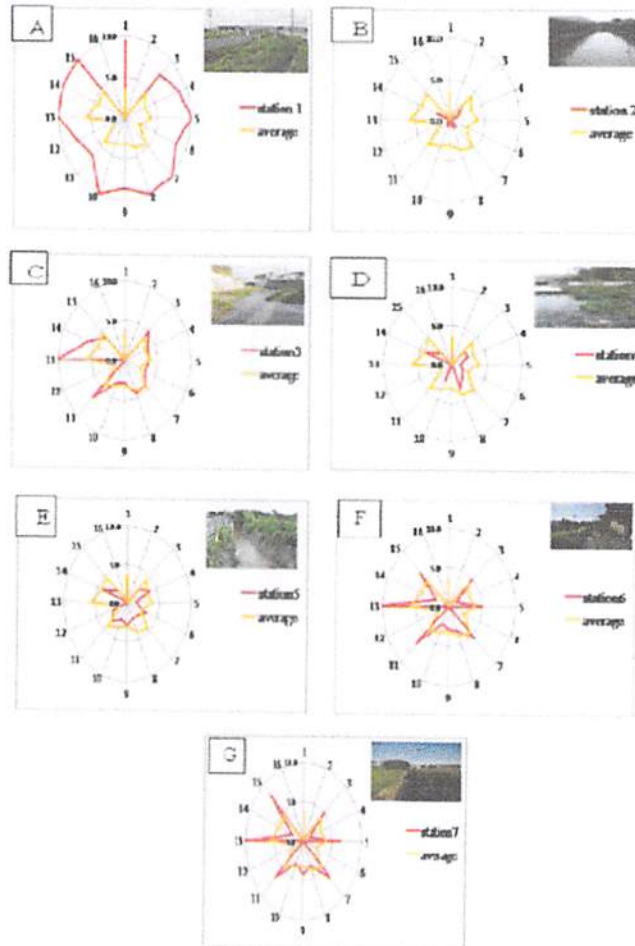
Figure 3: Fish biological integrity index.

Station 1 (Figure 3A). This station consisted predominantly (91%) of fast-current shallow habitats (riffles, rapids [two locations]), runs [4] and glides [6] and very few slow-current habitats (pools) about 16 cm in depth (Figure 4).

Gymnogobius petchiliensis. This station was considered to be in good condition, as all axes exceeded the average values, with the exception of axes 2 and 16 (i.e., exotic species and species that spawn in bivalves, respectively), which exhibited low values.

Station 2 (Figure 3B). This station consisted entirely of slow-current shallow habitats (slacks, and/or shallows) exhibiting uniform conditions (Figure 4). Overhanging vegetation, root wads and aquatic vegetation were absent at this station. *Cobitias Matsubarae* (31 individuals) was the only species present at this site. As a result, the index scores for station 2 were low, and it was considered to be in poor condition.

Station 3 (Figure 3C). This station comprised 42% fast-current shallow habitats (runs [three locations], and glides [1]). 42% slacks or shallows and 16% scour pools of 20 cm depth. Some vegetation and aquatic vegetation were present. Five fish species were found at this station: *Zacco platypus* (24 individuals), *Zacco temminckii* (2), *Misgurnus anguillicaudatus* (3), *Cobitias Matsubarae* (4), and *Rhinogobius sp.CB* (1). This station was assessed to be in moderate condition, as nearly all of the axes were similar to the average values. Axes 13 and 14 (i.e., fish that spawn on muddy bottoms and gravel bottoms, respectively) slightly exceed the average values.

Station 4 (Figure 3D). This station comprised 49% slow-current shallow habitats (scour pools of 18 cm depth and slacks/shallows), and 51% fast-current shallow habitats (runs [two locations] and glides [2]). Some vegetation occurred along approximately 20% of the channel. Three fish species were observed at this station: *Zacco platypus* (62 individuals), *Rhinogobius sp.CB* (5), and *Cobitias Matsubarae* (4). This station was considered to be in poor condition, as all axes were well below the average values.

Station 5 (Figure 3E). This station was in similar condition to station 2 in that, this area consisted entirely of slow-current shallow habitats (slacks or shallows) and very uniform condition however, some overhanging vegetation and some plants were present. Four fish were observed here: *Cobitias Matsubarae* (28 individuals), *Zacco platypus* (1), *Odontobutis obscura* (4), and *Cyprinus Carpio* (4). This station was assessed to be in poor condition, as nearly all of the axes were slightly below the average values. However, axes 12 (fish that spawn in vegetation) was slightly above the average value.

Station 6 (Figure 3F). This station comprised 75% slow-current shallow habitats (scour pools 19 and 35 cm deep and slacks/shallows), and 25% fast-current shallow habitats (riffles or rapids [two locations], and glides [1]). Overhanging vegetation, root wads and aquatic vegetation were absent. Five fish

Station 7 (Figure 3G). This station comprised 52% out of slow-current shallow habitats (scour pools 19 cm deep, and slacks or shallow and 48% fast-current shallow habitats (runs [one location], and glides [1]). Some vegetation occurred in approximately 10% of the channel. Six fish species were found at this station: *Cobitias Matsubarae* (151 individuals), *Odontobutis obscura* (5), *Rhinogobius sp.OR* (3), and one individual each of *Rhinogobius sp.CB*, *Misgurnus anguillicaudatus*, and *Gymnogobius petschiliensis*. This station was considered to be in moderate condition, as nearly all axes exhibited values similar to the average value, with the exceptions of axes 5, 13, and 15 (i.e., brackish water species, fish that spawn on muddy bottoms and fish that spawn on rocky bottoms, respectively), which were clearly above the average values.

Based on Figure 3, station 3 could be restored to enhance stream naturalness and environmental functions. Removing the concrete revetment would be the first step, and the river width would be broadened twice as wide as it used to be, then connecting the stream to riparian zones by providing a sloped river bank. Thereby ecotone and continuity between terrestrial and aquatic realm are restored. Various flow conditions were rehabilitated by installing approximately one meter sized rock. Such a restoration and improvement program could also reduce fine sediment deposition in spawning and/or rearing habitats by providing spawning vegetation and recruitment gravel within the stream to improve the quality and quantity of spawning habitat (see also Figure 5).

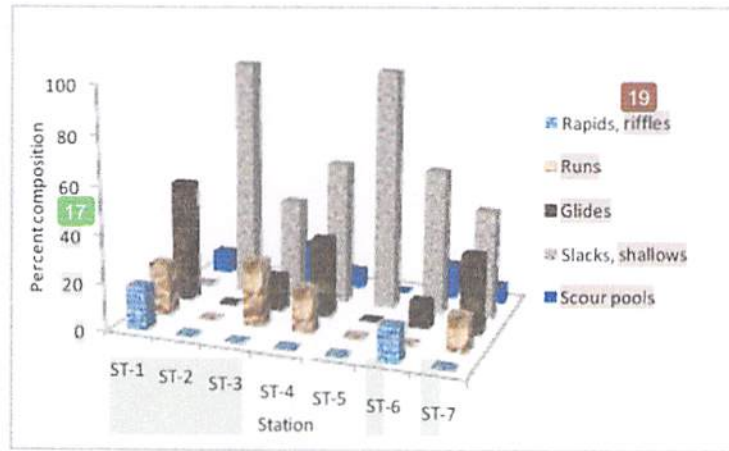
Figure 4: Composition of the flow ecology in the Kamisaigo river.
