## Debris flow velocity due to the collapse of natural dam

S Salahuddin<sup>1</sup>, F Maricar<sup>2</sup>, R T Lopa<sup>2</sup> and M P Hatta<sup>2</sup>

**Abstract.** Natural dam on Way Ela river was a landslide formation of Ulakhatu mount located at Negeri lima village, Distric Leihutu, Ambon island on 13<sup>th</sup> July 2012. The natural dam blockage the valley for 300 m wide and 200 m height with total 1,000 m dam area and providing 87 million m<sup>3</sup> volume of water storage. Slope failure trigger by slide area on the deeper surface structure leading to landslide. High risk landside increased by the high rainfall intensity of 432 mm/day and causing the failure of natural dam Way Ela. This study aimed to analyse debris flow velocity of the landslide of natural dam. Analysis performed based on debris during using geometric slope with empirical model system. PMF *Synder-Alexeyev* and GAMA-1 method and PMP frequency analysis equation method demonstrated that rainfall intensity data along with recurrent period of 100 years of  $Q_{peak}$  resulting debit volume of 448.85 m<sup>3</sup>/d. Furthermore, velocity estimation also showed that on 215.66 elevation high, allowable

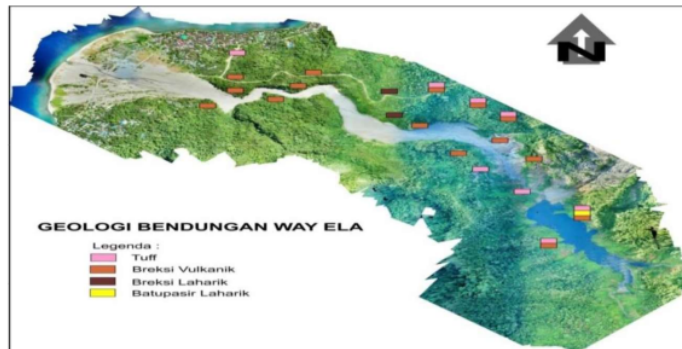
Figure 2. Map of natural dam geology distribution skeleton way ela.

Geological landscape around natural dam Way Ela commonly performed from discontinuity [1]. The discontinuity is a straight fracture which demonstrated general direction (southwest-northeast) and straight fracture normal. The nearest straight fracture facing northwest or toward DAS (drainage basin) Way Ela upper coarse or 5 km extend from Way Ela natural dam. These straight fracture also predicted as normal (southwest-northeast). Based on Regional geologic map scale 1:250.000 and mechanical process of natural dam breakage, it is predicted that there were five lithology type happens on natural dam Way Ela as presented on figure 2.

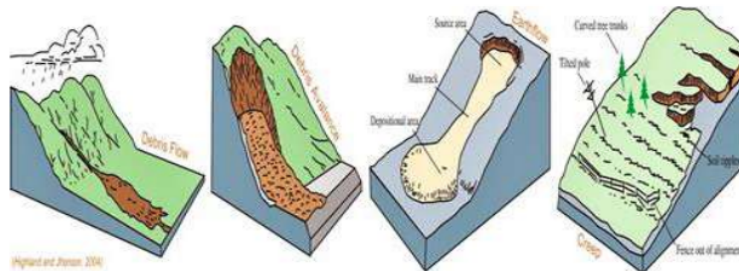
**Figure 3.** Illustration the debris flow.

Debris flow is moving mass of high sediment concentration on the river water that travels down a steep slope. The mass often contains larger rocks and driftwood. The flow moving on high velocity with destructive force risking human by significant damage and fatalities not only to the environment but also to human properties. Sediment movement by mass flowing and individual sediment movement are natural [2]. Both movements affected by the same factors such as debit flow, basic steepness, and basic material characteristic of the sediment. Force domination of the sediment movement is different, as well as individual sedimen movement by water pressure and mass sediment movement by gravitational force [2]. One form mass sediment movement is the flow of debris on this research is.

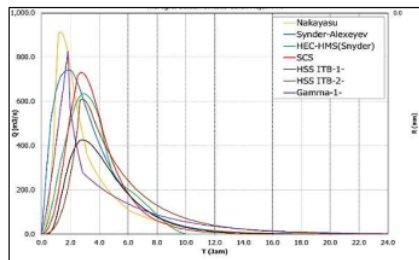
**Figure 5.** PMF hydrograph graph with rain re-period of Hersfield PMP.

**Table 4.** Discharge flood PMF from various hydrographs with PMP hersfield.

PMP (Hersfield)	HMS-Snyder	Snyder-Alexeyev	Nakayasu	SCS	HSS ITB 1	HSS ITB 2	GAMA-1	Rasional
$Q_{peak}$ (m <sup>3</sup> /s)	612.20	742.92	917.07	574.65	340.96	461.77	826.8	1216.12

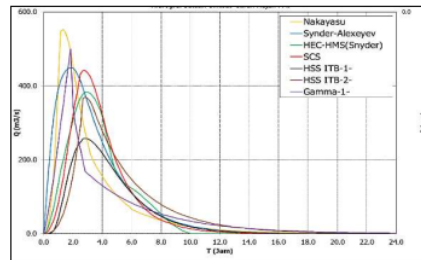
**Figure 6.** PMF hydrograph graph with rain reperiod PMP frequency analysis.

**Table 5.** Discharge flood PMF from various hydrographs with PMP frequency analysis.

PMP Log-Pearson 3	HMS-Snyder	Snyder-Alexeyev	Nakayasu	SCS	HSS ITB 1	HSS ITB 2	GAMA-1	Rasional
$Q_{peak}$ (m <sup>3</sup> /s)	437.10	530.46	654.81	410.31	243.45	329.72	499.7	868.34

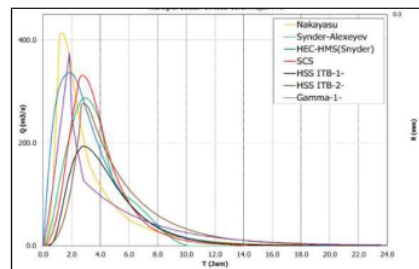
**Figure 7.** PMF hydrograph graph with rain re-period PMP Ishoyet PU.

**Table 6.** Discharge flood PMF from various hydrographs with PMP Isohyet PU.

PMP PU	HMS-Snyder	Snyder-Alexeyev	Nakayasu	SCS	HSS ITB 1	HSS ITB 2	GAMA-1	Rasional
$Q_{peak}$ (m <sup>3</sup> /s)	277.40	336.57	415.47	260.34	154.47	209.20	374.6	550.95

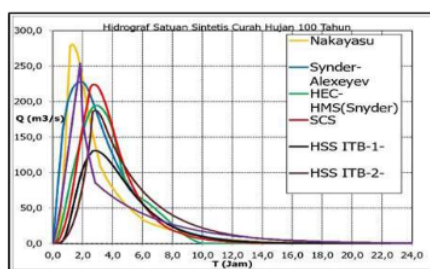
**Figure 8.** Graph synthesis hydrographs for rainfall reperiod 100 years.

Based on above calculation, method that fulfil requirement was debit PMF Synder-Alexeyev and GAMA-1 from PMP analysis frequency method. Subsequently, for routing Debit flooded PMF analysis frequency Synder-Alexeyev was used, and debit plan value used for spillway was 448.85 m<sup>3</sup>/s. Table 8 demonstrated characteristic of Way Ela river on the time of natural dam breakage. Debit flooded used rainfall intensity data on the day of dam failure.
