3
**Determining Direction Flow of Landfill Leachate
(Case Study: Antang Tamangapa Landfill)
Makassar, South Sulawesi Province**

M. F. Arifin^{1,2}, A. Imran², M. Ramli², M. P. Hatta³

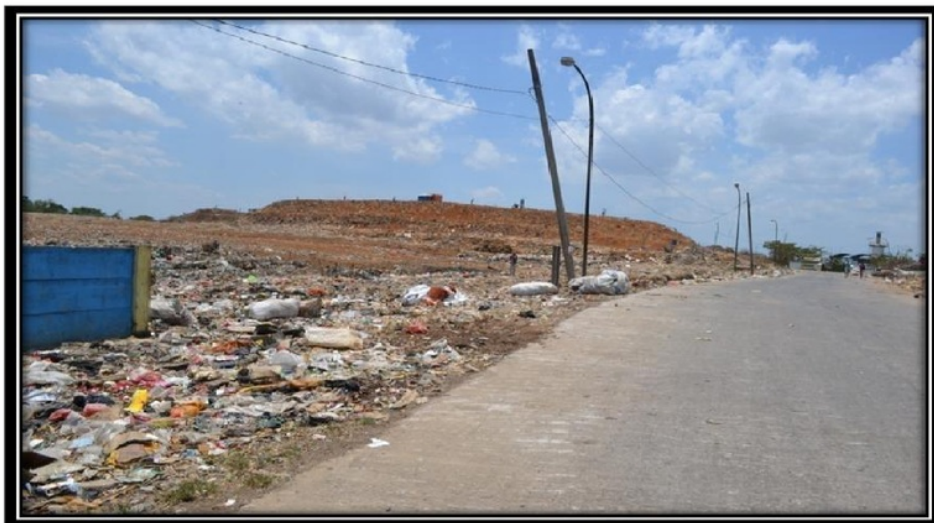
Figure 1. Showed morphology of location Antang Tamangapa Landfill

Topography of study area is slightly slope [8], ranging from 2°-4° (Figure 1). Three lithology

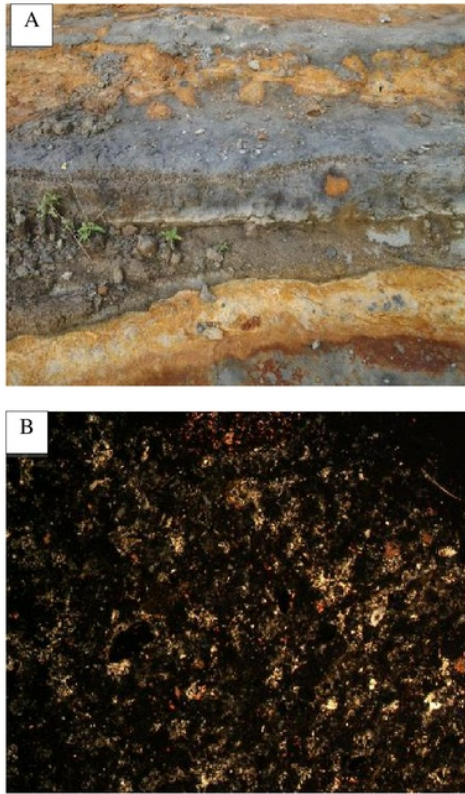
Figure 2. Outcrop view of coarse-grained tuff with colour light grey to yellow (a) and microphotograph view showing the mineral constituent (b).

Petrographic analysis of coarse tuff shows a pyroclastic texture, mineral size ranges from 0,25- 4 mm, Mineral compositions are pyroxene (5%), biotite (5-10)%, quartz (10-15)%, plagioclase (5)%, rock fragment (10%), volcanic glass (50-60)% and iron minerals (5%). Rock named "Vitric Tuff", [5], (Figure. 2). Structural geology composing of the area is joint and folding with dip 100 toward N48oE.

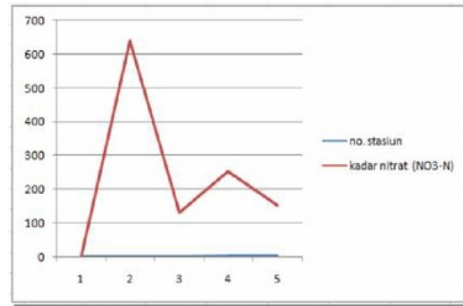
Figure 3. Nitrate Contamination ($\text{NO}_3\text{-N}$) at leachate sample

Groundwater contamination in the study area is mainly caused by disposal from Tamangapa Landfill. The contaminants are nitrate ($\text{NO}_3\text{-N}$), BOD, COD, and sulfate (SO_4). The highest concentration of nitrate is found at station 2 (638.8 mg/l) and the lowest concentration at station 1 (3.1 mg/l). Furthermore, chemical analysis of water from digging well shows a low concentration ranging from 15,795 mg/l to 1,948 mg/l. At the other location (station 2 and 4) leachate contamination of nitrate ($\text{NO}_3\text{-N}$) ranges from medium - high (200-638,8 mg/l).

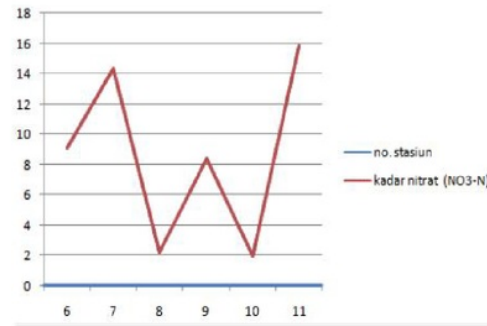
Figure 4. Nitrate Contamination ($\text{NO}_3\text{-N}$) at water sample that produced by well

Some places (station 6, 7, 8, 9, 10 and 11) have including in secure zone because have low

nitrate contamination Based on the regulation of Health Minister, RI value below safety threshold, according to the ketetapan Peraturan Menteri Kesehatan RI. No. 416/Men.Kes/Per/IX/1990 where the limit is 10 mg/l. Direction of nitrate distribution at leachate in the study area is relative to the Northeast that suitable with strike/dip stratification of the lithology, that is tuff. Contamination in the study area around 500 meters from the outer limit landfill had been determined by government.

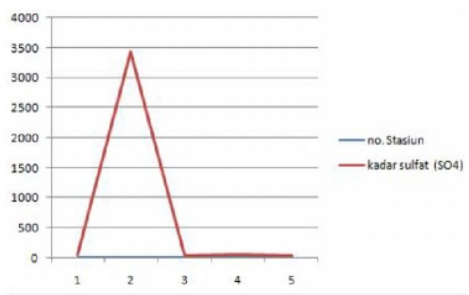
Figure 5. Sulfate Contamination (SO₄) at leachate sample

Leachate analysis at station 1-5 shows the highest SO₄ value at station 2 (3438,1 mg/l) and the lowest at station 3 (45,228 mg/l). Analysis of water produced by dug well at station 6-11 has the highest value at station 9 (22,6 mg/l) and the lowest at station 8 (7,29 mg/l). Accumulation of contamination unsure Sulfate (SO₄) in the study area is at station 2 is an area including highest scale impact, value 3000-3438,063 mg/l this area is danger zone where this station is peak area of the most accumulation of the rubbish. Whereas at station 6, 8, 10, and 11 are the area, including the lowest scale impact, value 7,295446396 - 400 mg/l this area is secure zone.

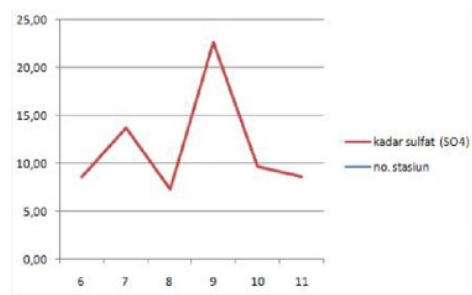
Figure 6. Sulfate Contamination (SO₄) at water sample that produced by well.

Water that produced by well at station 6, 7, 8, 9,10 and 11 including secure zone because have a value below safety threshold, according to the ketetapan Peraturan Menteri Kesehatan RI. No. 416/Men.Kes/Per/IX/1990, where the limit is below 400 mg/l. Direction of Sulfate distribution at leachate in the study area is relatively to the southeast, and suitable to the strike/dip of stratification lithology, that is tuff. Contamination is 50 meters from the outer limit landfill had been determined by government.

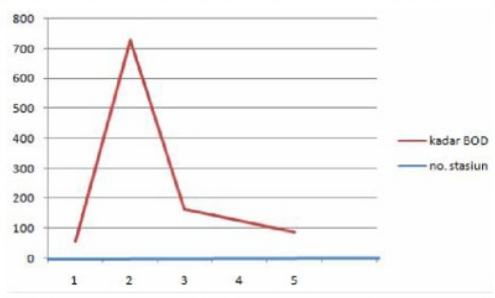
Figure 7. Contamination of BOD at leachate sample

Leachate analysis at station 1-5, the highest at station 2 with value 729 mg/l and the lowest at station 1 with value 58 mg/l. Analysis of water that produced by well at station 6-11, the highest at station 6 with value 9,26 mg/l and the lowest at station 7 with value 1,52 mg/l. Accumulation of contamination *Biological Oxygen Demand* (BOD) in the study area is at station 2 is area including highest scale impact, value 600-728,993042 mg/l this area is danger zone where this station is peak area of the most accumulation of the rubbish. Whereas at station 7, 8, 10, and 11 are the area, including the lowest scale impact, value 1,52 0625949-6 mg/l this area is secure zone.

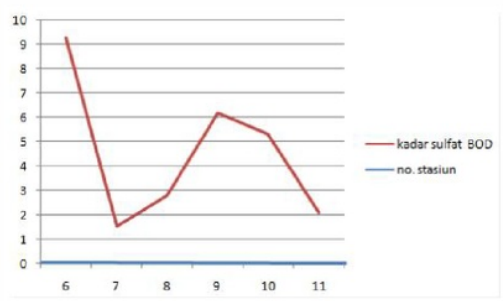
Figure 8. Contamination of BOD at water sample that produced by well

Water that produced by well at station 7, 8, 10 and 11 is a safety zone because it has a value below safety threshold, according to the *Ketetapan Peraturan Menteri Kesehatan RI. No. 416/Men.Kes/Per/IX/1990*, where the limit is 1,52062 - 6 mg/l mg/l. Direction of BOD distribution at leachate in the study area is relatively to the southeast, and suitable to the strike/dip of stratification lithology, that is tuff. Contamination is 1,5 kilometers from the outer limit landfill had been determined by government.

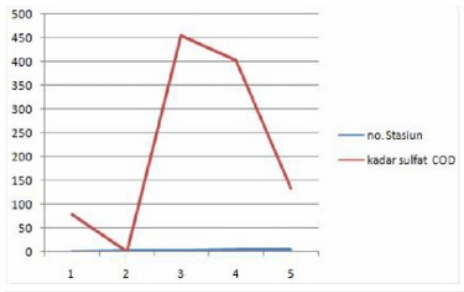
Figure 9. Contamination of COD at leachate sample.

Leachate analysis at station 1-5, the highest at station 2 with value 1277,2 mg/l and the lowest at station 1 with value 78,31 mg/l. Leachate analysis at station 6 - 11, the highest at station 9 with value 25,233 mg/l and the lowest at station 7 with value 2,48 mg/l.

Accumulation of contamination *Chemical Oxygen Demand* (COD) in the study area is at station 2-4 are the area, including medium-high scale impact, value 400-1277,18811 mg/l this area is danger zone where this station is peak area of the most accumulation of the rubbish. Whereas at station 7, 8, and 11 are the area, including the lowest scale impact, value 2,481146097 - 12 mg/l this area is secure zone.

Direction of COD distribution at leachate in the study area is relatively to the Northeast - southeast, and corresponds to the strike/dip of tuff stratification. Contamination is 1,5 kilometers from the outer limit landfill had been determined by government.

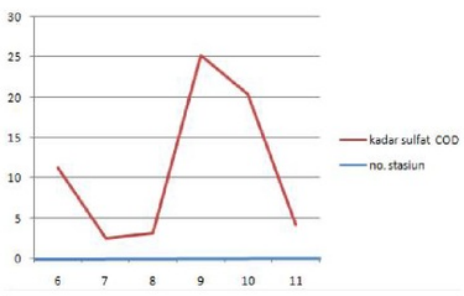
Figure 10. Contamination of COD at water sample that produced by well.

Water that produced by well at station 7, 8, and 11 including secure zone because having value below safety threshold, according to the *ketetapan Peraturan Menteri Kesehatan RI. No. 416/Men.Kes/Per/IX/1990*, where the limit is below 2,481146097 - 12 mg/l. Contamination of COD is higher than BOD because accumulation of anorganic rubbish is more dominant than organic rubbish in Tamangapa Landfill. This condition influences the content of chemical solvent.

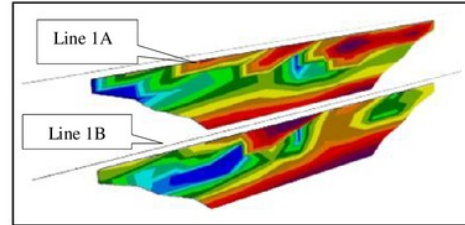
Figure 11. Geoelectric Inversion Section of resistivity line 1A and 1B

Line 1A resistivity value is interpreted that the position of contaminated water accumulation is at depth of 2,5 meters - 18,5 meters with resistivity value ranging from 0,348 .m to 1,62 .m. Meanwhile, at line 1B is interpreted that position of contaminated water accumulation is at depth of 2,5 meters -14 meters with resistivity value ranging from 0,145 .m to 1,34 .m , [7]. According to the resistivity value that found in the field corresponds to lithology of tuff.

Geoelectric measurement that using multichannel geoelectric equipment, resistivity method, wenner configuration. The result is 4 lines. Every geoelectric measurement have length of line is 150 meters and the space between electrodes is 10 meters. Line 1 consist in 2 lines with direction South Southwest - North Northeast. Line 2 consist in 3 lines with direction West Northwest - East Southeast. Line 3 consist in 3 lines with direction West Northwest - East Southeast. Line 4 consist in 2

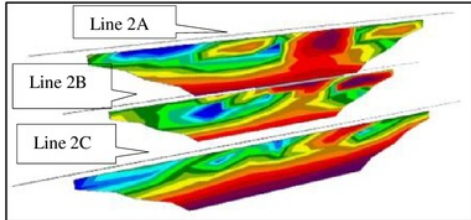
According to the resistivity that appropriate with lithology that found in the line 2, lithology that consist this study area is tuff. Line 2A can be interpreted that position of water accumulation that had been contaminated is at depth 5,5 meters - 22 meters and resistivity value is 1,22 .m until 4,37 .m. Meanwhile, at line 2B can be interpreted that position of water accumulation that had been contaminated is at depth 7,5 meters - 18,5 meters and resistivity value is 0,717 .m until 3,78 .m. And at line 2C can be interpret that position of water accumulation that had been contaminated is at depth 2,5 meters - 9 meters and 7,5 meters-24,5 meters,

with resistivity value is 0,609 .m until 2,49 .m , [7].

Figure 12. Geoelectric Inversion Section of resistivity line 2A, 2B and 2C.

Measurement of line 2 located at Northward of Tamangapa Landfill, coordinate 5° 17' 22.25" - 5° 17' 30.63" Southern Latitude, 119° 49' 01.43" - 119° 49' 16.80" Longitude East, with direction West Southwest - Southeast.

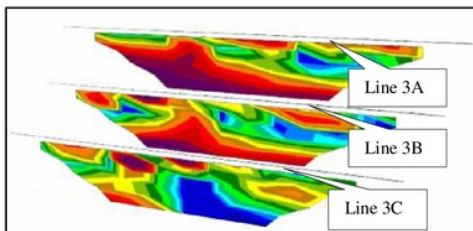
According to the resistivity that appropriate with lithology that found in the line 3, lithology that consist this study area is tuff. Line 3A can be interpreted that position of water accumulation that had been contaminated is at depth 2,5 meters - 12,5 meters and resistivity value is 0,477 .m until 1,58 .m. Meanwhile, at line 3B can be interpreted that position of water accumulation that had been contaminated is at depth 2,5 meters - 10 meters and 7,5 meters-24,9 meters, with a resistivity value is 1,56 .m until 5,33 .m. And at line 3C can be interpreted that position of water accumulation that had been contaminated is at depth 7,5 meters - 13 meters, with resistivity value is 0,624 .m until 99,3 .m , [7].

Figure 13. Geoelectric Inversion Section of resistivity line 3A, 3B and 3C.

Measurement of line 3 located at Southwestward of Tamangapa Landfill, coordinate $5^{\circ} 17' 82.01'' - 5^{\circ} 17' 89.35''$ Southern Latitude, $119^{\circ} 48' 01.12'' - 119^{\circ} 48' 88.08''$ Longitude East, with direction West Southwest – Southeast.

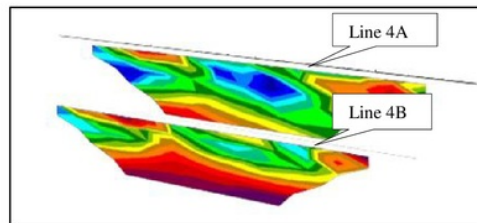
According to the resistivity that appropriate with lithology that found in the line 4, lithology that consist this study area is tuff. Line 4A can be interpreted that position of water accumulation that had been contaminated is at depth 18,5 meters - 24,9 meters and resistivity value is 0,504 .m until 2,34 .m. Meanwhile, at line 4B can be interpreted that position of water accumulation that had been contaminated is at depth 2,5 meters - 23 meters, with resistivity value is 0,210 .m until .m, [7].

Figure 6. Geoelectric Inversion Section of resistivity line 4A and 4B.

Measurement of line 4 located at Pesantren, southeastward of Tamangapa Landfill, coordinate $5^{\circ} 17' 76.27'' - 5^{\circ} 17' 65.88''$ Southern Latitude, $119^{\circ} 49' 49.51'' - 119^{\circ} 49' 42.85''$ Longitude East, with direction West Southwest - Southeast.

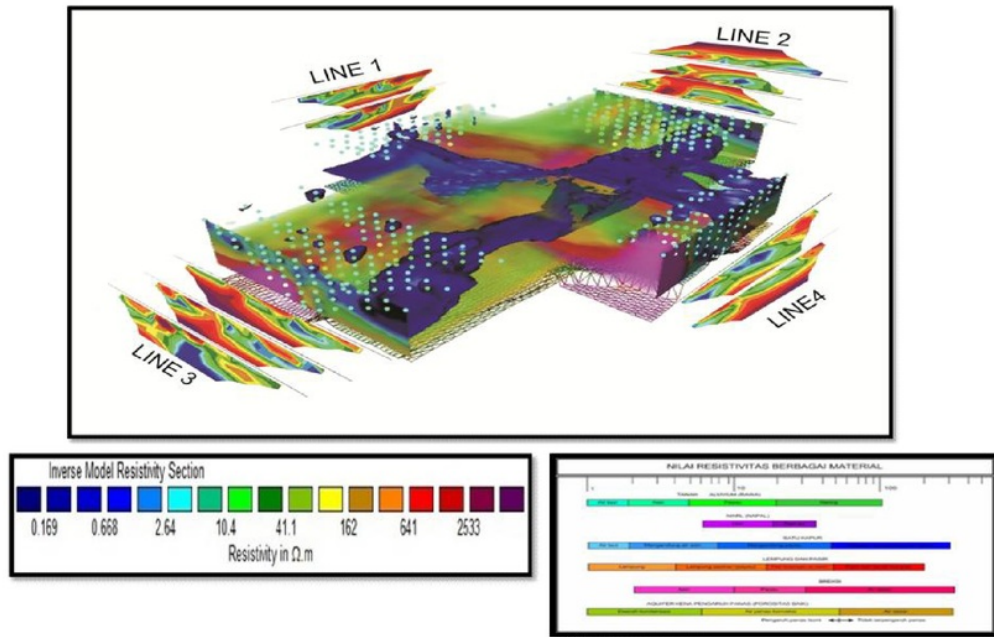
Figure 7. 3D Model the result of processing data at Antang Tamangapa Landfill

The geoelectric measurement using multichannel geoelectric equipment, resistivity method, wenner configuration giving the result of 4 resistivity lines, after that with Res2dinv program to analyze the data from all the resistivity lines and show the 3D Model of Tamangapa Landfill (Figure. 7). The leachate, by the advection process follow the groundwater flow relatively Northwest to the Southeast as the 3D Model result show blue colour.
