Celebes International Conference on Earth Science
(CICES) 2014

Geohydrological Investigation of Garbage Final Disposal Site (Case Study of Tamangapa Antang Site of Makassar, South Sulawesi Province)

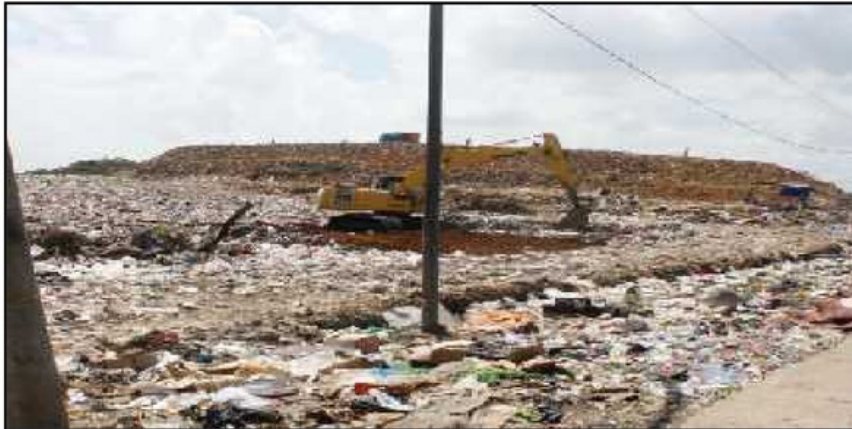
Photo 1. Shows a sloping plain on the morphology of the landfill waste Antang.

Morphographic approach is carried out through direct observation in the field and the area has a flat topography appearance. Based on the results of data processing and morphometric characteristics and a description of this area, the relief in the form of plain, (photos 1).
